| HV Battery Replacement due to P0A80 | | USA |
| 2012-2017 Prius C | | |

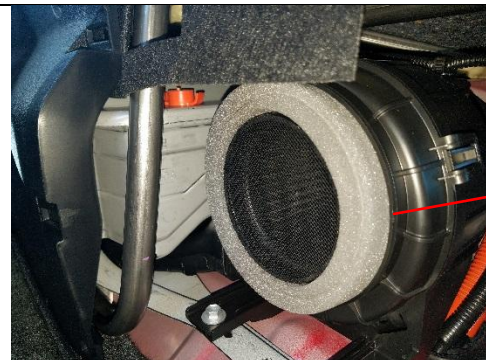
Filter mounted on the blower

- For vehicles produced prior to Sep. 2013 install a new filter G923G-52010
- For vehicles produced after Sep. 2013 clean the dust off filter
- Remove "Front Floor Cover for inspection" under rear seat on the driver side to inspect the filter

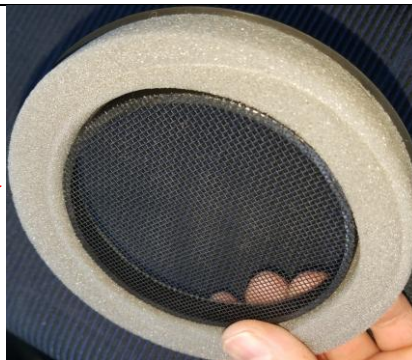
Remove filter for cleaning

New tighter mesh filter was implemented in Sep. 2013
