# Technical Service Bulletin

## 01 MIL on, DTC P20E900 or P20FE00 stored in ECM

01 18 81 2034359/5 July 31, 2018. Supersedes Technical Service Bulletin Group 01 number 18-80 dated July 30, 2018 for reasons listed below.

| Model(s) | Year | VIN Range | Vehicle-Specific Equipment |
|---|---|---|---|
| Q7 | 2012 - 2015 | All | TDI |

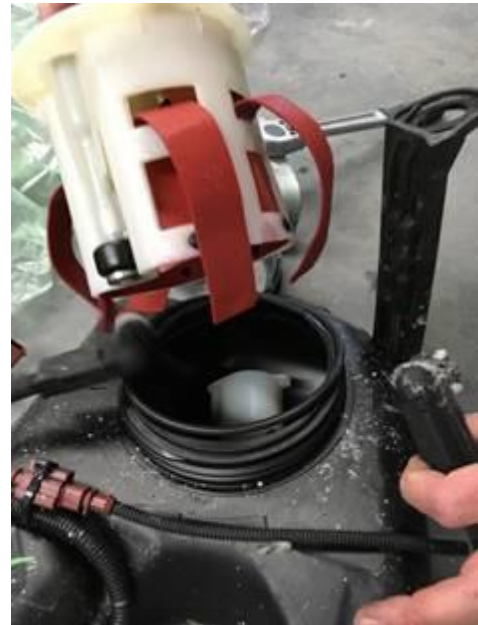
In vehicles produced during a certain period, the AdBlue filter seal within the level sensor module may have been damaged during the assembly process or the AdBlue filter housing may come loose over time. This can allow unfiltered AdBlue to be drawn into the delivery system, subsequently damaging the pressure sensor and reducing agent pump V437.

**Figure 1.** Filter element housing loose inside tank.

1. In cases with the above fault codes, remove the active tank according to instructions in the Elsa Repair Manual.
2. Remove the G684 Reducing Agent Tank level sensor.
3. Inspect the reducing agent filter housing which should be clipped to the G684 level sensor module. If the filter housing is loose (see Figure 1 and Figure 2), **then the G684 level sensor AND the V437 reducing agent pump must be replaced.**
