# Preliminary Information

PIT5487C Service Park Assist/Camera/Cruise/ and/or Front Park/Turn/Cornering Light Inop Blown Fuses (Front Fascia/Bumper Harness Chaffing)

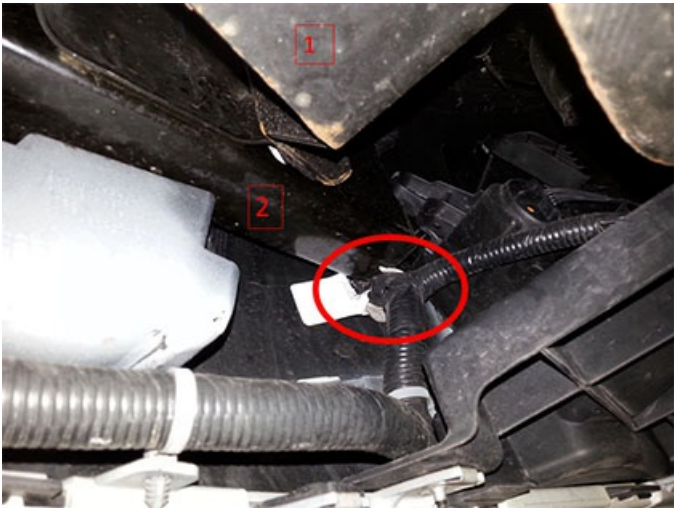
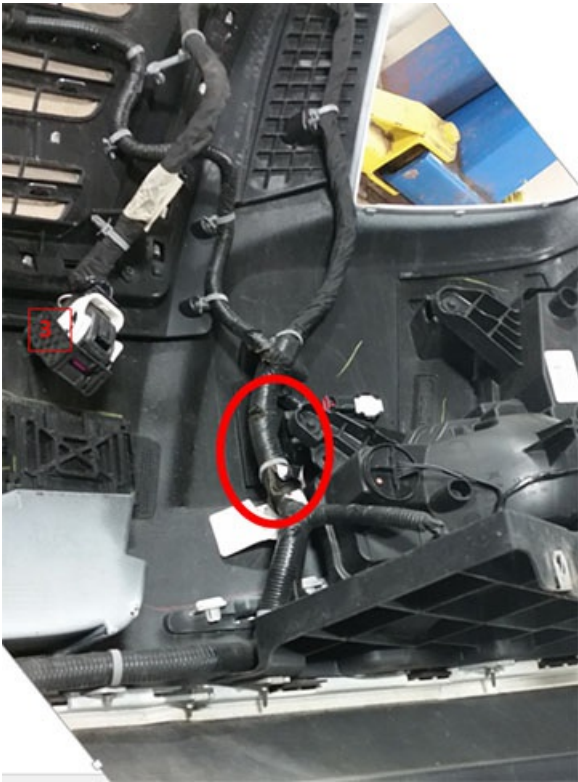
These concerns could be caused by the front fascia/bumper harness shorted at the end of the right front bumper bar (2), as shown below.

- 1. Right front frame rail
- 2. Right side of front bumper bar
- 3. X100 inline connector

The front fascia may need to be removed to make repairs to the wiring harness if any damage is found. After repairing any damaged circuits, reinstall the front fascia and pay close attention to reroute the wiring harness behind the front bumper bar and secure with a zip tie to the fascia, as shown below. This will prevent it from damage again in the future.
