# Technical Service Bulletin

## 35 Gearbox warning light on (DTCs P179E00, P179F00, P0700, P060A)

35 12 08 2032211/1 December 21, 2012.

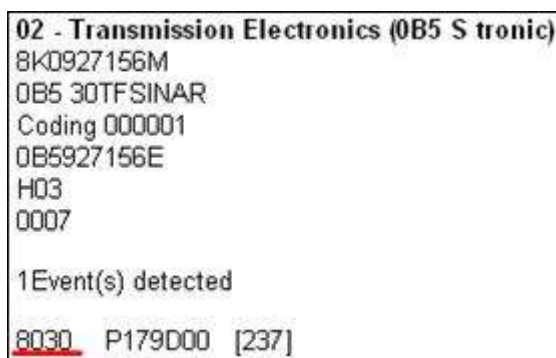
The DFCC is the 4-6 digit code that is typically listed before the fault code (Figure 1).

*Figure 1. DFCC 4-6 digit code listed before the fault code.*

**Tip:** Fault codes and DFCC codes must match *exactly* or this TSB should not be followed.

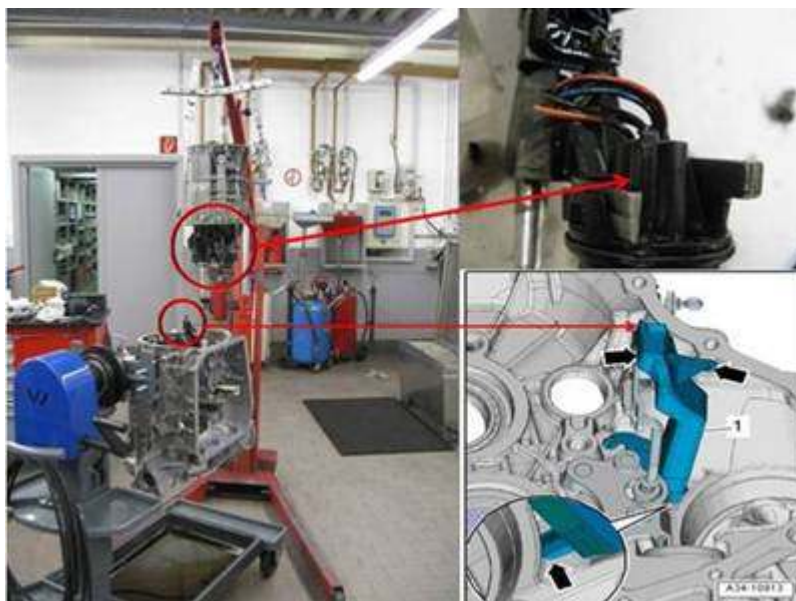
**Tip:** Use caution when lifting or lowering intermediate housing to avoid damage to components (Figure 2).

**Figure 2.** Caution points: Drip tray- Sensor module connector.

1. If faults shown in Condition above along with the matching DFCC's are present, replace the G676 sensor module with circuit board by following instructions in *ELSA >> Repair manual >> Transmission >> S Tronic Transmission Internal Components Gears, Shafts >> Removal and Installation >> Sensor Module with Transmission Input Speed Sensor -G612-, -G632-, -G676- Circuit Board 3*
2. When replacing the sensor module, its wiring loom must also be replaced.

**Note:** These instructions require transmission case disassembly. Audi Academy course #950224 is required viewing before attempting repair service. Complete the course and the assessment #950224B before attempting repair or warranty claim may be denied. This can be found on the Audi Academy CRC site.
