# Tech Tips

TT 24-08-01

**1998-2005 Models with 1.8T Engine - Pressure Loss Fault Code P1297**

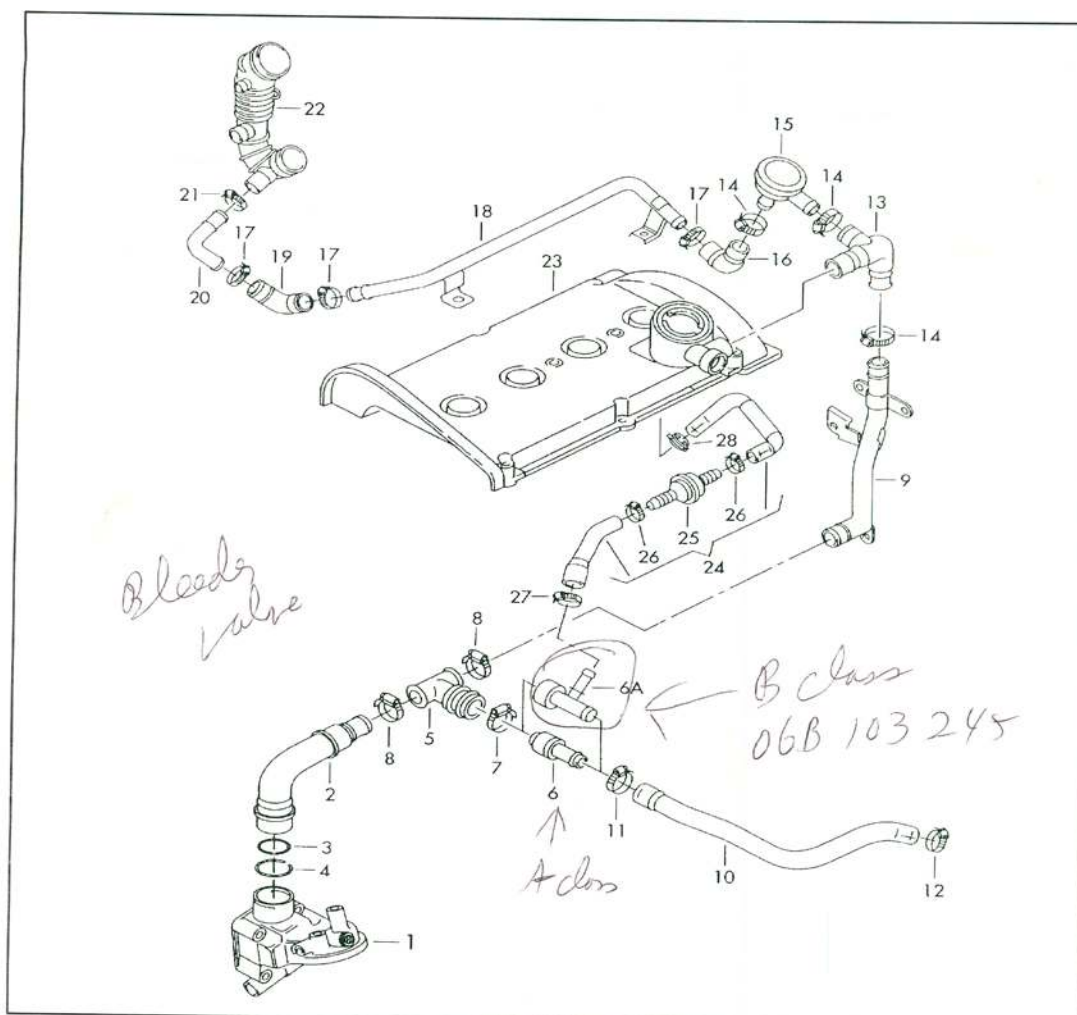
Fault code P1297 may be set and fuel mixtures may go lean if the vehicle is driven under load or revved up and then returned to idle. If these symptoms should occur, it is recommended to check the pressure relief valve in the crankcase breather system (as shown below) to ensure the valve is moving freely. Replace as necessary.
