## Advanced Technical Information

Panamera (971)

1710 9787

### Ground Strap Loose or Coated, Causes Starter Issues (P305400)

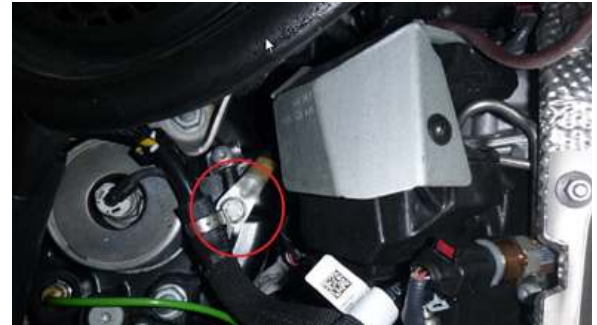
Figure 1

This fault and failure combination often results from a faulty ground strap connection. (See figure 1.) The bolt at the ground strap could (a) be loose or (b) have an incidental coating of paint. Both of these defective conditions would have been present from the time of vehicle production at the assembly plant. Porsche has corrected the assembly process to prevent issue recurrence on future vehicles.

While this failure is most likely to occur on V8 and diesel engines, it will possibly occur on other engine variants as well.

Service Information: Please inspect for and correct the two conditions referenced above first. Clean the contact surfaces and remount the bolt using 15 ft lbs (20 Nm) of torque.

Typically, the starter is not defective and thus should not be replaced. You should only consider replacing it after inspecting the ground strap connection for the defects indicated above and verifying a starter defect.
