# Technical Bulletin

20 17 02 August 15, 2017 2034072 Supersedes Technical Bulletin V201602 dated November 21, 2016 to include an additional DTC.

**Activated Charcoal Filter System, Solenoid Valve 1 -N80- (Canister Purge Valve) Diagnosis**

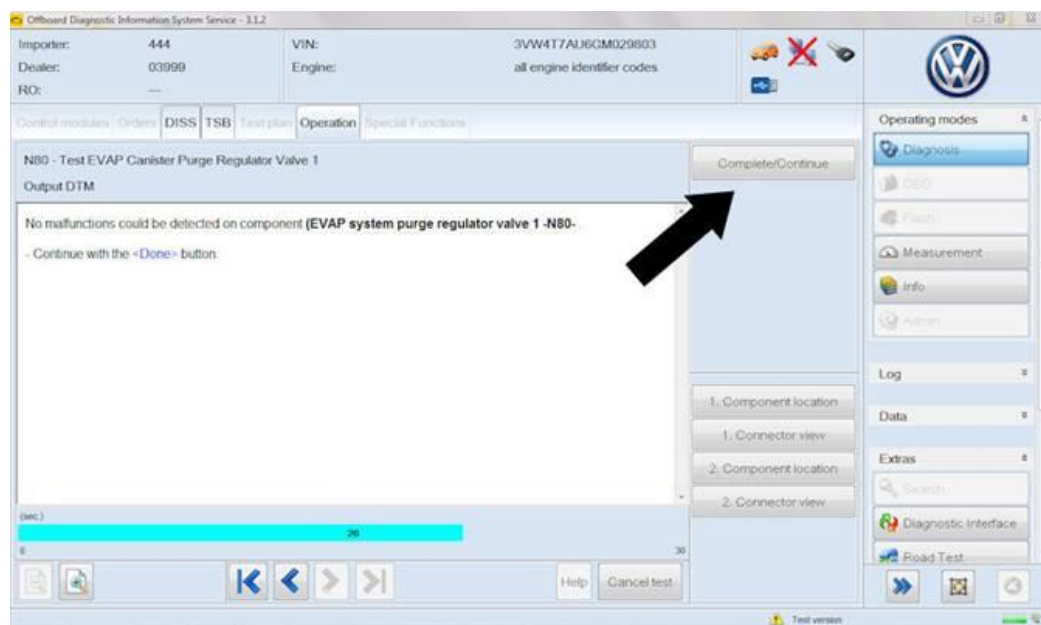
When the test starts, the -N80- Canister Purge Valve will be activated via the output diagnosis test mode, listen and/or feel for an audible “click” sound coming from the -N80- purge valve. The audible “click” sound may be heard easier if the vehicle hood is open.

- If audible “click” noise is heard, the -N80- Activated Charcoal Filter System Solenoid Valve is operational (Figure 6, 7 and 8), and a vacuum check must be performed to verify if the valve is sealing properly.
- If audible “click” noise is not heard this bulletin does not apply, continue Guided Fault Finding based diagnosis.

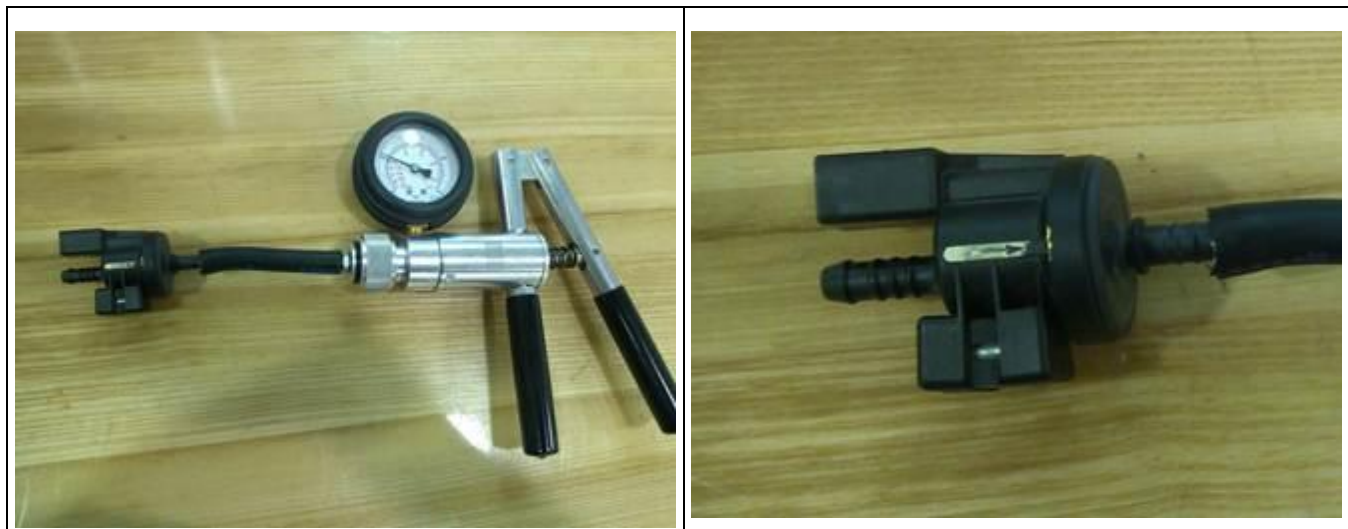
**Figure 10**

- Correct installation of VAS6213 vacuum pump on the Canister Purge Valve -N80- (Figure 10, Bosch valve shown below).

- If the valve holds vacuum, **do not** replace -N80- Activated charcoal filter system, solenoid valve. The canister purge valve is not causing the fault codes to store. This bulletin does not apply. Continue Guided Fault Finding based diagnosis for faults.
- If the valve does not hold vacuum, replace -N80- Activated charcoal filter system, solenoid valve. Perform leakage test to verify there are no further issues.
- Clear any DTCs that were caused by disconnecting the canister purge valve electrical connector during the test.

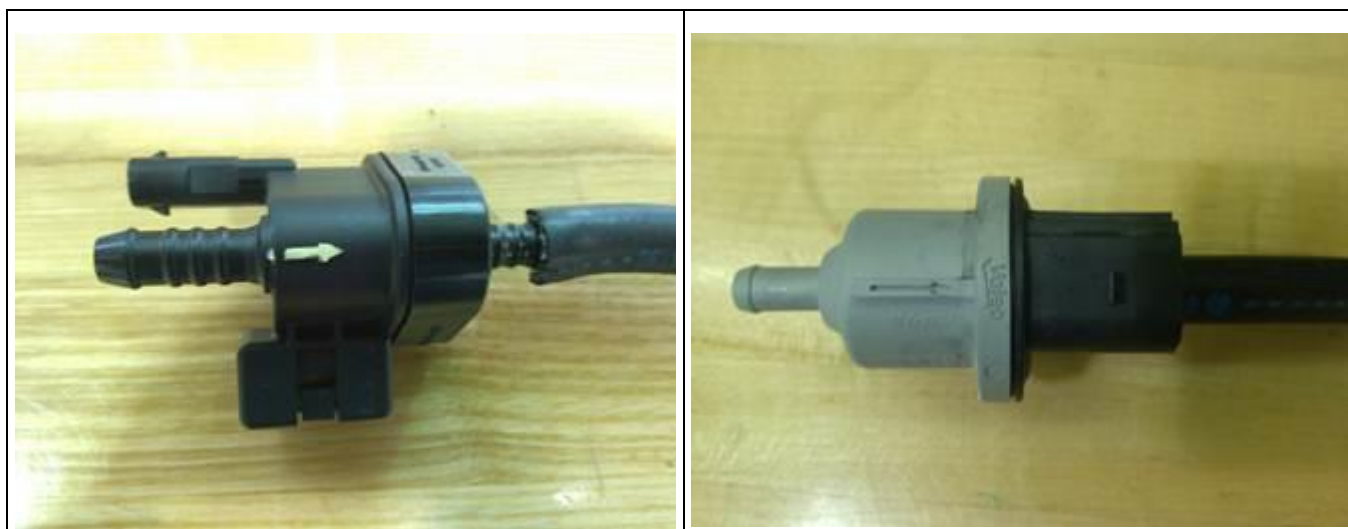
**Figure 11**

- Correct installation of VAS6213 vacuum pump on the Canister Purge Valve -N80- (Figure 11, Freudenberg and Valeo valves shown below).

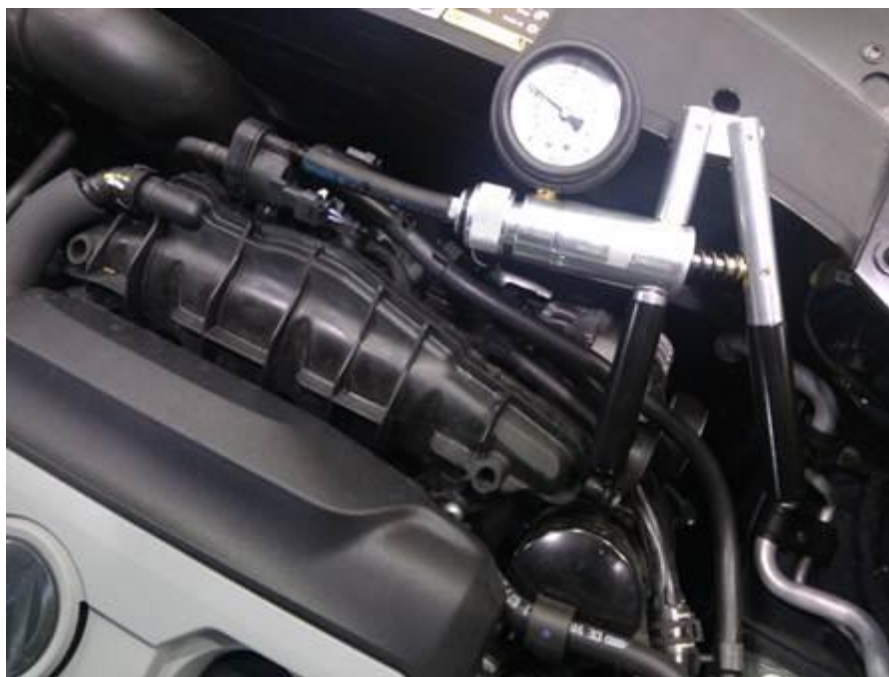
**Figure 12**

- With the engine OFF, remove rubber hose from EVAP Canister side of -N80- Canister Purge Valve.
- Install VAS6213 vacuum pump to the -N80- purge valve as shown below (Figure 12).

- Disconnect the electrical connector from the purge valve.
- Start the engine and allow it to idle.
- Monitor the reading on the vacuum gauge.

The reading should be at 0 PSI or higher (no vacuum should be measured).

- If there is no vacuum present at the vacuum gauge, **do not** replace -N80- Activated charcoal filter system, solenoid valve. The canister purge valve is not leaking and is not causing the fault codes to store. This bulletin does not apply. Continue Guided Fault Finding based diagnosis.
- If vacuum is present, replace -N80- Activated charcoal filter system, solenoid valve. Perform leakage test to verify there are no further issues.
- Clear any DTCs that were caused by disconnecting the canister purge valve electrical connector during the test.

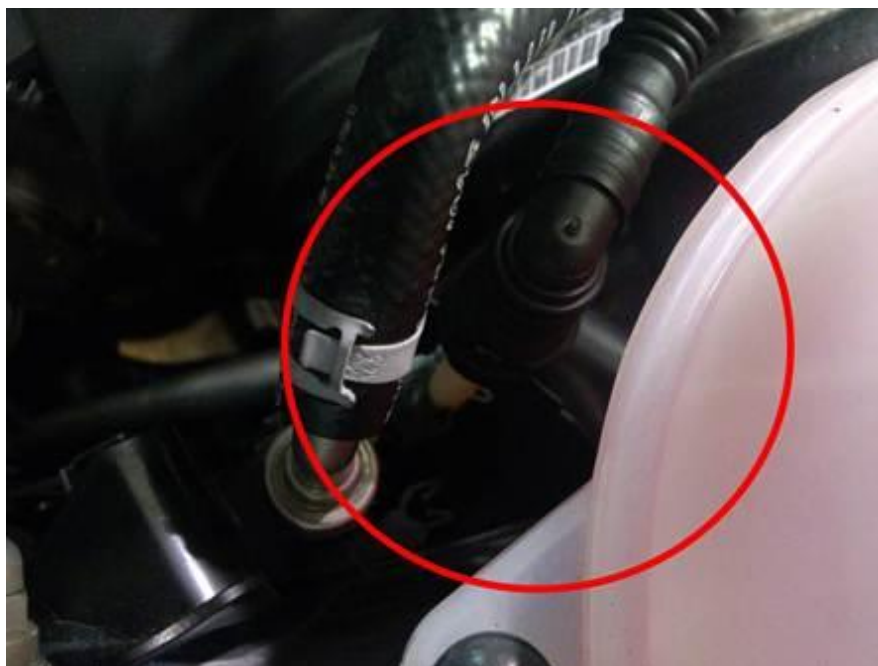
Figure 13

- With engine off, disconnect EVAP line connection to -N80- purge valve beneath coolant expansion tank shown below (Figure 13).

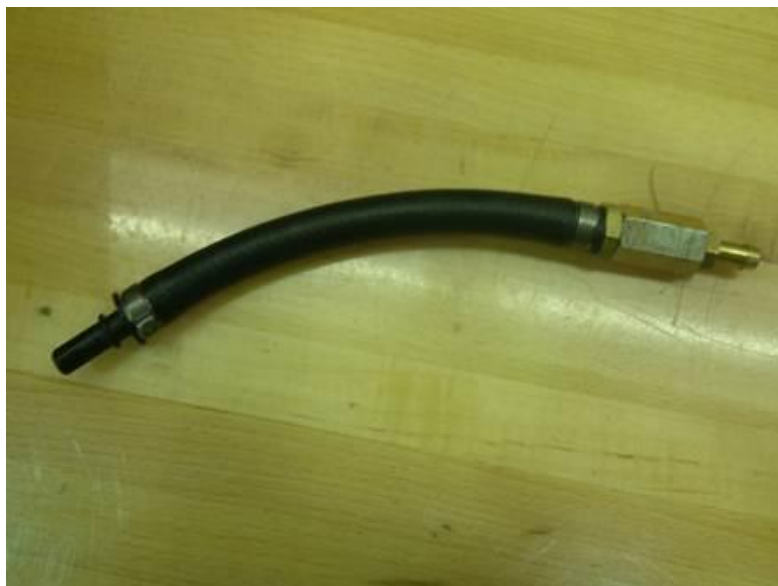
**Figure 14**

- Use the VAG1318 pressure gauge kit to assemble an adaptor using tool numbers VAG1318/24, VAG1318/11, and the female to female adaptor for the pressure gauge as shown below (Figure 14).

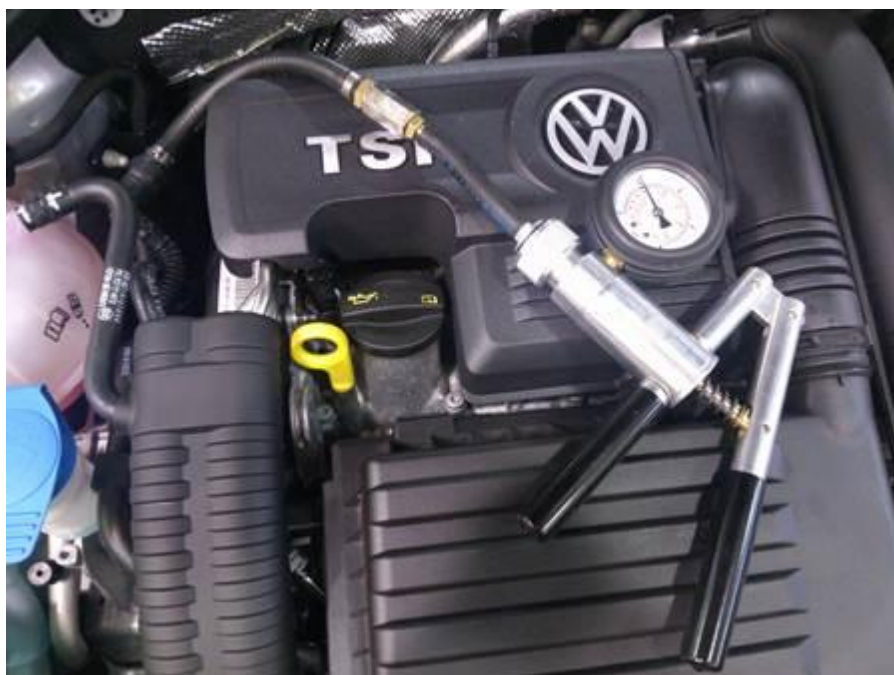
**Figure 15**

- Install the adaptor to the EVAP line connection to the -N80- purge valve and connect VAS6213 vacuum pump to the adaptor as shown below (Figure 15).

- Disconnect the electrical connector from the purge valve.
- Start the engine and allow it to idle.
- Monitor the reading on the vacuum gauge.

The reading should be at 0 PSI or higher (no vacuum should be measured).

- If there is no vacuum present at the vacuum gauge, **do not** replace -N80- Activated charcoal filter system, solenoid valve. The canister purge valve is not leaking and is not causing the fault codes to store. This bulletin does not apply. Continue Guided Fault Finding based diagnosis.
- If vacuum is present, replace -N80- Activated charcoal filter system, solenoid valve. Perform leakage test to verify there are no further issues.
- Clear any DTCs that were caused by disconnecting the canister purge valve electrical connector during the test.
