Preliminary Information

PIC6073E Diagnostic Tip: EL-51578 MOST Bus Diagnostic Tool Kit  
Models

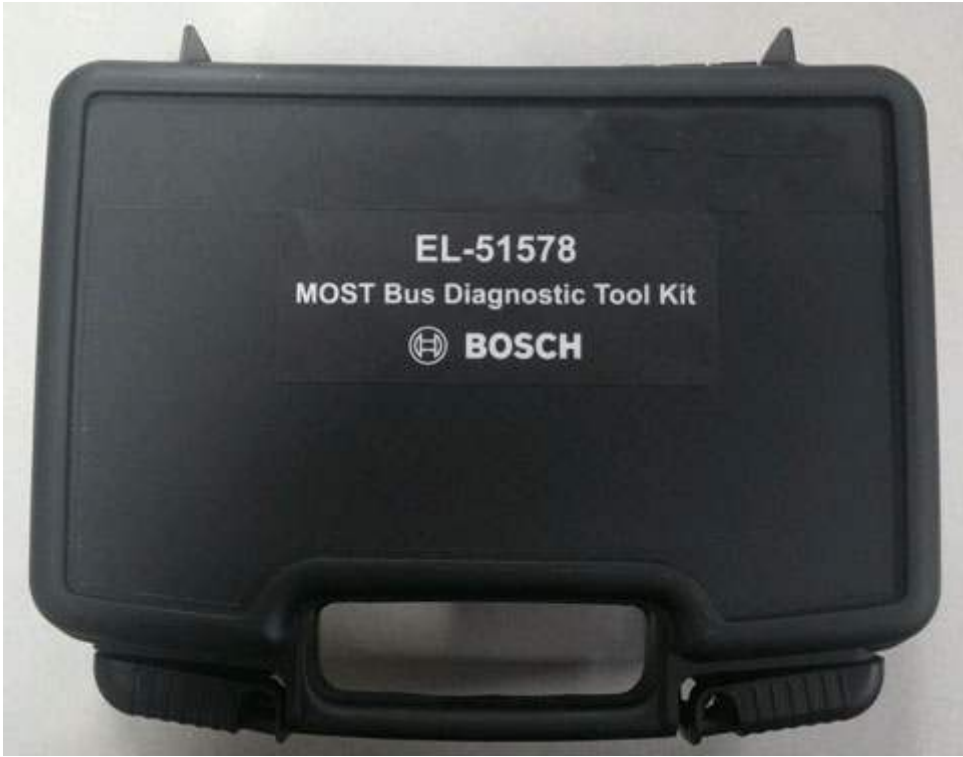
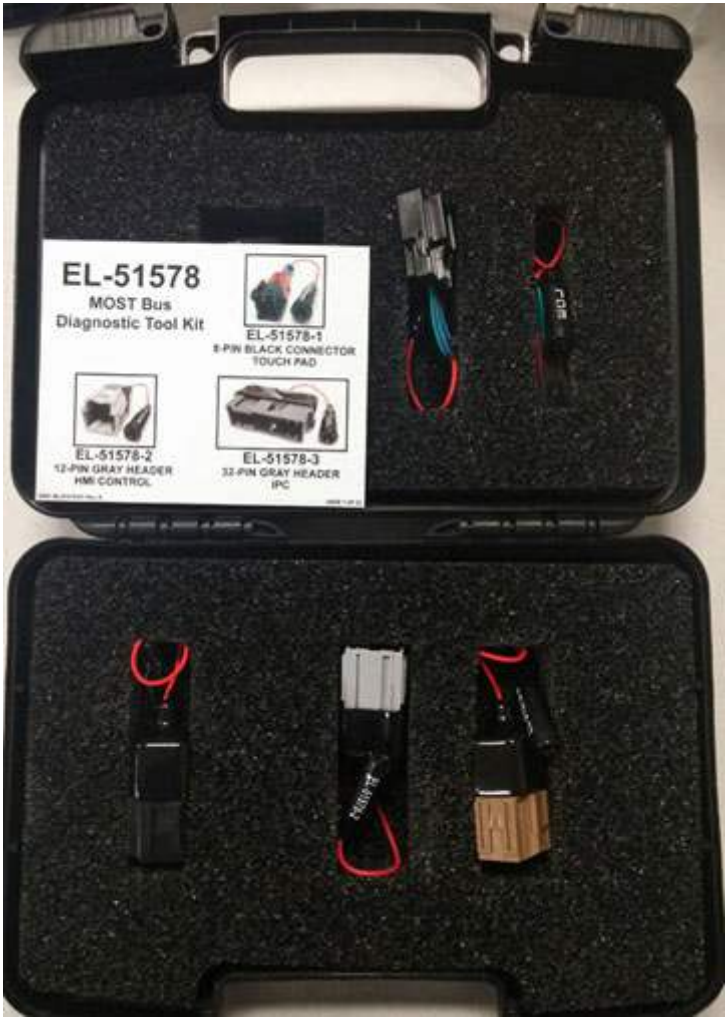
The EL-51578 MOST Bus Diagnostic Tool Kit has been released to aid in diagnosing MOST buss concerns. The kit contains header connectors that are installed to bypass MOST bus modules. The bypass connectors also contain a terminal for verifying ECL voltages (MOST control circuit). The kit does not contain a bypass for the radio, which is the master of the buss.

The Radio U0028 sym00 will be used to determine MOST buss state of health. If the module with the concern is bypassed, the Radio U0028 sym00 will report as history. Infotainment functions will return with the exception to what the bypassed module controls. For example, if the amplifier is bypassed and DTC U0028 sym00 changes from current to history, ignore the symptom of no audio as the amplifier is bypassed. Other examples, display will be inoperative with HMI bypassed. DIC and steering wheel controls will be inoperative with IPC bypassed. CD/DVD will be inoperative with Media disc player bypassed.

Usually there may be 1 of 2 modules suspect with a current Radio U0028 sym00 set depending on which Node positions are listed. If both of these 2 suspect modules are bypassed and the Radio U0028 sym00 stays current, check the MOST bus circuits and ECL for opens, shorts, high resistance, or terminal concerns.
