# Technical Service Bulletin

| Topic | Front or rear door(s) - Soft close function failure - DTC B122D29 Bentayga 22MY - 25MY |

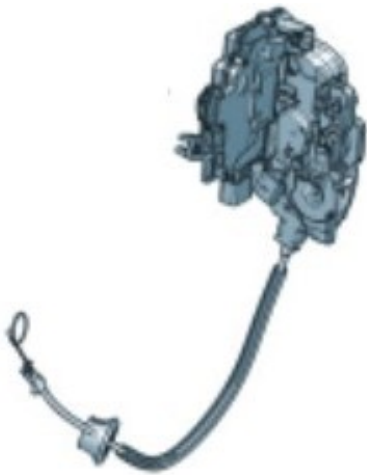
**Note:** For reference purposes Figure 1 shows an example of a door latch

**Step 2 - Door latch replacement**

Referring to Rep.Gr 57 (front) or Rep.Gr 58 (rear) replace the applicable door latch

**IMPORTANT:** The operative must ensure the door trim is refitted as per all Rep.Gr instructions before conducting the remaining steps
