# Technical Service Bulletin

CHECK ENGINE LIGHT ON WITH DTC P0126:00

Bulletin No.: 01-001/26

Last Issued : 01/07/2026

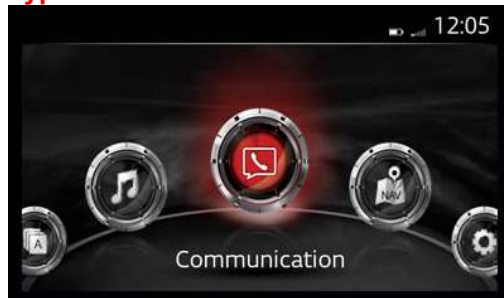
**Type A:**

**NOTE:** 2020 CX-5 with **Type B** Mazda Connect (7th Gen Infotainment) use MDARS and models with **Type A** Mazda Connect (6th Gen Infotainment) use IDS.

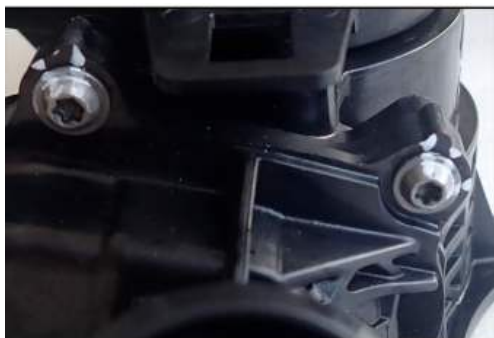
**Marking Example 1:** Draw marking lines over the screws and the thermostat cover as shown above.

a) Mark the four (4) screws and the respective holes before loosening them to ensure that the screws are placed in their original holes when reinstalling.

**NOTE:** If the screws are not reinstalled in their original holes, the holes may become deformed.

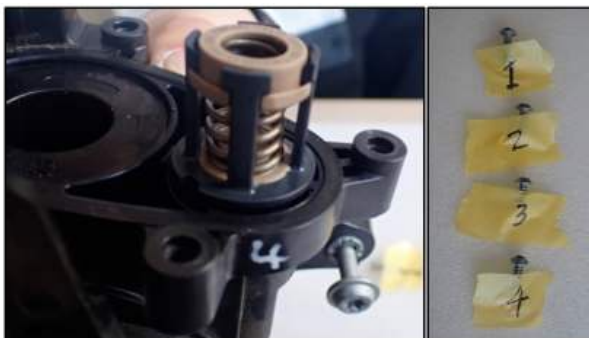
**Marking Example 2:** Number each screw and their respective hole as shown above.

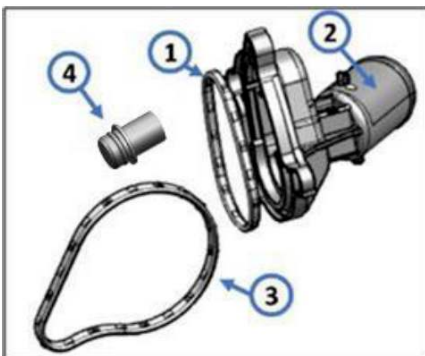
**Dummy Plug for CCV set includes:**

1. Thermostat cover gasket\*
2. Thermostat cover
3. Water outlet gasket
4. **Dummy** Plug

\*Thermostat cover gasket is already assembled to the thermostat cover.

Fig. 2: Correct dummy plug (4) orientation to the thermostat cover (2).
