# Technical Service Bulletin

**ENGINE TEMPERATURE AND HEATER PERFORMANCE  
CONCERNS WITH OR WITHOUT DTC P0126:00**

**Bulletin No.: 01-001/26**

**Last Issued : 01/30/2026**

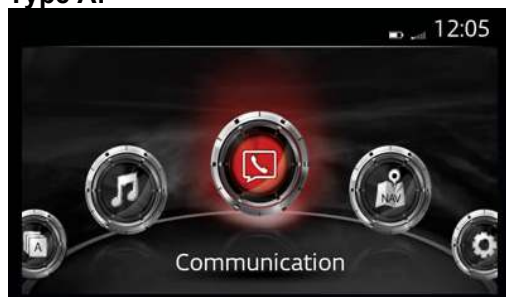
**Type A:**

**NOTE:** 2020 CX-5 with **Type B** Mazda Connect (7th Gen Infotainment) use MDARS and models with **Type A** Mazda Connect (6th Gen Infotainment) use IDS.

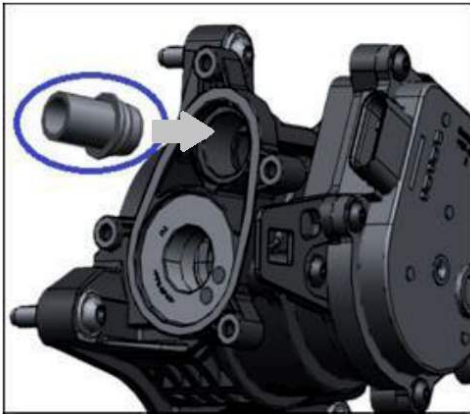
Fig. 1: Shows correct orientation with the flat side (or short end) of the dummy plug (with o-ring) going into the upper hole (see arrow) of the CCV.

- Pay close attention to the orientation of the dummy plug when installing it into the coolant control valve (CCV).
- DO NOT force the dummy plug in the wrong direction.
- If the dummy plug is installed in the wrong direction, it may cause DTC P0126:00 to return and slow heating of the HVAC system.
- Be aware that Fig. 1 and Fig. 2 (below) are both correct, but show the dummy plug orientation from opposite ends.

**NOTE:** Be sure to install the dummy plug into the correct CCV hole.

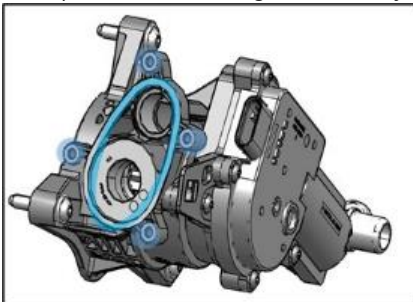
- a) Before installing the dummy plug into the CCV, check the mounting area for dirt and clean the area.

- b) When installing the dummy plug into the CCV, push it firmly until it makes a clicking noise to ensure it has been installed properly.

- Insert the dummy plug so that its notch matches the protruding area in the CCV hole.
- Add 1-2 drops of coolant as necessary to the O-ring to help slide it into the thermostat cover.
