# Service Bulletin

Bulletin No.: PIC6649

**Subject: Poor Active Grille Air Shutter Performance w/ DTC P059F Set**

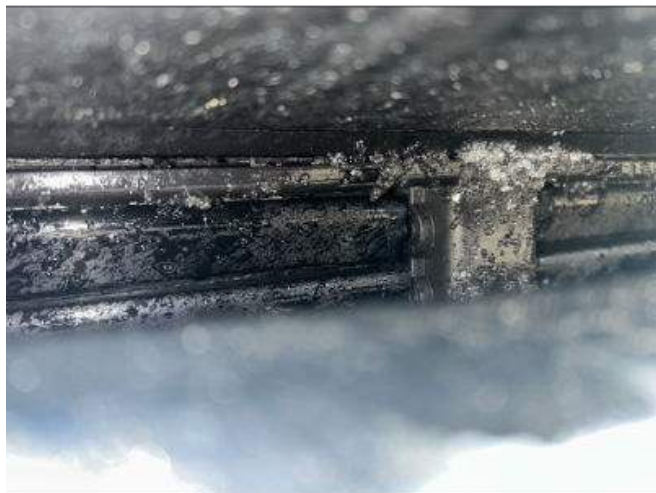
7099336

| <b>Cause</b> | The front fascia air shutter may also have snow/ice build-up, causing the shutter to not be able to calibrate/reach its travel angle as designed.<br>Once build-up is gone, the message and DTC should disappear. |

Any snow/ice build-up, if present, should be cleared from front fascia air shutter, see image below.
