# Technical Service Bulletin

**ENGINE TEMPERATURE AND HEATER PERFORMANCE  
CONCERNS WITH OR WITHOUT DTC P0126:00**

**Bulletin No.: 01-001/26**

**Last Issued : 03/04/2026**

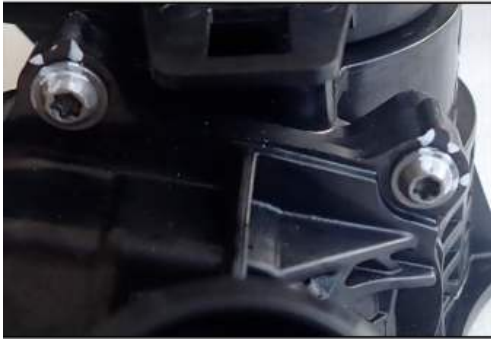
**Marking Example 1:** Draw marking lines over the screws and the thermostat cover as shown above.

a) Mark the four (4) screws and the respective holes before loosening them to ensure that the screws are placed in their original holes when reinstalling.

**NOTE:** If the screws are not reinstalled in their original holes, the holes may become deformed.

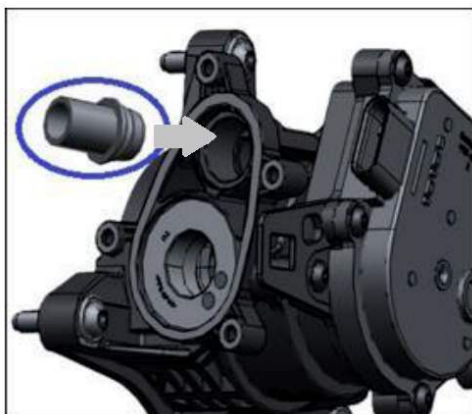
Fig. 1: Shows correct orientation with the flat side (or short end) of the dummy plug (with o-ring) going into the upper hole (see arrow) of the CCV.

- Pay close attention to the orientation of the dummy plug when installing it into the coolant control valve (CCV).
- DO NOT force the dummy plug in the wrong direction.
- If the dummy plug is installed in the wrong direction, it may cause DTC P0126:00 to return and slow heating of the HVAC system.
- Be aware that Fig. 1 and Fig. 2 (below) are both correct, but show the dummy plug orientation from opposite ends.

**NOTE:** Be sure to install the dummy plug into the correct CCV hole.

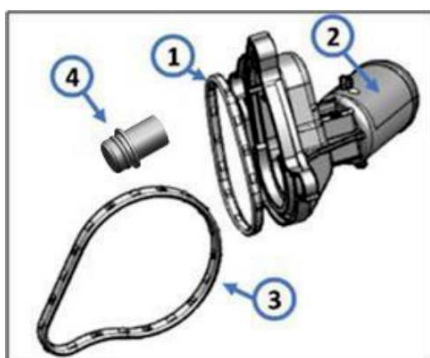
**Dummy Plug for CCV set includes:**

1. Thermostat cover gasket\*
2. Thermostat cover
3. Water outlet gasket
4. Dummy Plug

\*Thermostat cover gasket is already assembled to the thermostat cover.

Fig. 2: Correct dummy plug (4) orientation to the thermostat cover (2).
