## Technical product information

| <b>Topic</b> | DTC B101629 and/or B12F129 and/or B151329 evident with 0015 (Airbag) with Airbag Indicator Lamp - Illuminated |
| <b>Transaction No.</b> | 2080902/2 |

DTC B101629 and/or B12F129 and/or B151329 evident with 0015 (Airbag) with  
Airbag Indicator Lamp - Illuminated

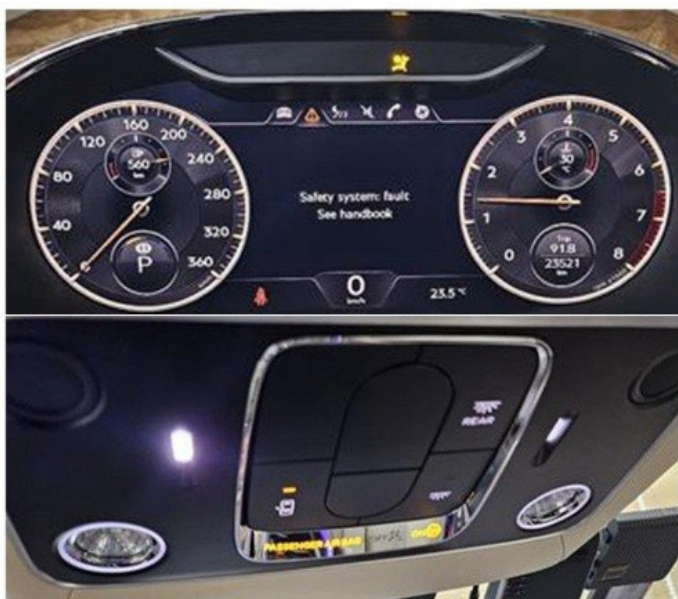
The customer reports that the airbag warning lamp is illuminated in the instrument cluster and the front passenger airbag indicator lamp within the roof console does not function.

**Figure 1.** Airbag warning illuminated in the instrument cluster

Customer findings of airbag warning lamp illuminated in the instrument cluster verified in the workshop with the following DTCs stored in the airbag control module (address word 0015):

- B101629: Front passenger airbag - disabled- indicator lamp implausible signal – symptom code 9442857
- B12F129: Front passenger airbag -enabled- indicator lamp implausible signal – Symptom code 9629993
- B151329: Front Passenger airbag indicator lamp, text illumination implausible signal – symptom code 9769769

An implausible signal from the passenger airbag indicator is being reported to the airbag control unit. This behaviour is consistent with a connection or fitment issue at the roof console indicator module. A connection check and module fit inspection is required. Refer to the *Measure* section for the approved service action.

1. Inspect the roof console module and ensure the housing is fully clipped together.

Gaps or incomplete assembly may cause the indicator not to function.

2. Remove the front roof console module, check all electrical connectors at the roof console module.

3. Confirm terminals are fully seated, check for bent, recessed or damaged pins

4. Disconnect and reconnect the roof console module.

5. Clear DTCs and recheck operation.
