## SERVICE BULLETIN

| AT16-001n | NTB16-110n | March 4, 2020 |

### 2013-2017 ALTIMA AND 2014-2017 ROGUE; 4 CYLINDER WITH DTC P17F0, P17F1, P0776, P2813, P1715, AND/OR P0841 STORED

**APPLIED VEHICLES:** 2013-2017 Altima (L33)  
2014-2017 Rogue (T32)  
**APPLIED ENGINE:** QR25DE (4 cylinder only)

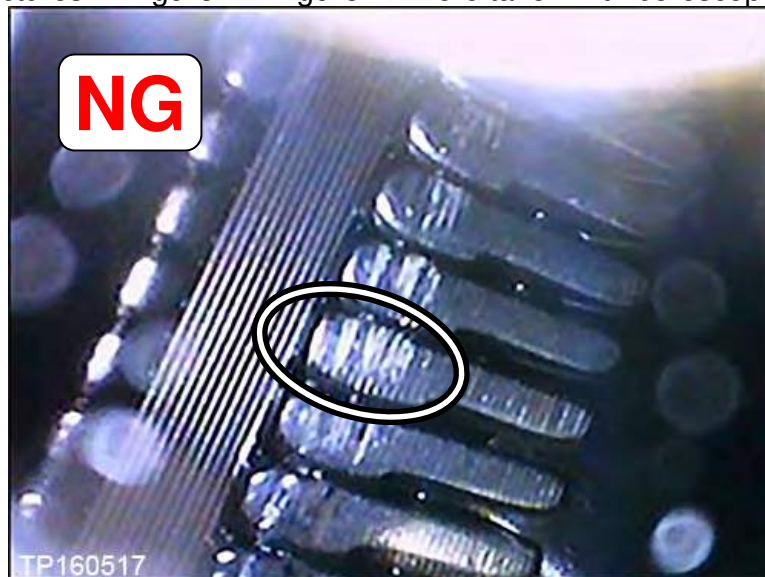
Figure 22: Example of NG belt

Pictures in Figure 22-Figure 24 were taken with borescope J-51951.

8. If the belt inspection result is **NG**, replace the CVT sub-assembly and valve body, and then check step 139 on page 79 to confirm if a TCM reprogram is available.

- Go to **CVT Assembly Removal**, page 17.
