## SERVICE BULLETIN

| AT16-001o | NTB16-110o | March 25, 2020 |

### 2013-2017 ALTIMA AND 2014-2017 ROGUE; 4 CYLINDER WITH DTC P17F0, P17F1, P0776, P2813, P1715, AND/OR P0841 STORED

**APPLIED VEHICLES:** 2013-2017 Altima (L33)  
2014-2017 Rogue (T32)  
**APPLIED ENGINE:** QR25DE (4 cylinder only)

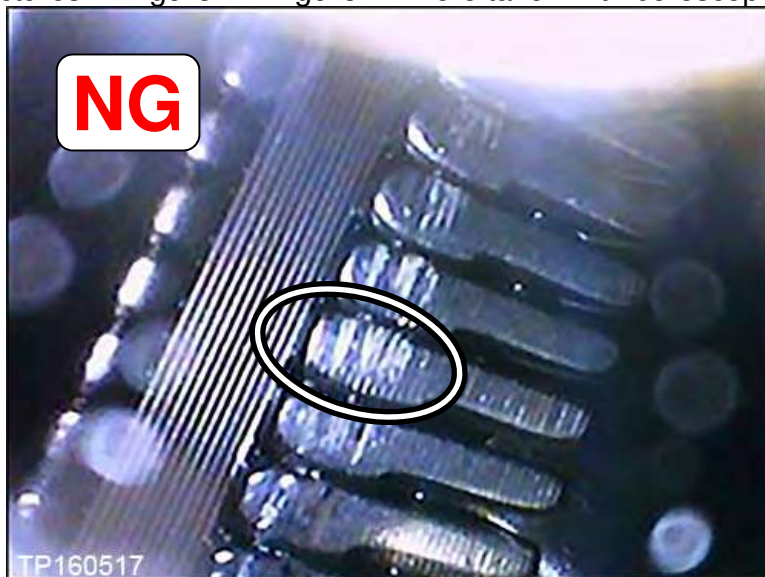
Pictures in Figure 22-Figure 24 were taken with borescope J-51951.

Figure 22: Example of NG belt

8. If the belt inspection result is **NG**, replace the CVT sub-assembly and valve body, and then check step 139 on page 79 to confirm if a TCM reprogram is available.

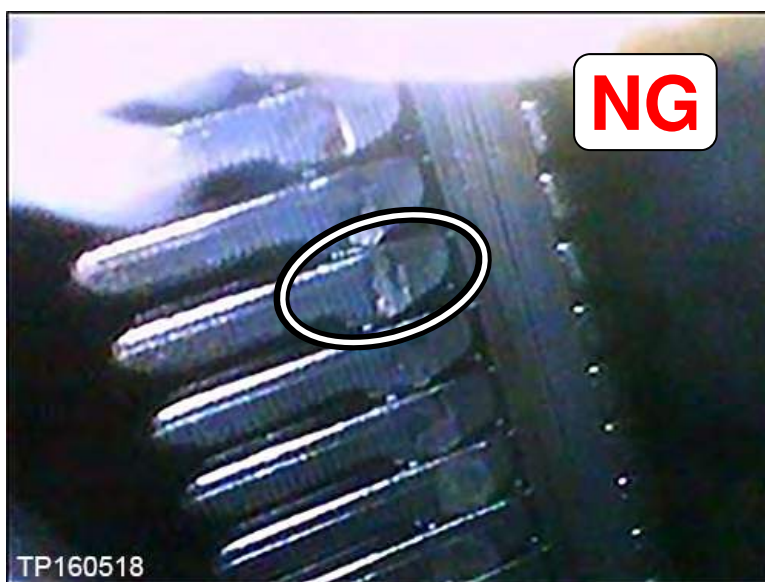
Figure 23: Example of NG belt

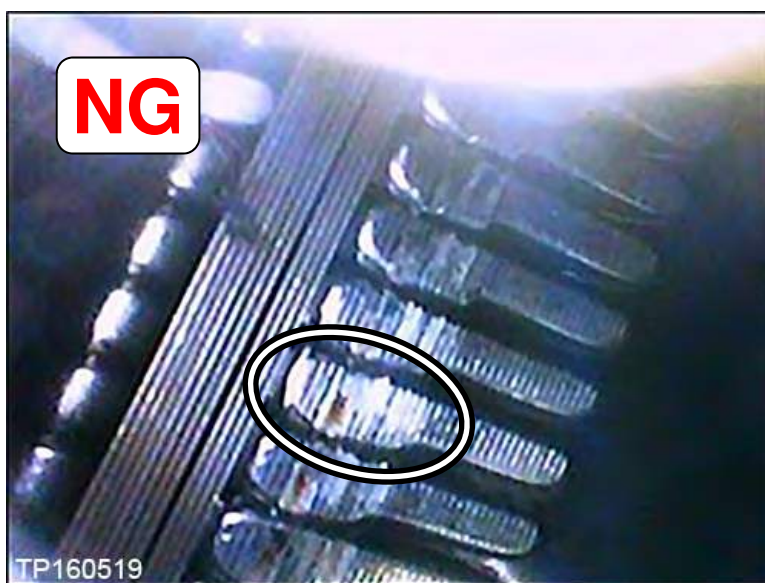
Figure 24: Example of NG belt
