# Technical Service Bulletin

**CHECK ENGINE LIGHT ON WITH DTC P111A:00 / ENGINE  
OVERHEATING / POOR A/C PERFORMANCE**

**Bulletin No.:** 01-007/20

2019-2020 CX-5 SKYACTIV-G 2.5T

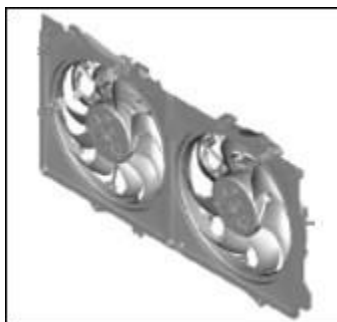
This concern may be due to improper control module software, which causes the cooling fan to run improperly, resulting in high coolant temperature. The fan control module is integrated into the cooling fan component.

To eliminate this concern, the fan control module software has been modified.

1. Verify the customer concern.
2. Replace the cooling fan with a modified one according to MGSS online (COOLING FAN MOTOR REMOVAL/INSTALLATION).
3. Verify the repair.
