# STAR Case

**Case Number:** S1318000031

CEL (Check Engine Lamp) on, DTC P0455 Evaporative System Large Leak

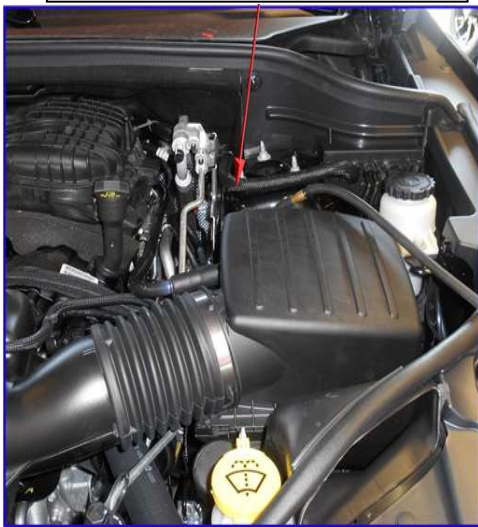
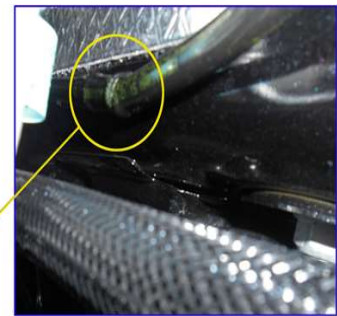
Review Suspect Location

A recent report indicates the CEL is on with DTC P0455 Evaporative System Large Leak stored or active. Inspection revealed an evaporative line loose crimp at the left shock tower location. Review the line in the suspect area, replace, re-position, and secure the hose as needed to repair.

Review hose routing at the left shock tower.
