| <b>HYUNDAI</b><br><b>Technical Service Bulletin</b> | GROUP<br><b>CAMPAIGN</b> | NUMBER<br><b>20-01-004H-1</b> |
| <b>SUBJECT:</b> THETA GDI ENGINE DTC P1326 - ENGINE INSPECTION / REPLACEMENT (SERVICE CAMPAIGN T3G) | | |

**Description:** Applicable vehicles with 2.0L Turbo and 2.4L GDI engines may experience the Check Engine warning lamp illuminated with DTC P1326. Follow the procedure to inspect the vehicle and replace the engine or update the engine ECU software based on the inspection results.

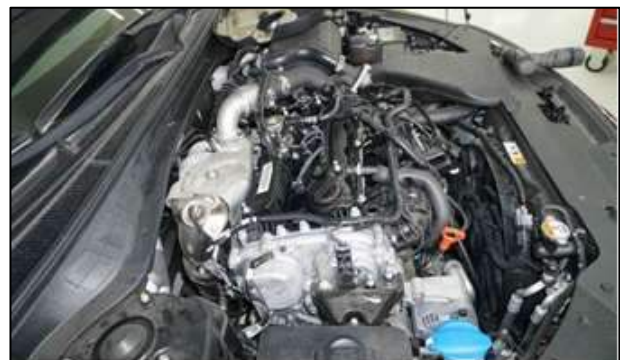
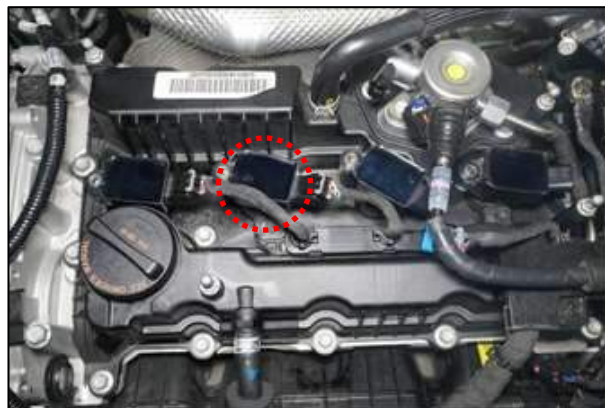
2. Remove the engine cover and the 4 ignition coils.

### Tightening Torque (ignition coils):

**9.8 - 11.8 N·m (1.0 - 1.2 kgf·m, 7.2 - 8.7 lb·ft)**

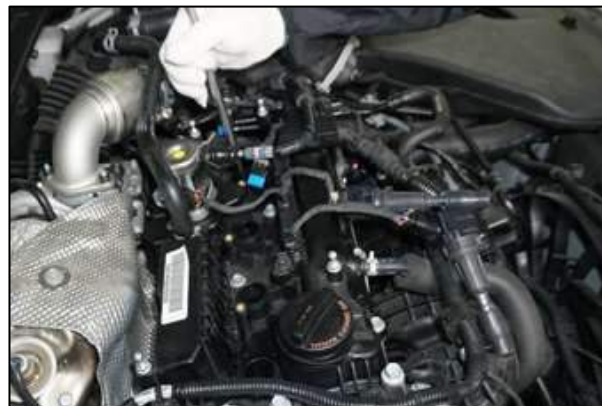
3. Remove the 4 spark plugs.

***Tightening Torque:***

***14.7 - 24.5 N·m***

***(1.5 - 2.5 kgf·m, 10.9 - 18.0 lb·ft)***

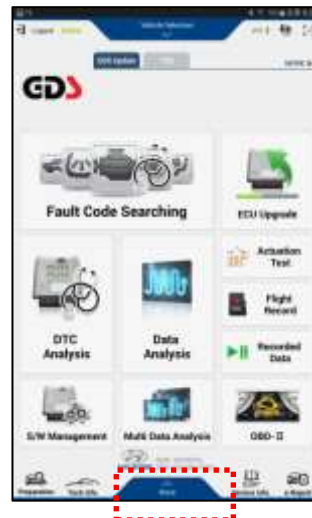
6. Swipe up on the 'More' tab at the bottom of the GDS home screen. Select the 'Special Inspection' function.

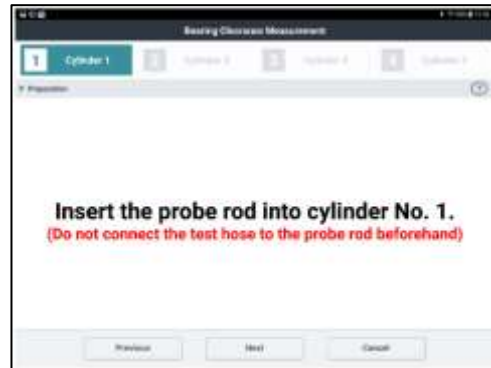
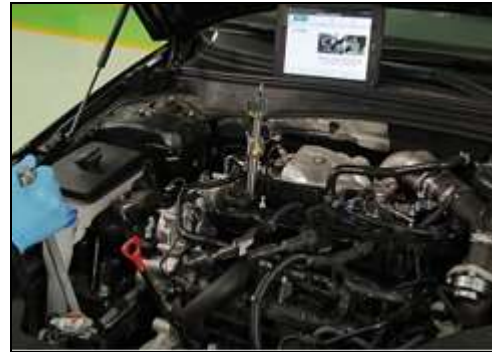
12. To find TDC compression (TDC), rotate the crankshaft with the crank rotator SST at least one cycle (1/2 turn). If the SST does not fit the specific vehicle type, remove the front passenger wheel and wheel liner or underbody tray as needed to rotate the crankshaft using standard shop tools.

Monitor the value on GDS screen or the clearance gauge SST while turning the wrench. Turn the wrench slowly as the value reaches a max/min value. When the value changes direction (increasing → decreasing or decreasing → increasing), stop turning the crank.

**Ensure the test hose is disconnected from the clearance gauge when finding TDC.**

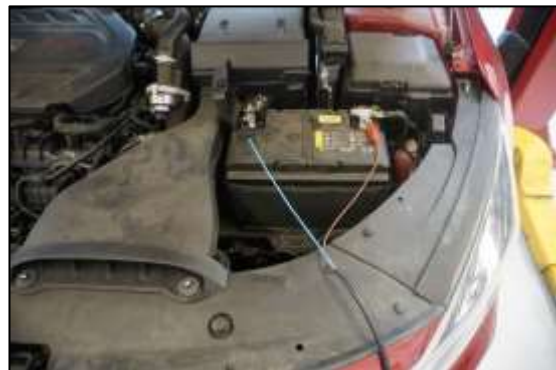
16. Connect the SST power cables to the vehicle's 12V battery. Turn the bearing tool SST power switch 'ON'.

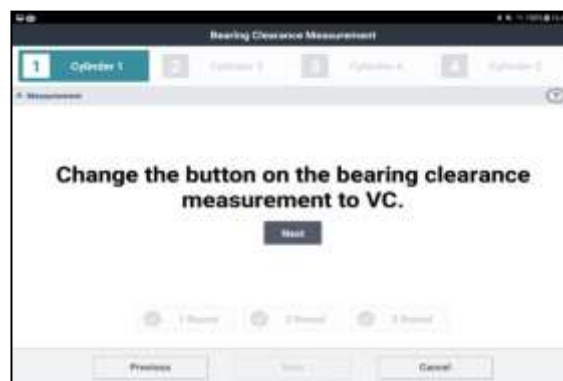
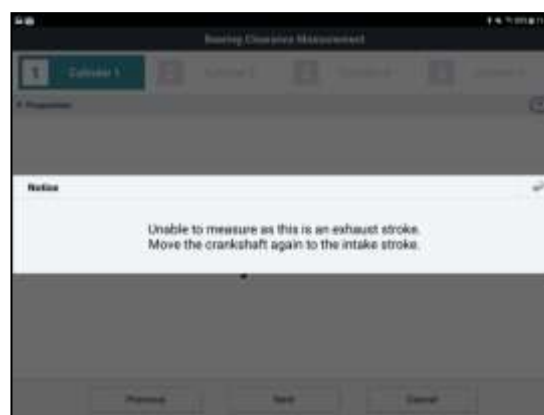
19. On the bearing tool SST, change the AP/VC switch to the VC position when instructed by the GDS.

If the bearing measurement value does not change when the AP/VC is switched or the “Unable to measure” message appears on the GDS, rotate the crankshaft further as the exhaust valves could be open. Set the crankshaft to TDC again (Step 11).

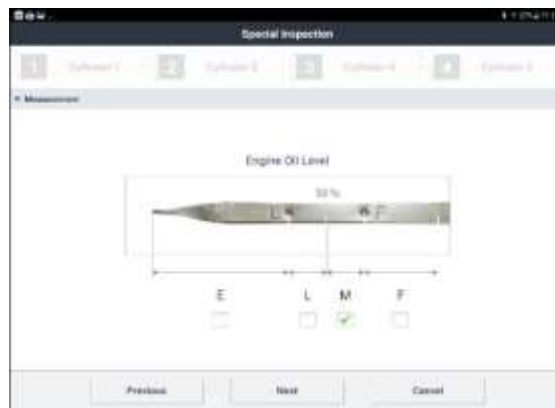
20. Continue following the instructions on the GDS to complete the bearing inspection. Check the engine oil level and select the level in the GDS.

21. If the test result is “PASS”:

- Save a screenshot of the results screen.
- Refer to Campaign 953 to update the Engine ECM if new software is available.
- Reinstall all components in the reverse order of removal.
- Check for DTCs and perform the appropriate diagnostic service. Ensure no warning lights are present to complete the procedure.

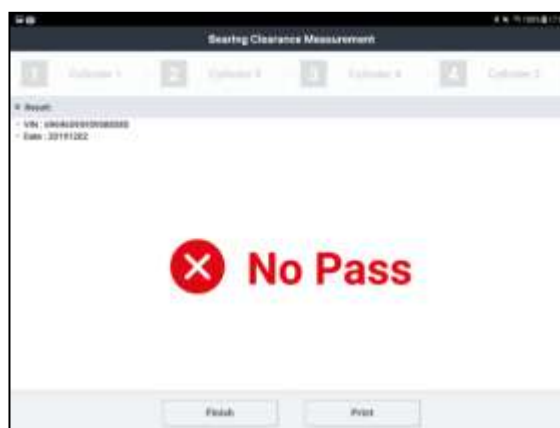
If the test result is “NO PASS”:

- Save a screenshot of the results screen.
- Continue to the engine replacement procedure.
- Refer to Campaign 953 to update the Engine ECM if new software is available.
- Check for DTCs and perform the appropriate diagnostic service. Ensure no warning lights are present to complete the procedure.

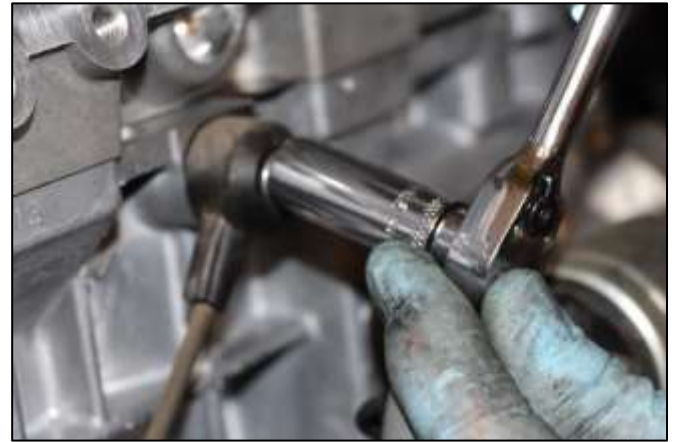
5. Remove and reinstall the engine knock sensor from the old engine to the new engine.

**Knock Sensor Fastener**

**Tightening torque:** 21Nm (15.5lb-ft)

Ensure the knock sensor is torqued to specification using a torque wrench. Improper installation can result in DTC codes.

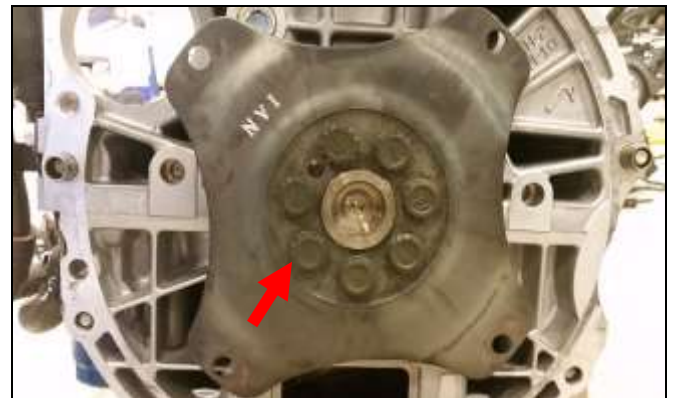
6. **If 21101-2GK70QQA engine is used:**

- Install the oil filler cap from the old engine to the new one.
- Install the drive plate/flywheel on the new engine using new bolts (QTY 7).

**Drive Plate Tightening torque :**

111.7 ~ 127.5 Nm (86.8 ~ 94.1 lb-ft)

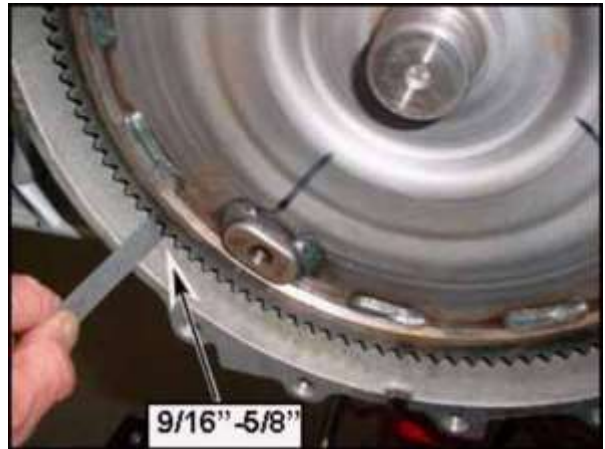
If the torque converter has moved from the fully inserted position, carefully push inward and rotate the torque converter until the converter is recessed approximately 9/16 - 5/8" (14 -16 mm) into the transaxle case when reinstalling the automatic transaxle.

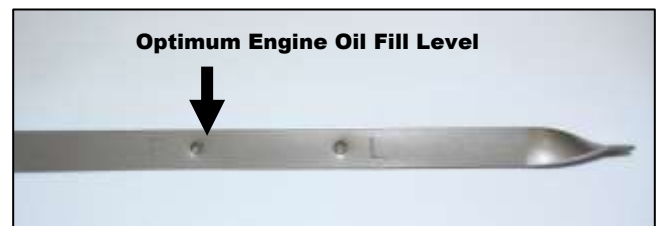
13. Start the engine to warm it up and begin the cooling system air bleeding process.
  - Check for any leaks during this time.
  - After the engine has warmed up to normal operating temperature, turn the engine off, wait a few minutes, and then **adjust the engine oil level to near the “F” mark as shown.**
