# Technical Service Bulletin

**17 MIL on or noises from the engine compartment, DTC P052E00 is stored in the ECM**

17 20 08 2060259/1 July 21, 2020.

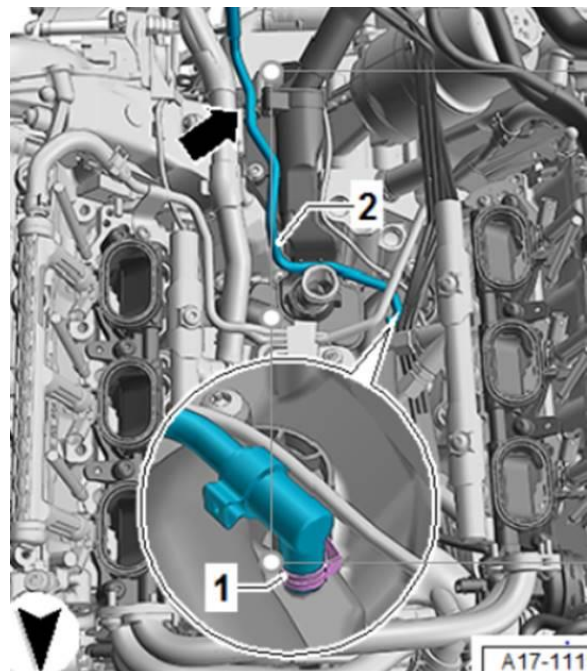
Figure 1. Elbow piece.

Fuel additives can cause the elbow piece on the crankcase breather to crack.

The elbow piece (Figure 1, position 1 in magnifier) on the crankcase breather can be individually replaced. The hose clips no longer open as required. If the hose clip is overstretched, this can lead to leaks in the crankcase breather system.

1. Replace the elbow piece and the hose clip using VAS 6362.
