# SERVICE BULLETIN

AT19-002d

## DTC P0741/4/6, P0776, P0841, P0965, P2857/8/9, P17F0/1/2/4 AND/OR P285A STORED, AND MAY HAVE HESITATION AND/OR REDUCED POWER

**APPLIED VEHICLES:** 2018-2020 Kicks (P15)  
2020 Versa Sedan (N18)

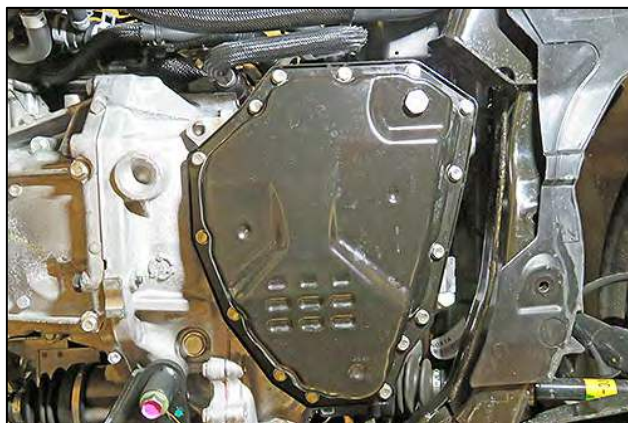
Figure 1

6. Remove the oil pan mounting bolts, and then remove the oil pan and oil pan gasket.
  - Do not discard the bolts. These will be reused during assembly.

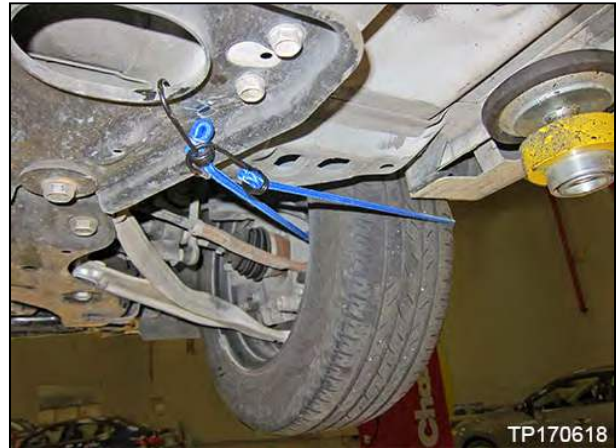
Figure 7

13. Secure the front right tire with a suitable strap.
  - This will assist in making the belt turn during the borescope belt inspection step.
14. Mark the front left tire with a suitable marking.
  - This will assure all 360° of the belt is inspected.

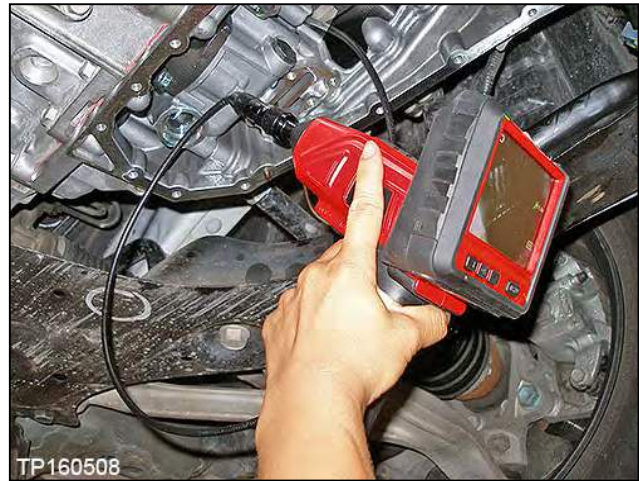
Figure 12

- c. Using the mark applied to the left front tire for reference, slowly and carefully rotate the front left tire one full turn in either direction to view all of the belt.
- Holding the borescope (camera flexible tube) with one hand allows rotation of the tire with the other hand (see Figure 12).

- Holding the borescope (camera flexible tube) with one hand allows rotation of the tire with the other hand (see Figure 12).

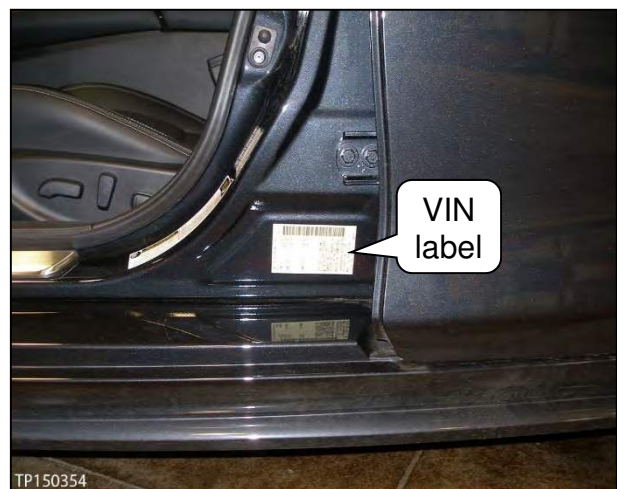
Figure 23

24. If CVT replacement is required based on the inspection results from steps 18 and 19, use borescope J-51951 to record a continuous video, 15 seconds or less, of the most severe evidence of belt slip and the VIN on the F.M.V.S.S. certification label (VIN label). See Figure 23.

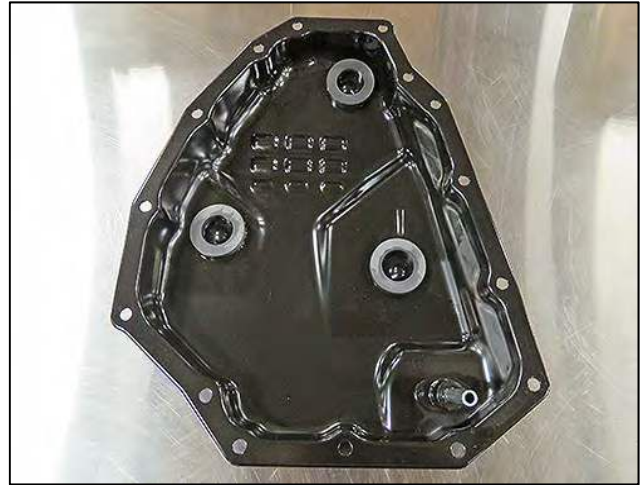
Figure 24

36. Reinstall the magnets to the oil pan in their original positions.
