## STAR ONLINE PUBLICATION

**Case Number:** S2008000115

**Symptom/Vehicle Issue:** There Is No Backup Camera Image Displayed When Shifting To Reverse. DTC's U0264-00 And B280B-00 May Be Set

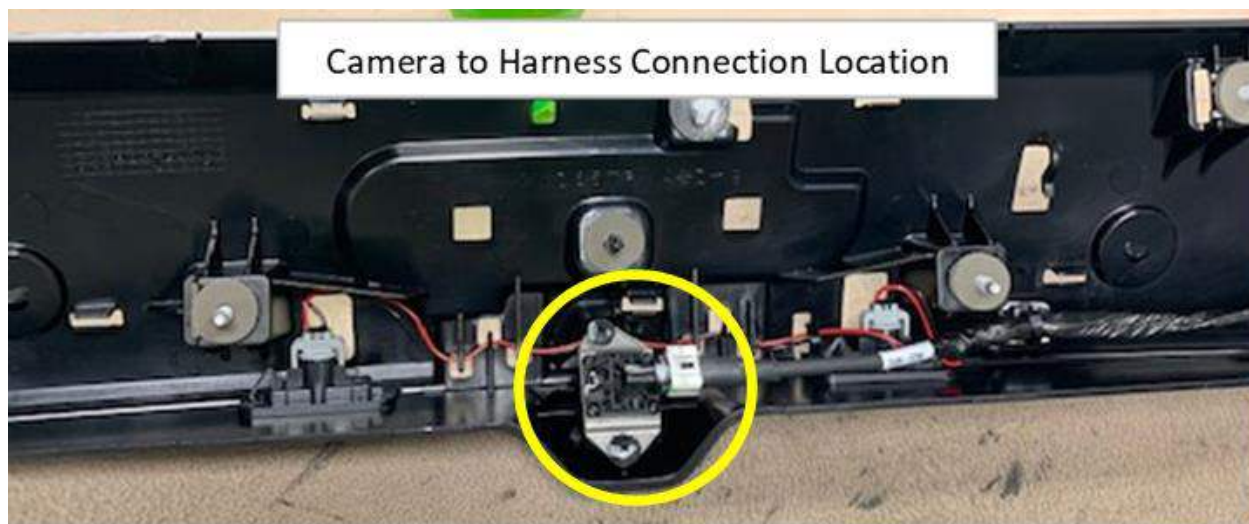
**Diagnosis:** The rear backup camera connector may not have been fully seated during vehicle assembly. Inspect the backup camera connector within the rear liftgate.

**Repair:** Fully disengage and reengage the connector to confirm it is fully seated.
