# SERVICE BULLETIN

AT19-013a

October 13, 2020

## 2018 ALTIMA AND 2018-2019 ROGUE; DTC P17F0, P17F1, P0776, P2813, P1715, AND/OR P0841 STORED

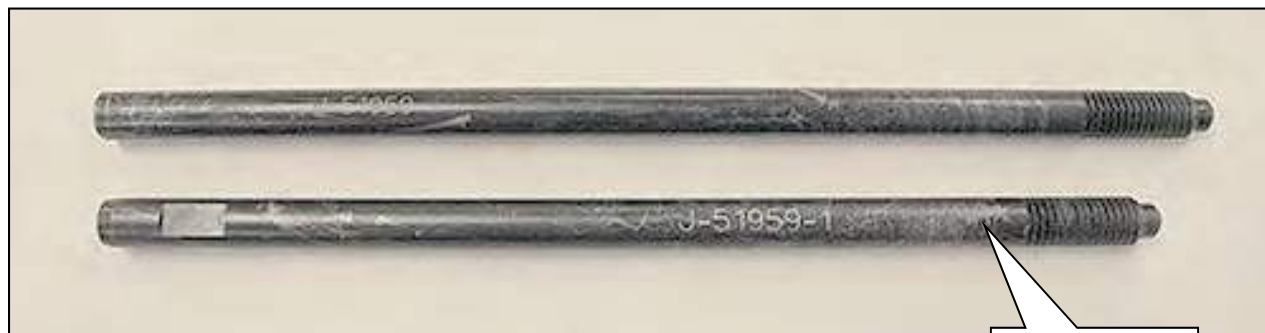
Figure 2

**J-51959**  
Guide Pins

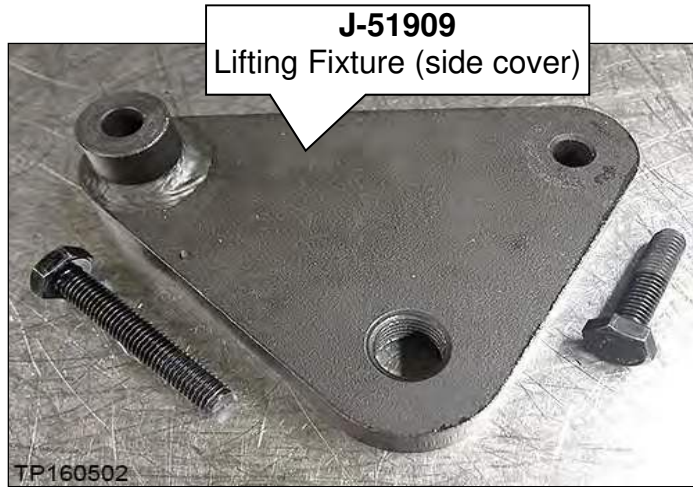
Figure 5

**Use for Altima  
only**

## Tech Cam J-51951

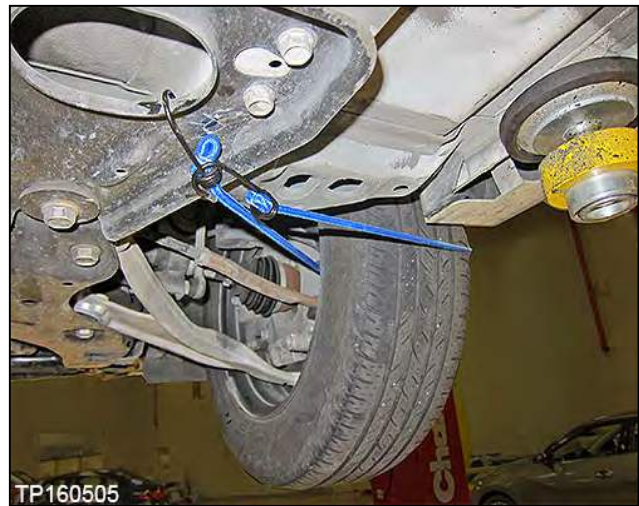
Figure 10

4. Secure the front right tire with a suitable strap, so that it cannot rotate.
  - This will assist in making the belt turn.
5. Mark the front left tire with a suitable marking.
  - This will assure all 360° of the belt are inspected.

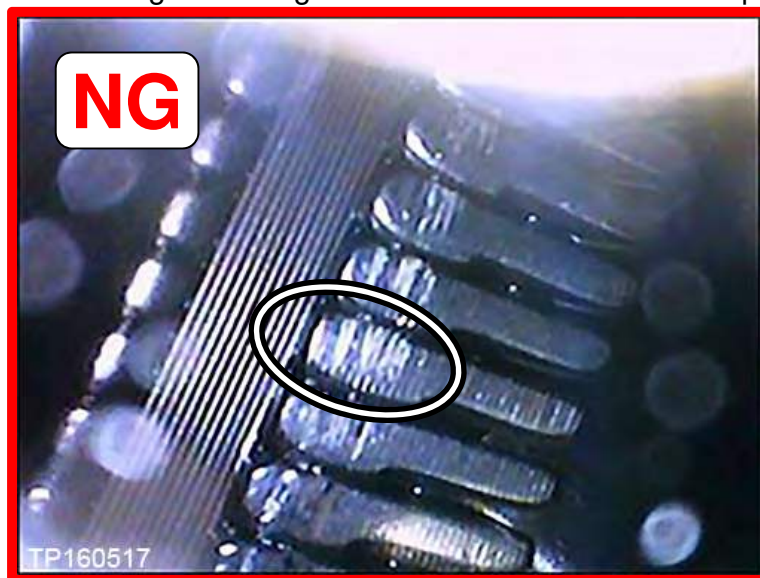
Pictures in Figure 22-Figure 24 were taken with borescope J-51951.

Figure 22: Example of NG belt

- If the inspection result is **OK**, inspect the other side of the belt in step 8.
- If the inspection result is **NG**, replace the CVT sub-assembly (page 18), control valve (page 76) and, if applicable, reprogram the TCM (page 83).

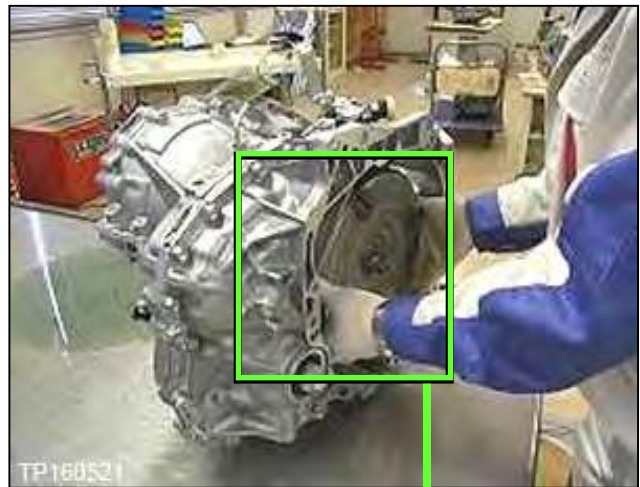
Figure 26

12. Remove the torque converter.

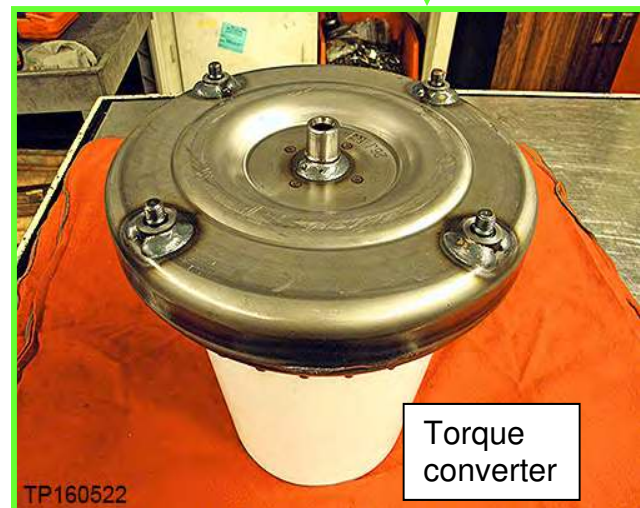
Figure 27

13. Drain the torque converter.

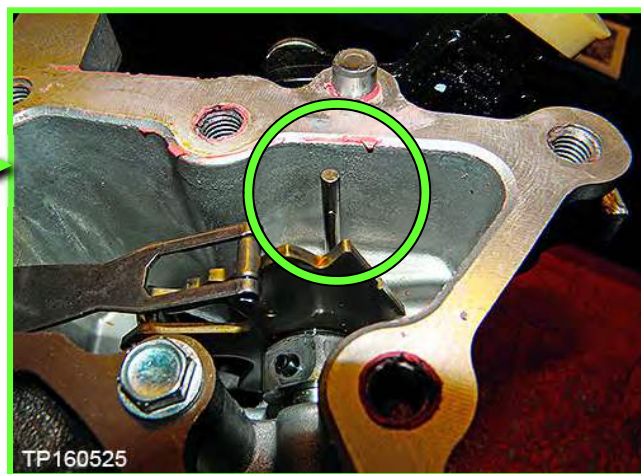
Figure 33

17. Note the location of the pin shown in Figure 32 and Figure 33.

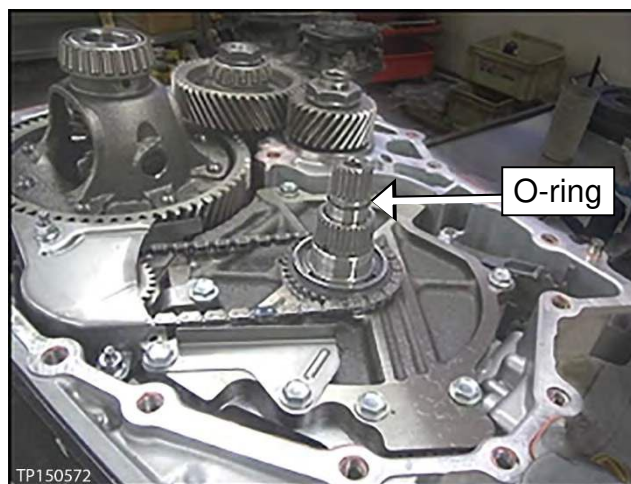
Figure 34

18. Remove the O-ring from the input shaft.

- This O-ring will be replaced with a new one.

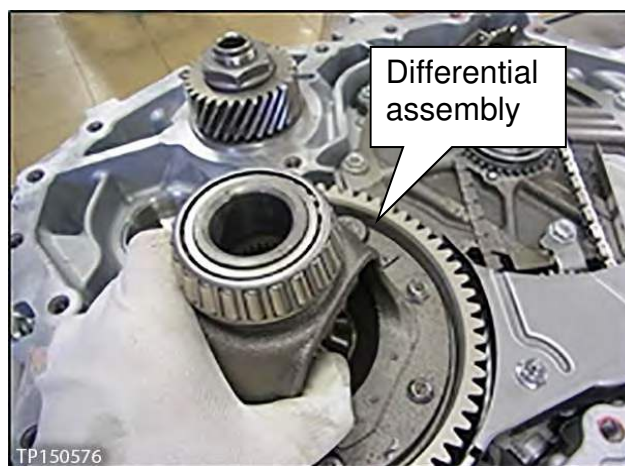
Figure 36

20. Carefully remove the differential assembly (Figure 36).

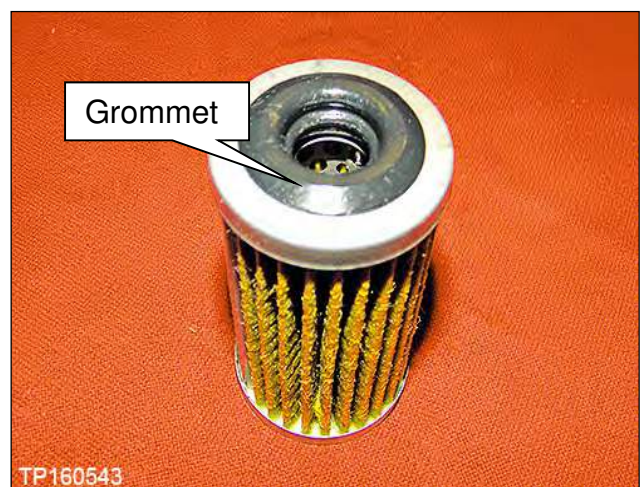
Figure 55

- Do not reuse the oil filter and seal. They will be replaced later.
- The grommet seal is fitted to the bottom end of the filter and is included with the replacement filter (Figure 55).

36. Clean the area where the CVT fluid filter fits (Figure 58).
  - Make sure the old filter grommet seal is removed (Figure 55).
37. Clean the fluid passages to and from the filter (Figure 58).

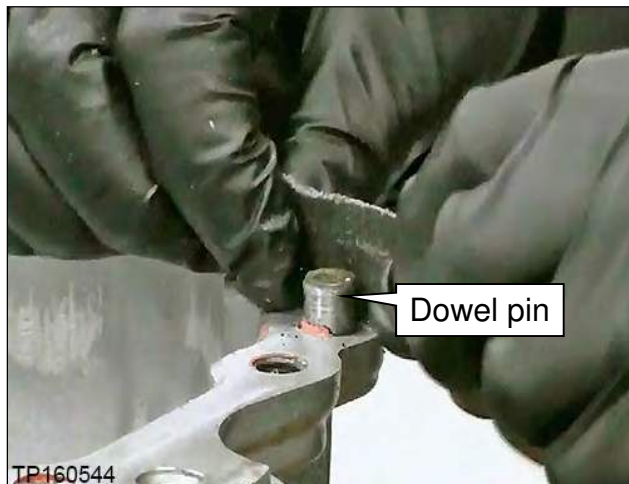
Figure 56

- DO NOT use sanding discs, similar abrasive tools, or metal blades.
- Use brake cleaner or equivalent solvent and lint free towel only.
- Make sure rust and debris have been cleaned off of dowel pins and receiving holes (Figure 56 and Figure 57).

35. Clean the dowel pins and dowel pin receiving holes of any rust and debris (Figure 56 and Figure 57).

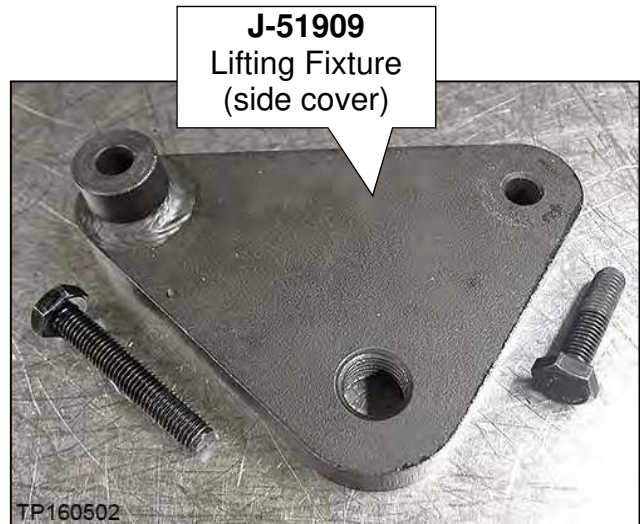
Figure 81

58. Attach Lifting Fixture J-51909 (Figure 81) with eyelet from J-51595 (Figure 73) to the side cover at point shown in Figure 82.

- Eyelet bolt torque: Hand tight.

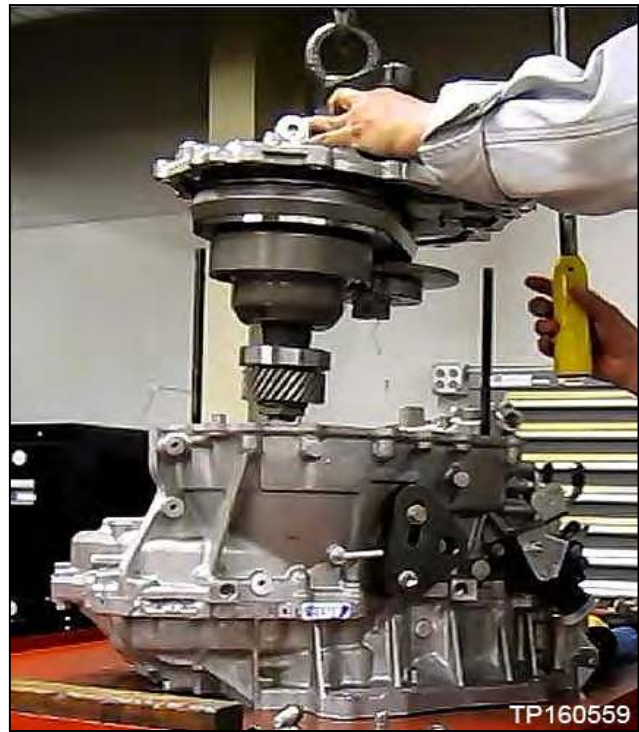
Figure 91

66. Raise the Lifting Fixture to remove the “side cover with pulleys and belt sub-assembly” (sub-assembly) from the CVT case (Figure 91).

- The speed sensor **will** be reused.
- **DO NOT** discard the speed sensor.
- This sub-assembly **will not** be reused.

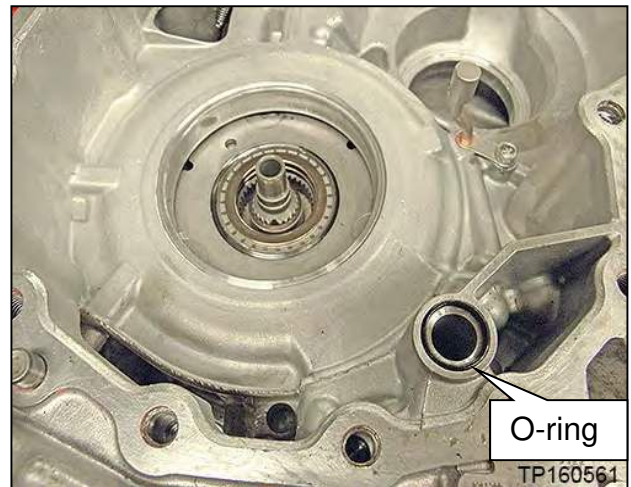
Figure 93

69. Replace the O-ring on the CVT case side with a new one from the PARTS KITS REFERENCE TABLE; do not reuse the original O-ring.

- Coat the O-ring with CVT fluid before installing.

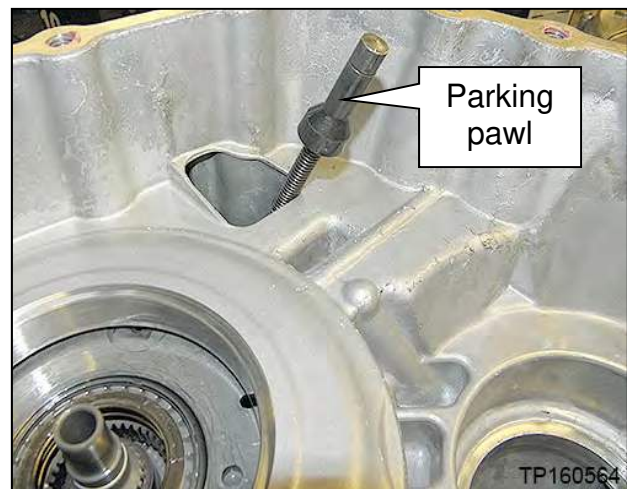
Figure 96

71. Rotate the shift select lever counter clockwise to the “L” range position (Figure 95), so that the parking pawl is at its lowest position (Figure 96).

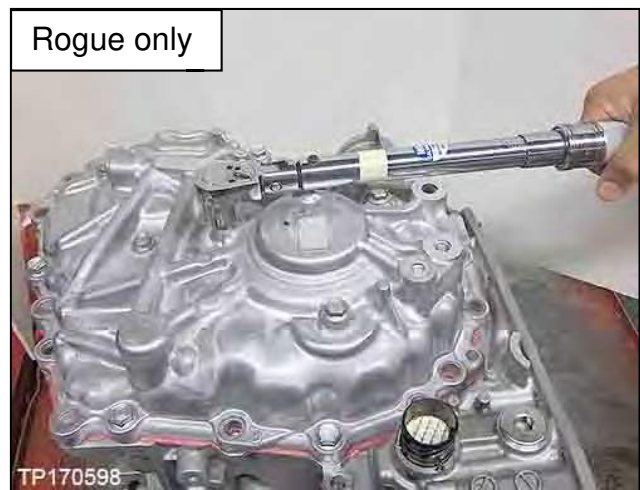
Figure 118

88. For **Rogue ONLY** torque all six (6) bolts.

- **All other models, proceed to step 89.**
- Bolt torque: 28 N•m (2.8 kg-m, **20 ft-lbs**).

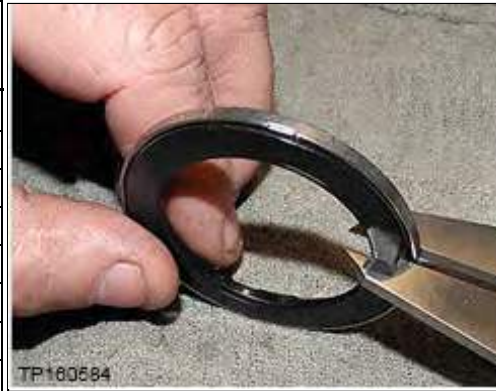
Figure 129

- Refer to the **PARTS INFORMATION** on page 95 for Thrust Bearing part numbers by thickness.
- c. Measure and confirm that the selected thrust bearing is the correct thickness before installing (Figure 129).
- d. Circle the thrust bearing part number that was selected in **Table A**.

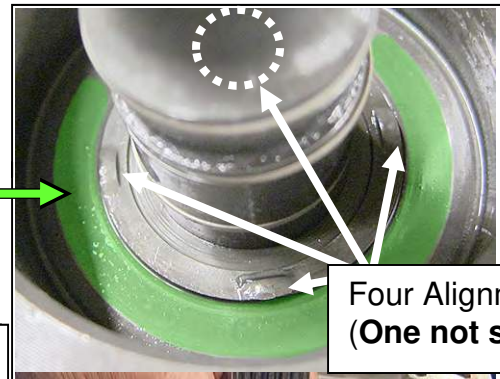
Figure 131

**HINT:** The thrust bearing has two sides. See Figure 130 through Figure 133 for the correct orientation.

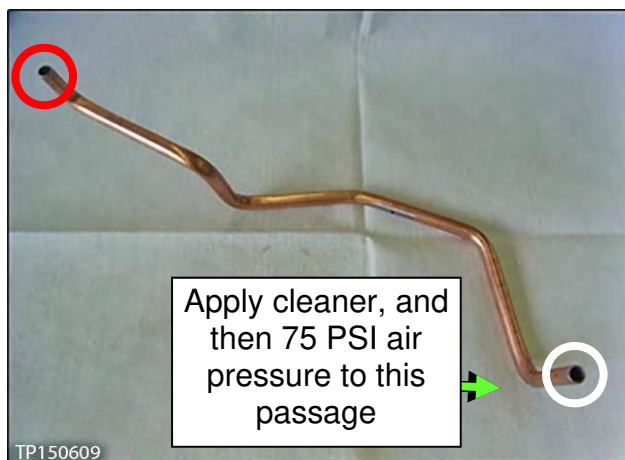
Figure 137

100. Clean the oil passages of the converter housing, lubrication tube and dummy cover with brake cleaner (or equivalent) where shown in Figure 136 through Figure 139 below.

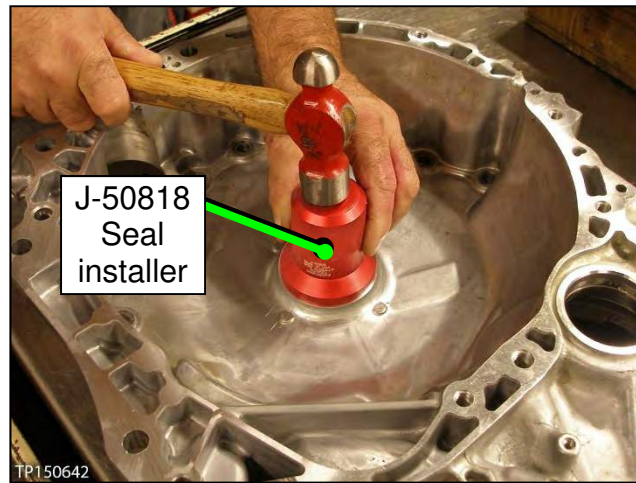
Figure 142

102. Install the torque converter housing side axle seal (Figure 142) on FWD vehicles. For AWD vehicles, skip to step 104.

- Place the torque converter housing seal flat during installation.
- Apply a light coat of CVT fluid to the seal lip surfaces.
- The torque converter housing seal will be 0.5 mm (**0.020 inches**) below the bore's surface when the seal installer bottoms out.

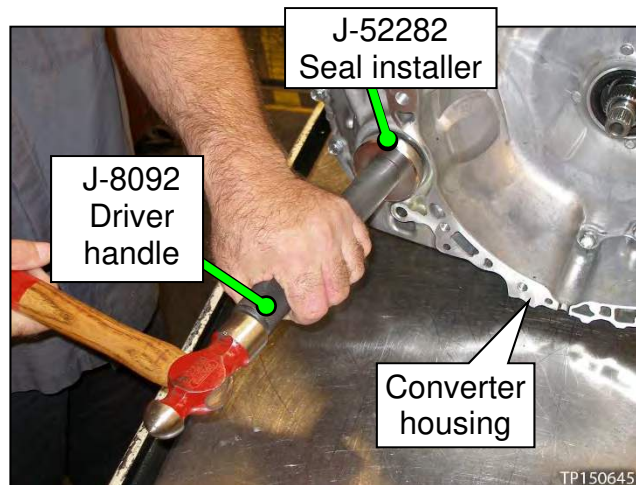
Figure 143

103. Install the torque converter housing side axle seal (Figure 143).

- Use Seal Installer J-52282 and Driver Handle J-8092.
- Apply a light coat of CVT fluid to the seal lip surfaces.

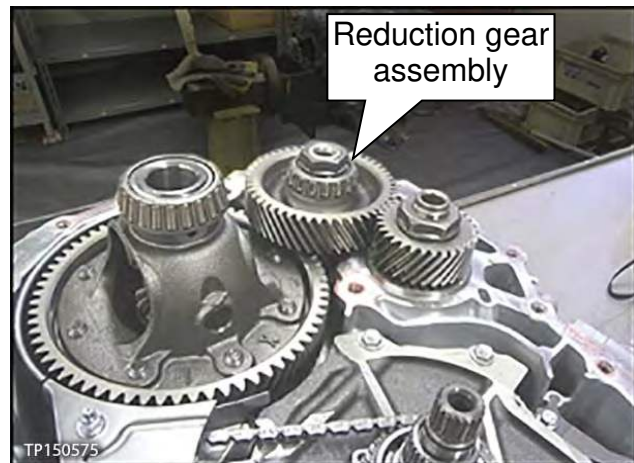
Figure 155

113. Install the differential assembly and the reduction gear assembly into the CVT case (Figure 154 and Figure 155).

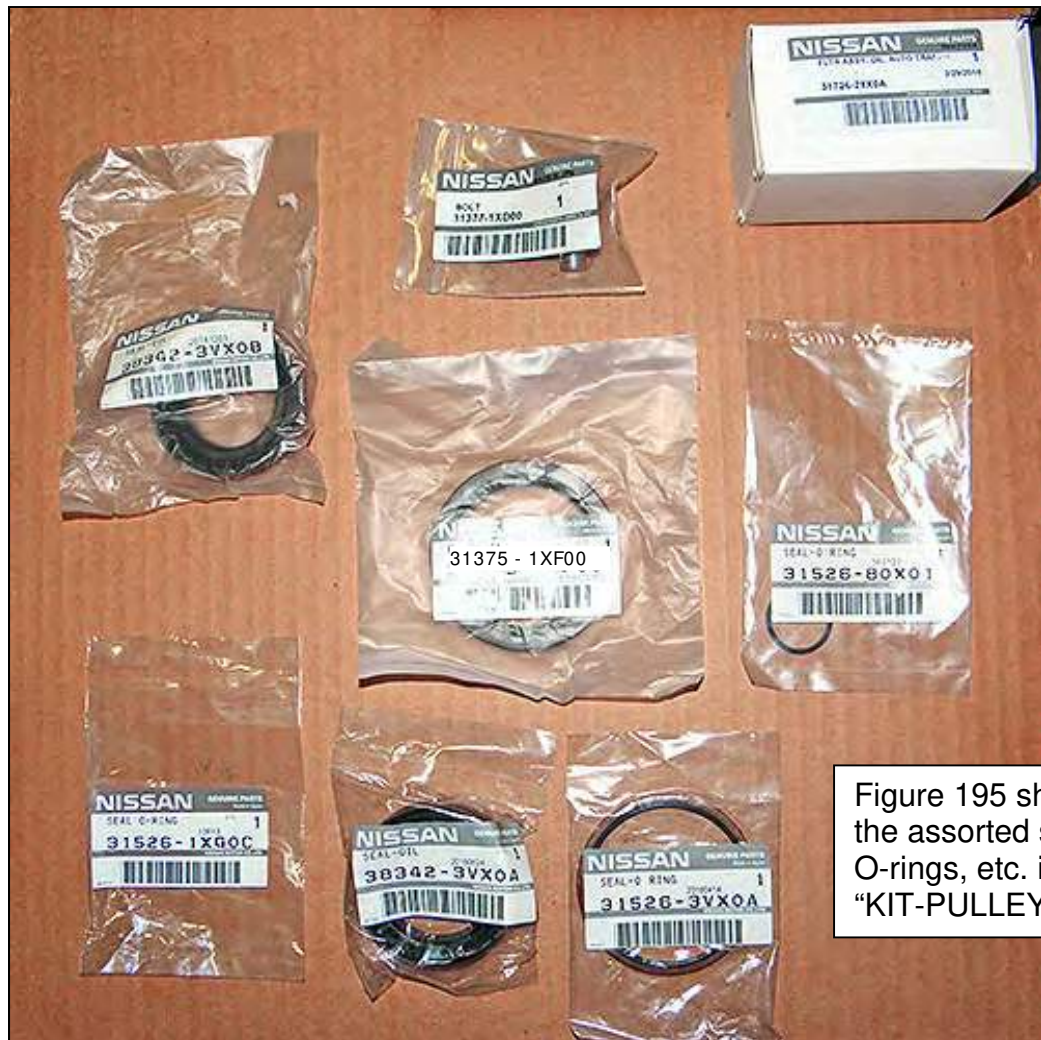
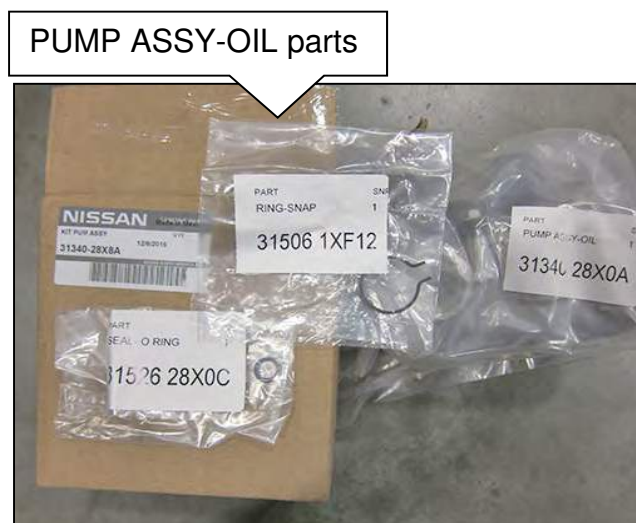
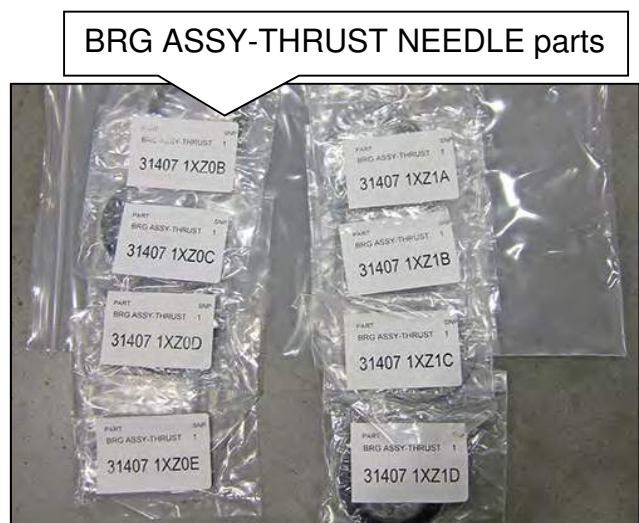
- The following Figures show the smaller components of KIT-PULLEY.
- KIT- CONTROL VALVE is not shown.
