| <b>HYUNDAI</b><br><b>Technical Service Bulletin</b> | GROUP<br><b>CAMPAIGN</b> | NUMBER<br><b>20-01-004H-2</b> |
| <b>SUBJECT:</b> THETA GDI ENGINE DTC P1326 - ENGINE INSPECTION / REPLACEMENT (SERVICE CAMPAIGN T3G) | | |

**Description:** Applicable vehicles with 2.0L Turbo and 2.4L GDI engines may experience the Check Engine warning lamp illuminated with DTC P1326. Follow the procedure to inspect the vehicle and replace the engine or update the engine ECU software based on the inspection results.

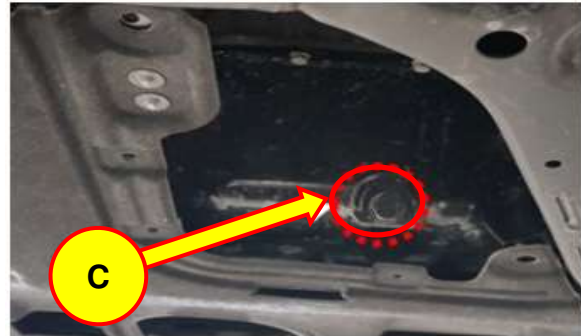
2. Lift up the vehicle and remove the oil drain plug (C).

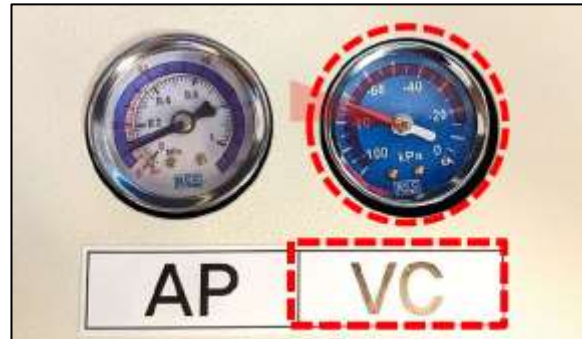
Confirm the shop air pressure and VC/AP pressures on the bearing tool meet requirements. The correct ranges for VC/AP air pressures are also indicated with red/blue decals on the gauges. Using STUI in the GDS, take and submit a picture of the gauges with the pressure levels clearly visible and the VIN in the background of the photo (RO or last 6 digits written on paper) for records.

**Shop air supply:**  
0.36MPa (50 psi) minimum

**AP: 0.1 ~ 0.11MPa,**  
**VC: -73 ~ -83Kpa**

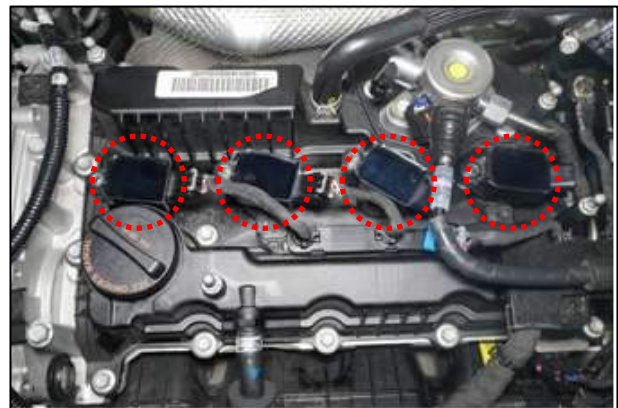
2. Remove the engine cover and the 4 ignition coils.

**Tightening Torque (ignition coils):**  
**9.8 - 11.8 N·m (1.0 - 1.2 kgf·m, 7.2 - 8.7 lb·ft)**

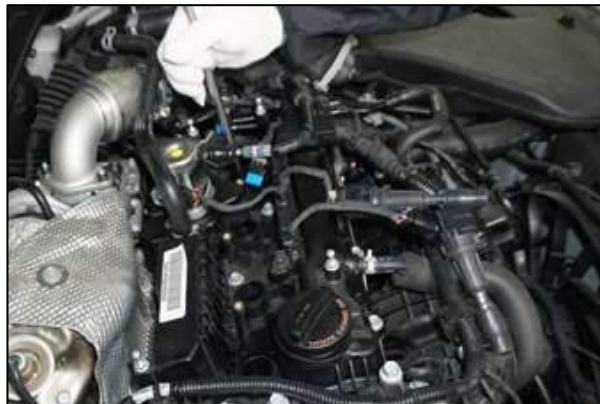
3. Remove the 4 spark plugs.

**Tightening Torque:**

**14.7 - 24.5 N·m**

**(1.5 - 2.5 kgf·m, 10.9 - 18.0 lb·ft)**

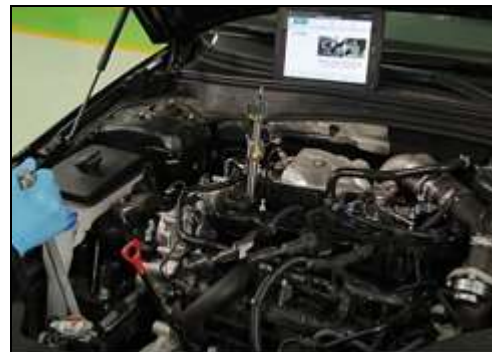
Monitor the value on GDS screen or the clearance gauge SST while turning the wrench. Turn the wrench slowly as the value reaches a max/min value. When the value changes direction (increasing → decreasing or decreasing → increasing), stop turning the crank.

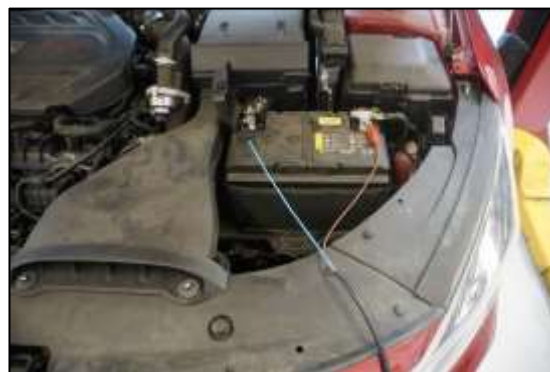
16. Connect the SST power cables to the vehicle's 12V battery. Turn the bearing tool SST power switch 'ON'.

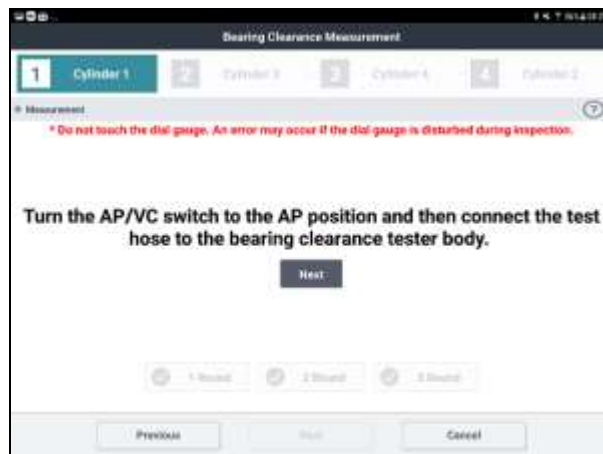
17. Locate the AP/VC switch on the bearing tool SST and switch it to the AP Position.

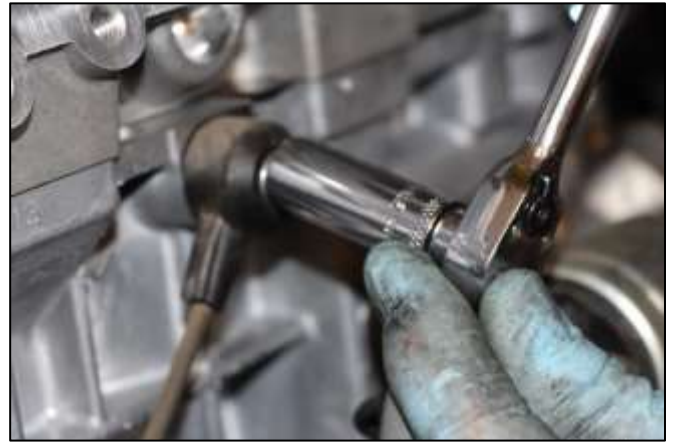
5. Remove and reinstall the engine knock sensor from the old engine to the new engine.

***Knock Sensor Fastener***

***Tightening torque: 21Nm (15.5lb-ft)***

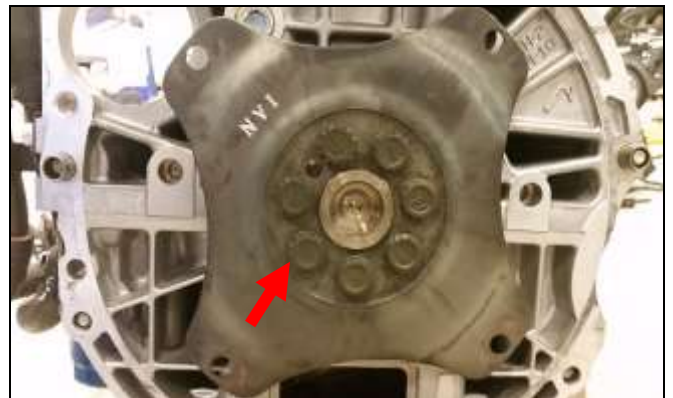
- Install the oil filler cap from the old engine to the new one.
- Install the drive plate/flywheel on the new engine using new bolts (QTY 7).

***Drive Plate Tightening torque :***

***111.7 ~ 127.5 Nm (86.8 ~ 94.1 lb-ft)***

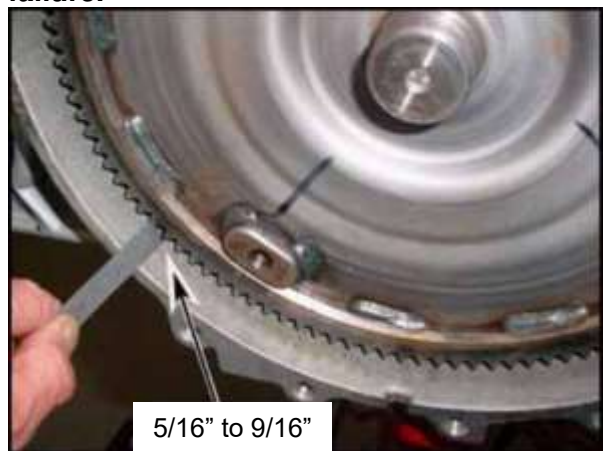
5/16" to 9/16"

If the torque converter has moved from the fully inserted position, carefully push inward and rotate the torque converter until the converter is recessed approximately 5/16" - 9/16" (8 -14 mm) into the transaxle case when reinstalling the automatic transaxle.

Check the depth of the torque converter to confirm it's fully installed in the transmission otherwise the oil pump may be damaged resulting in transmission failure.

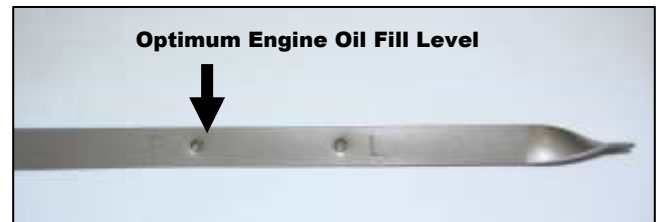
13. Start the engine to warm it up and begin the cooling system air bleeding process.
  - Check for any leaks during this time.
  - After the engine has warmed up to normal operating temperature, turn the engine off, wait a few minutes, and then **adjust the engine oil level to near the “F” mark as shown.**
