DA17-028B

ITB18-006B

## 2013 JX35 AND 2014-2017 QX60; VDC WARNING LAMP ON WITH DTC C1116 STORED

APPLIED VEHICLES: 2013 JX35 (L50)  
2014-2017 QX60 (L50)  
APPLIED SYSTEM: Without Intelligent Cruise Control ONLY

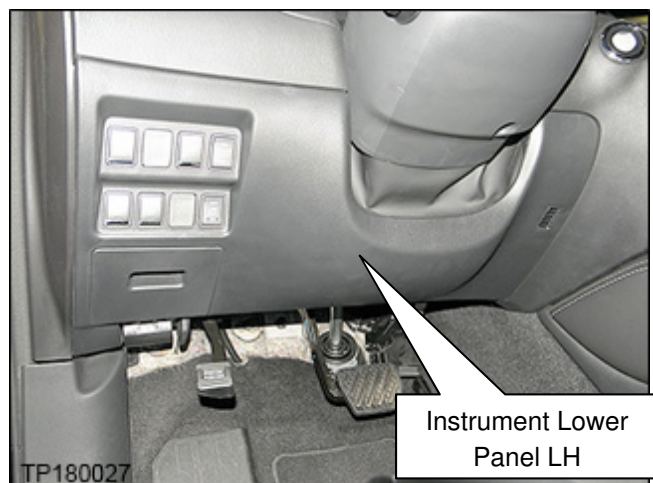
Figure 1

4. Remove the Instrument Lower Panel LH.
  - For the procedure to remove the Instrument Lower Panel LH, refer to the ESM section, BODY INTERIOR > INSTRUMENT PANEL > REMOVAL AND INSTALLATION > INSTRUMENT LOWER PANEL LH > Removal and Installation.

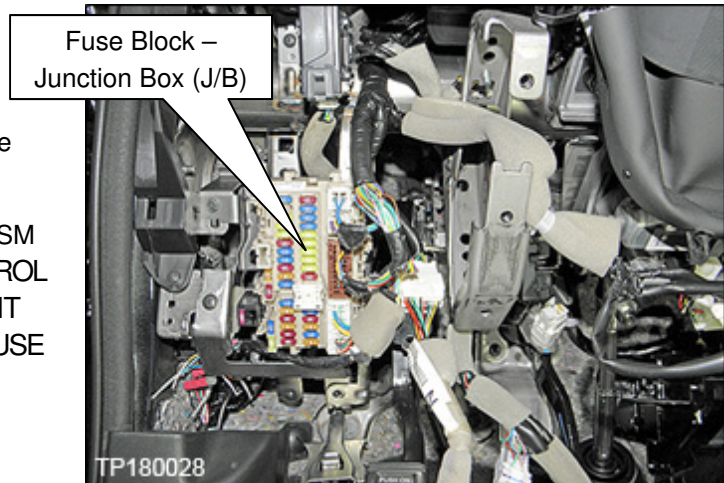
Figure 2

5. Completely disconnect and remove the Fuse Block – Junction Box (J/B).
  - For additional information refer to the ESM section, ELECTRICAL POWER CONTROL > POWER SUPPLY, GROUND CIRCUIT ELEMENTS > WIRING DIAGRAM > FUSE BLOCK – JUNCTION BOX (J/B).

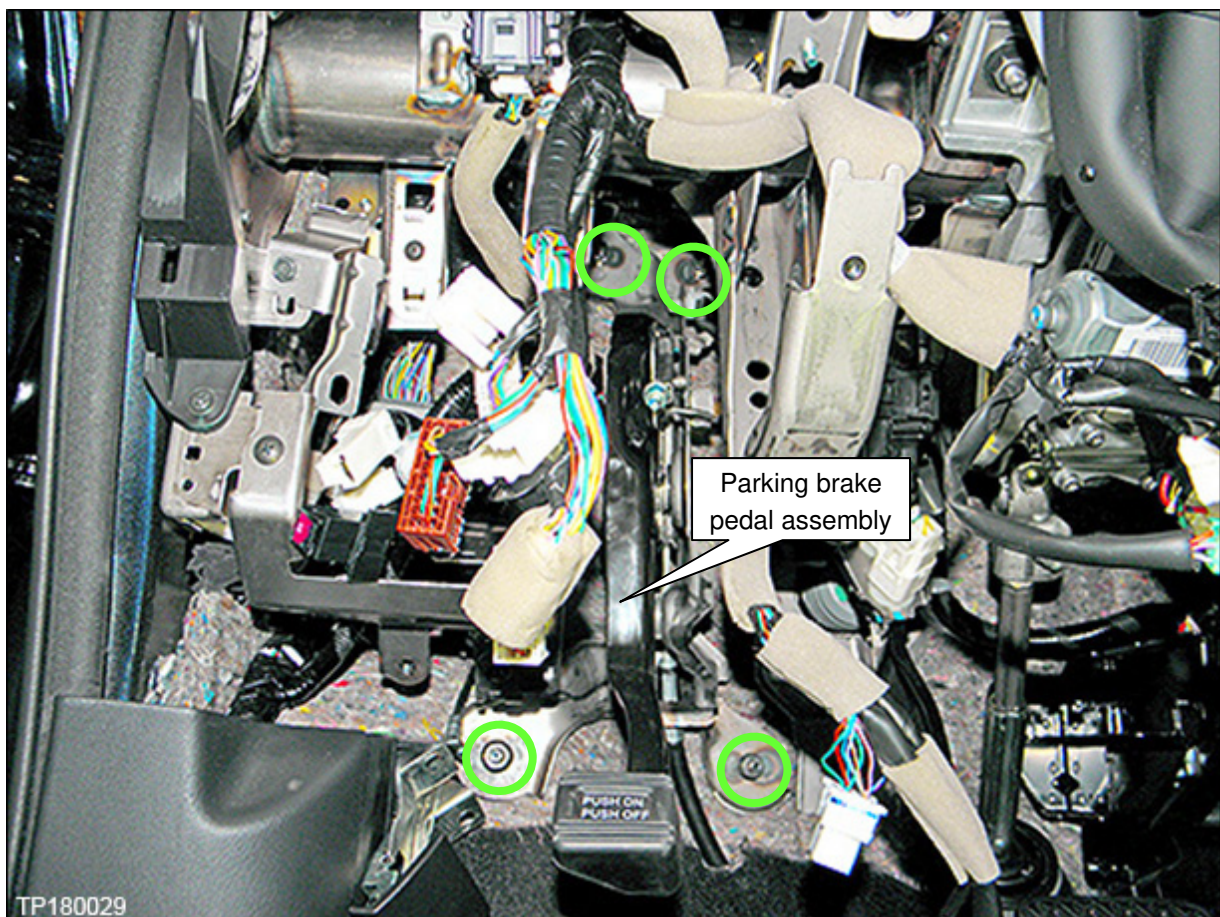
Figure 3

6. Unbolt the parking brake pedal assembly.
    - Remove four (4) bolts shown in Figure 3.
- NOTE: Do not disconnect the parking brake cable.

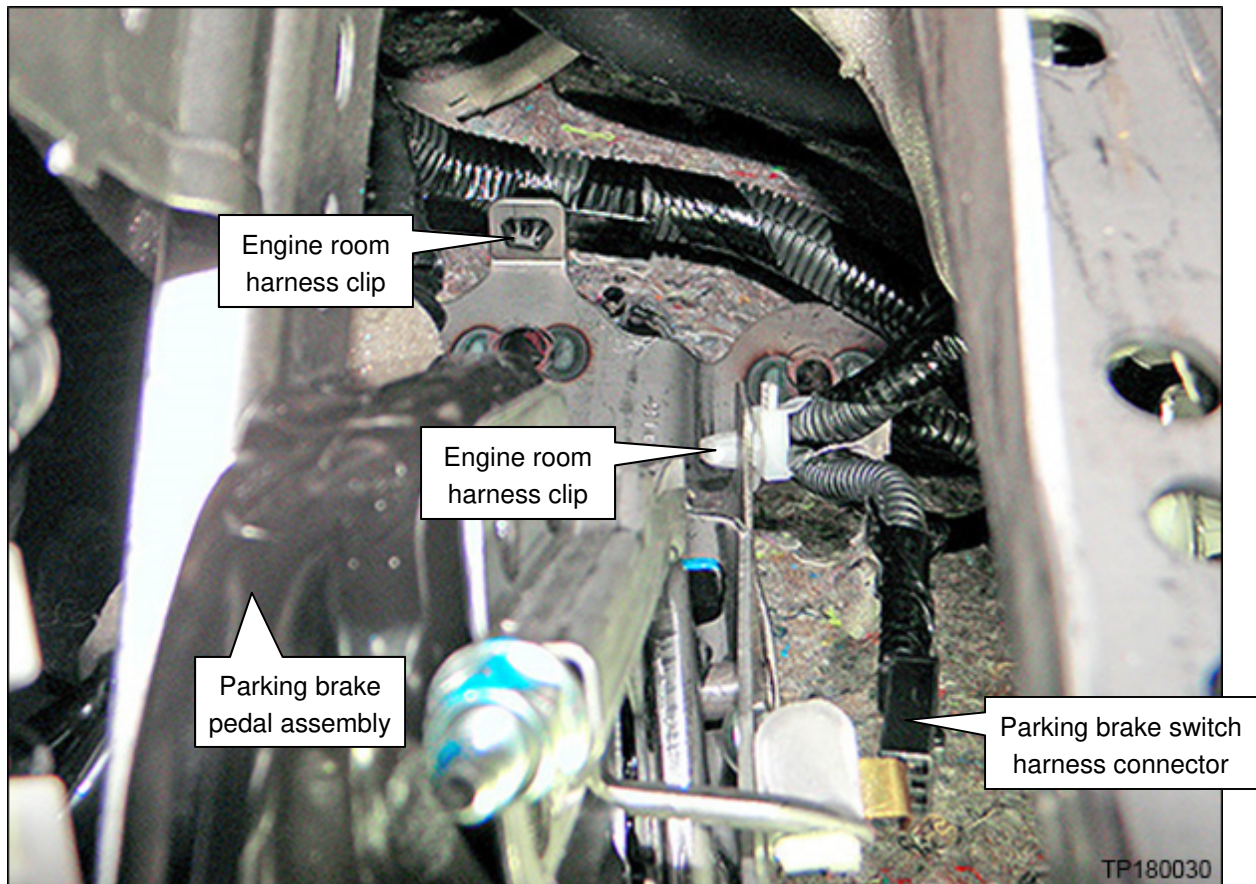
7. Unclip the engine room harness from the parking brake pedal assembly in the two locations shown in Figure 4 and unplug the parking brake switch harness connector.

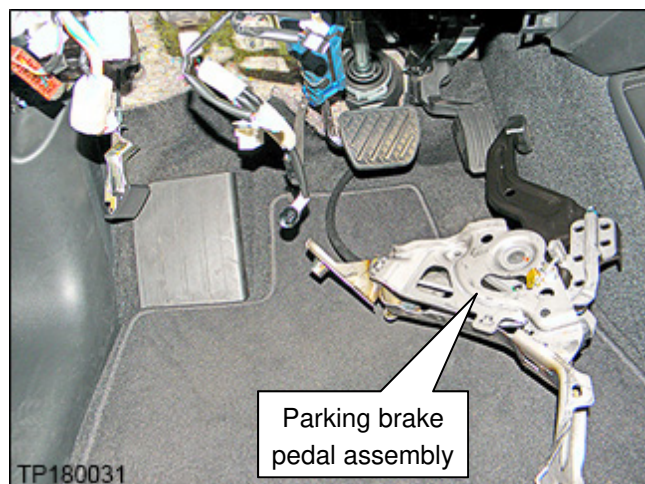
Figure 5

8. Remove the parking brake pedal assembly from under the Instrument Panel and lay it on the floor as shown in Figure 5.

NOTE: Do not disconnect the parking brake cable.

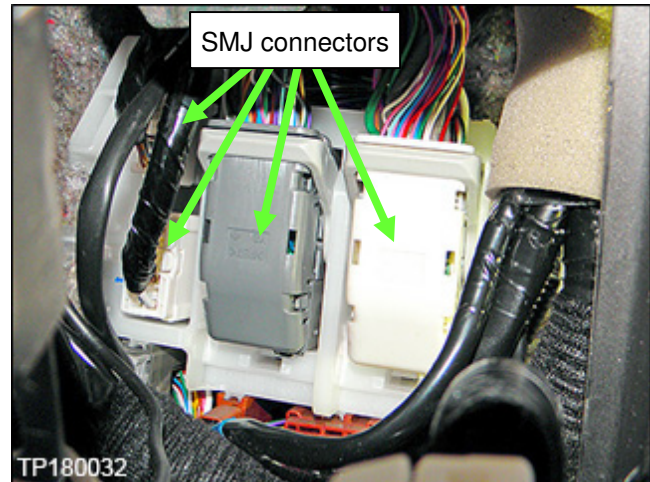
Figure 6

9. Disconnect the Super Multiple Junction (SMJ) connectors.

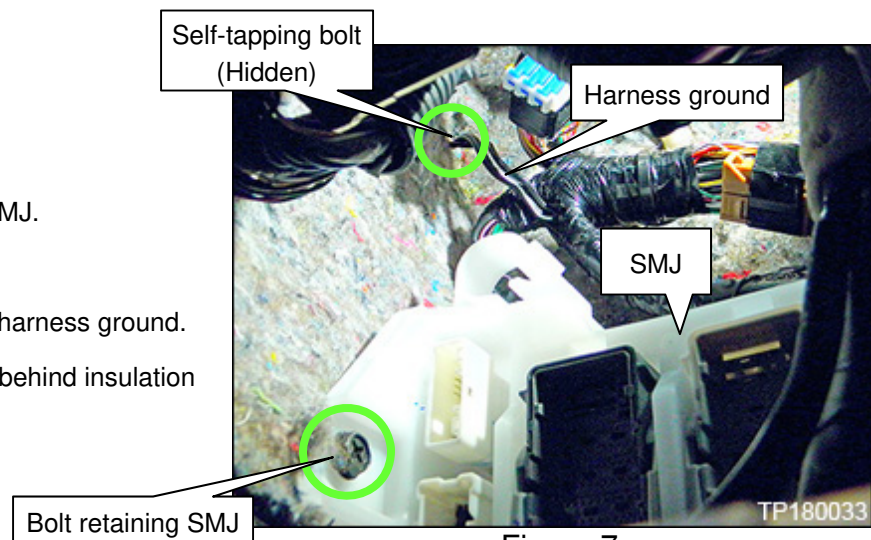
10. Remove bolt that is retaining SMJ.
11. Remove self-tapping bolt from harness ground.
- NOTE: Bolt hidden in Figure 7 behind insulation material.

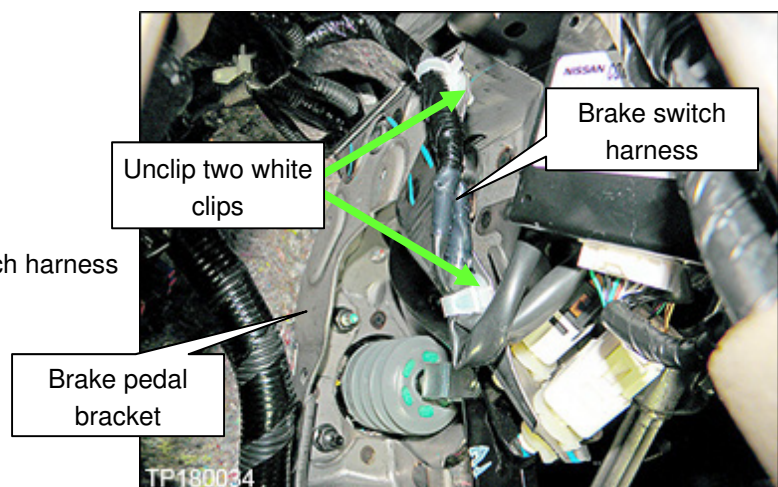
Figure 8

12. Unclip two (2) white clips of brake switch harness from brake pedal bracket.

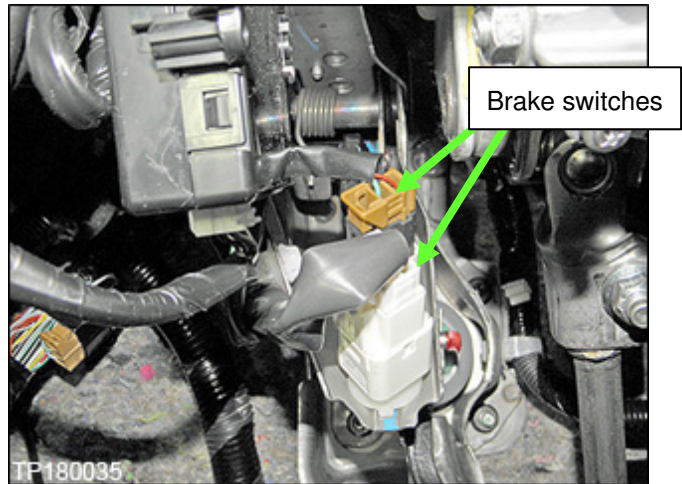
Figure 9

13. Disconnect both brake switch harness connectors from the brake switches.

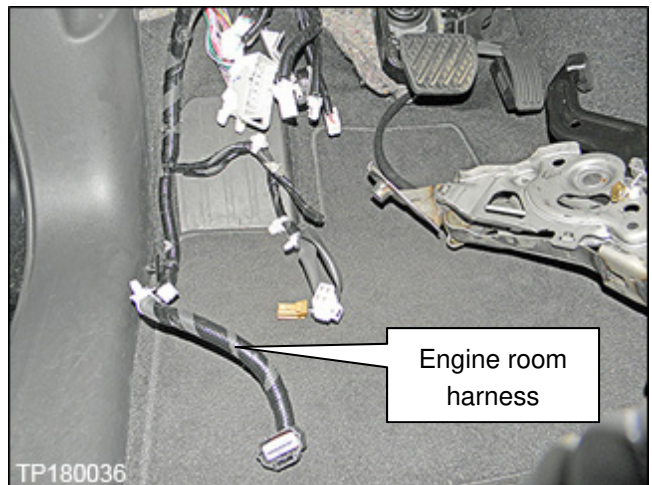
Figure 10

14. Remove the engine room harness completely from the Instrument panel and lay it on the floor.

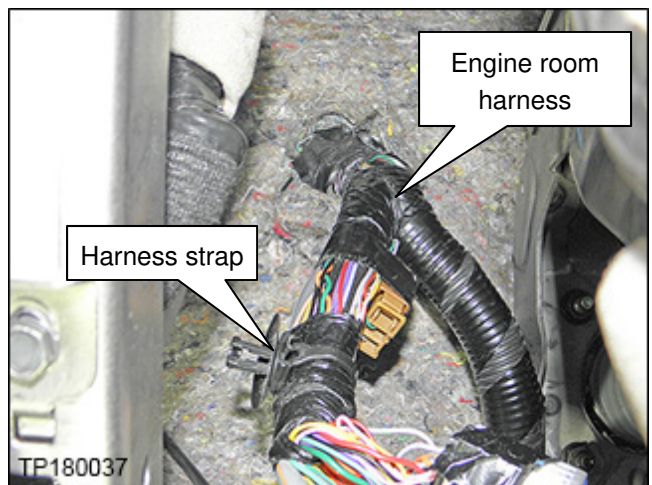
Figure 11

15. Detach harness strap from threaded stud, if not already detached.

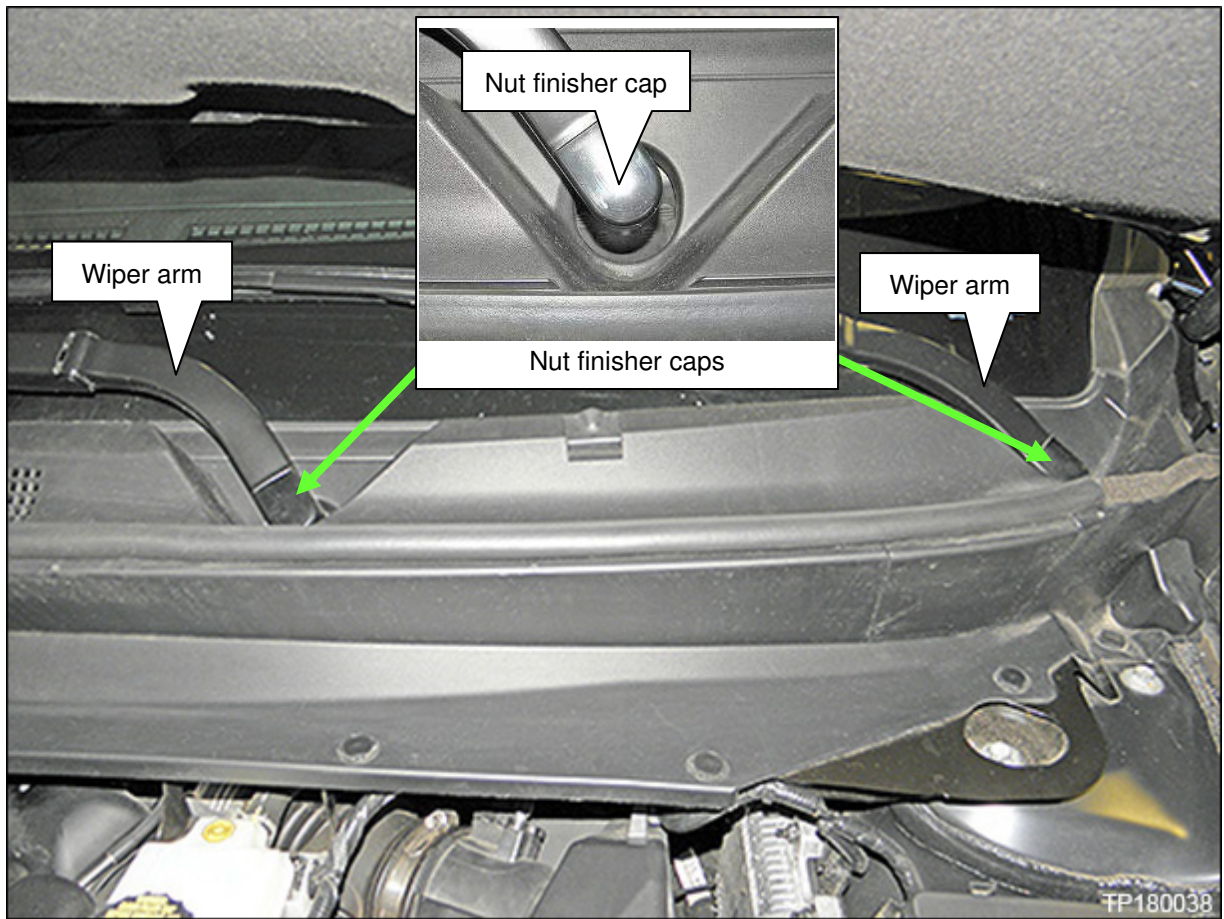
Figure 12

- a. Remove the nut finisher caps.

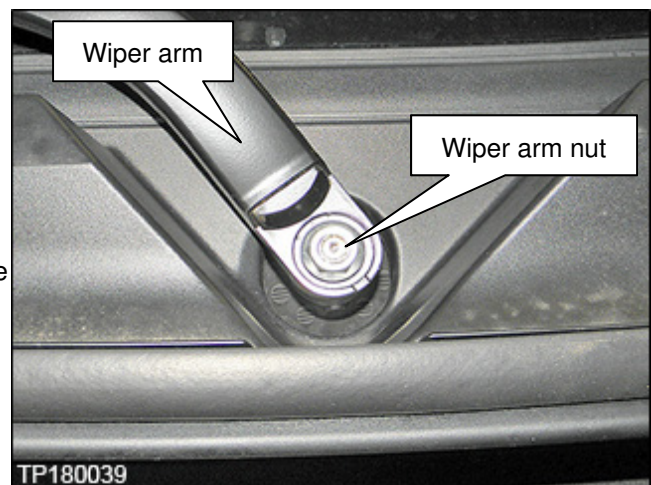
Figure 13

- b. Place masking tape on the windshield directly parallel to the wiper blades as alignment markers for wiper arm re-installation.

- c. Remove the nuts that retain both wiper arms to the wiper motor shafts.

- d. Remove both wiper arms.

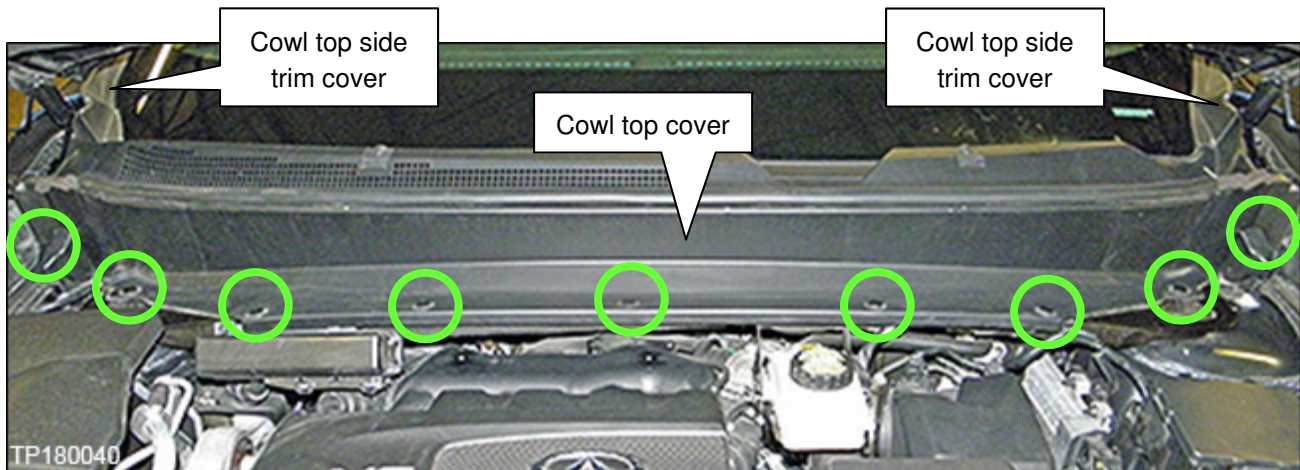
Figure 14

18. Remove the 9 clips that attach the cowl top cover (Figure 14).

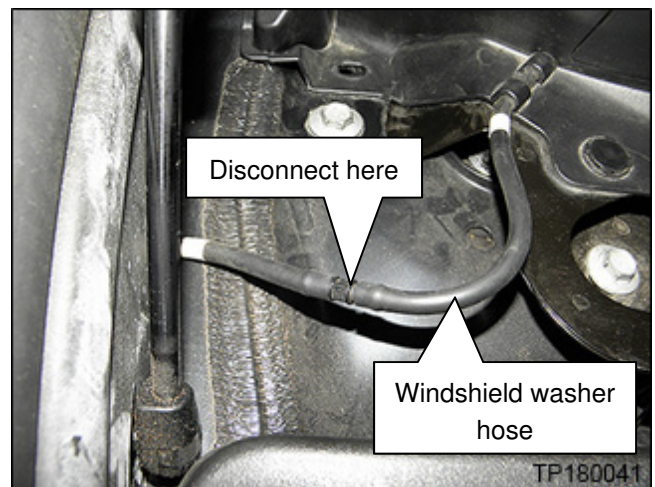
Figure 15

19. Disconnect the windshield washer hose.

20. Remove the cowl top cover.

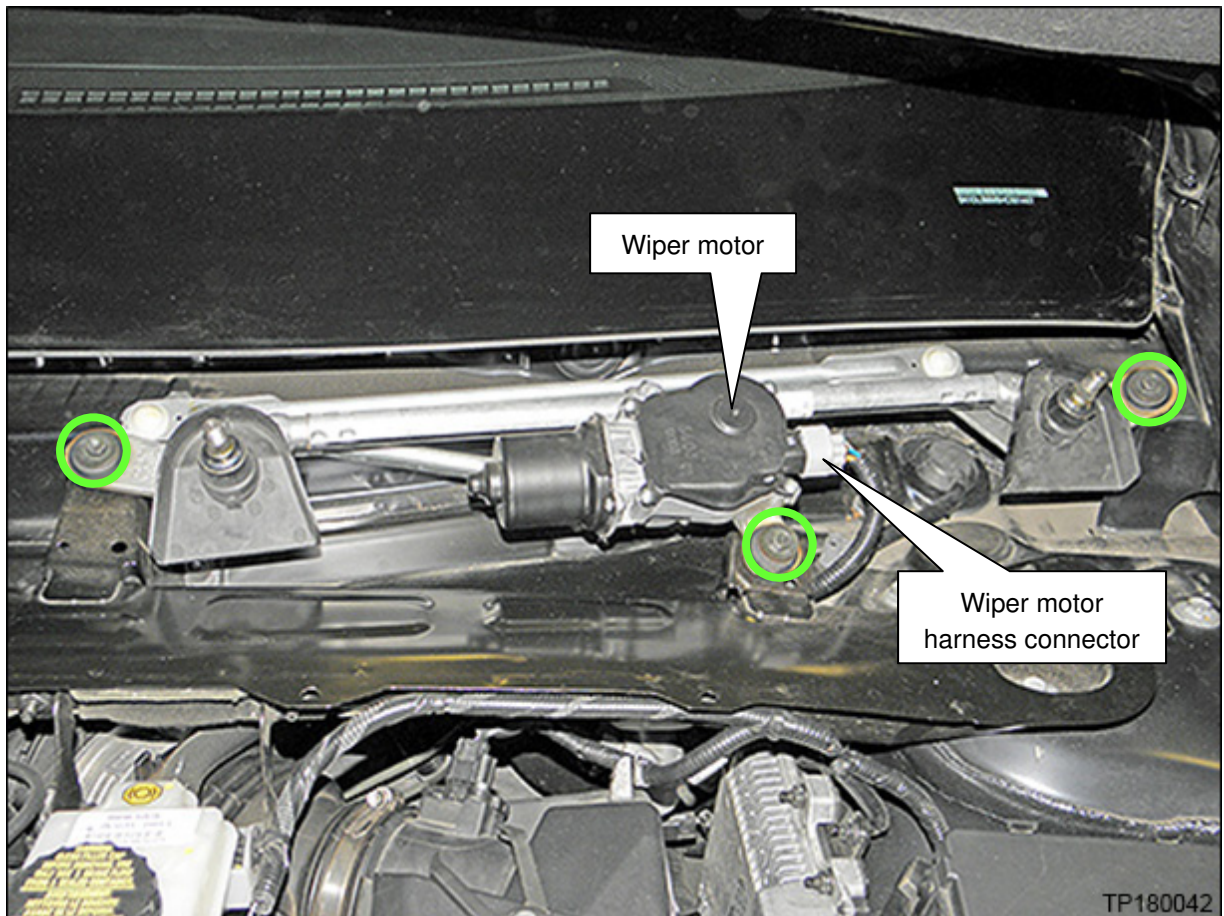
Figure 16

21. Remove the three nuts retaining the wiper motor.

22. Disconnect the wiper motor harness connector.

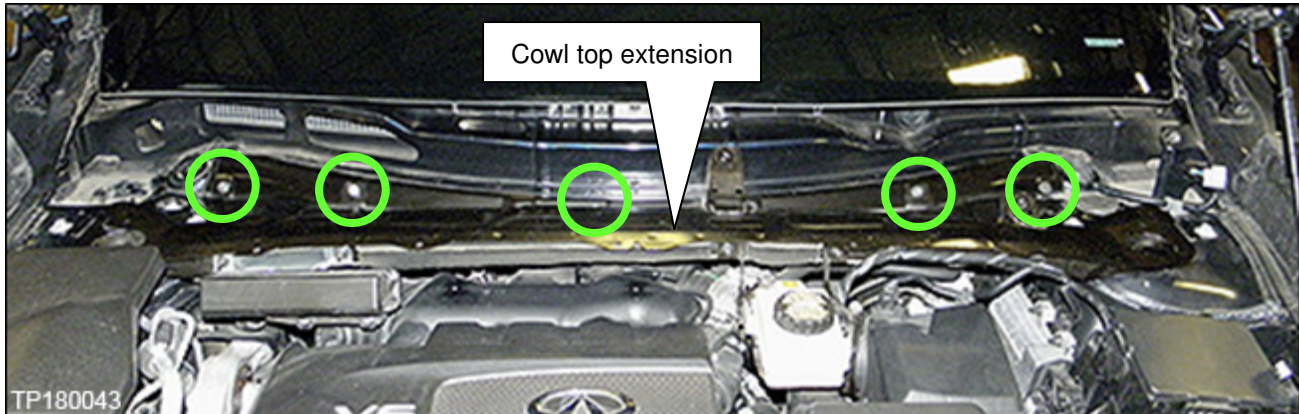
Figure 17

- a. Remove four (4) bolts and one (1) nut along the rear edge of the cowl top extension.

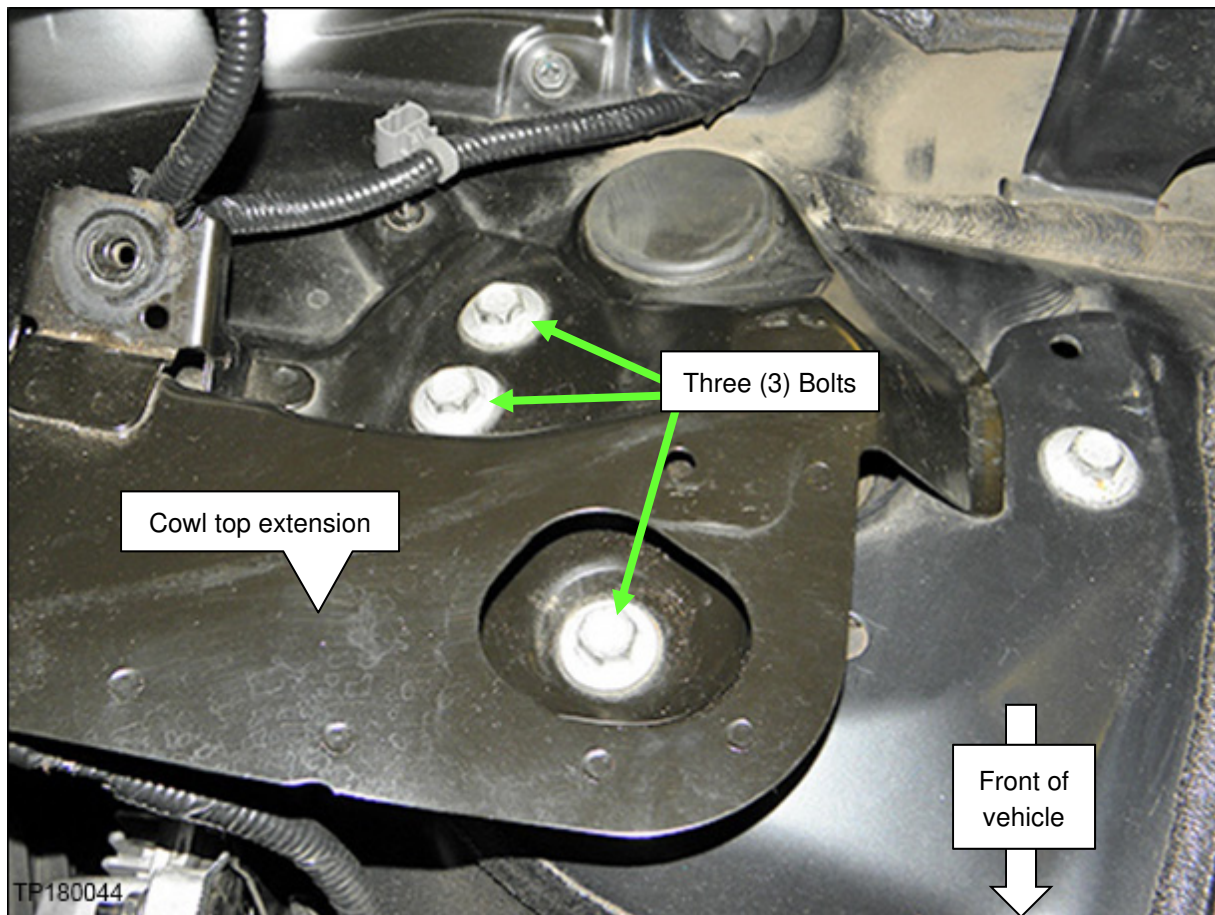
- b. Remove the six (6) bolts that attach the cowl top extension; three (3) at each end.
  - Three (3) bolts shown in Figure 18 are on the driver's side. Three (3) bolts for passenger side are similar, but not shown.

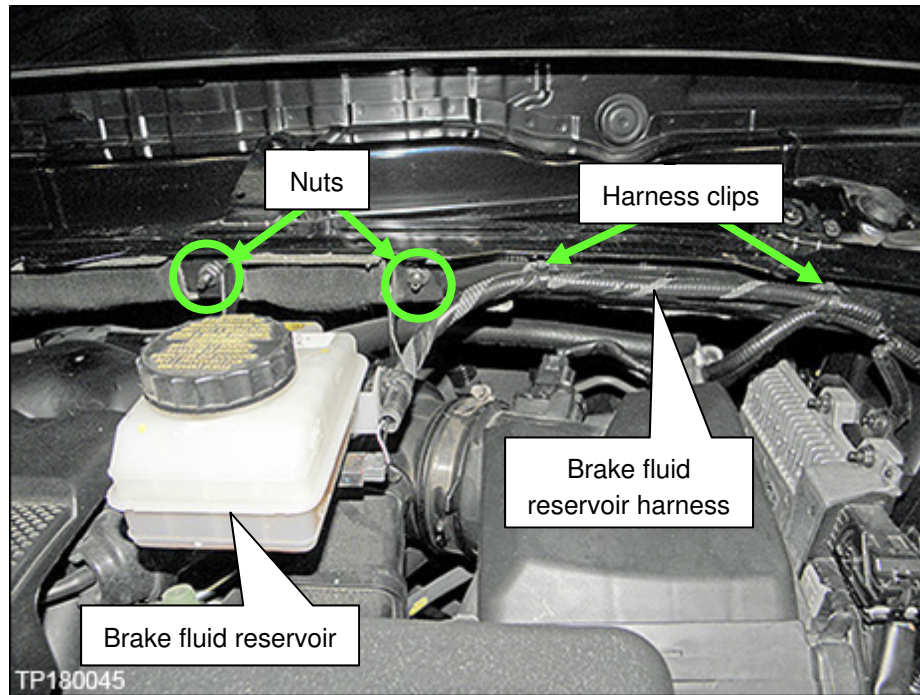
Figure 19

- c. Remove two (2) nuts that attach the brake fluid reservoir to the cowl top extension.
- d. Disconnect brake fluid reservoir harness clips from the cowl top extension.

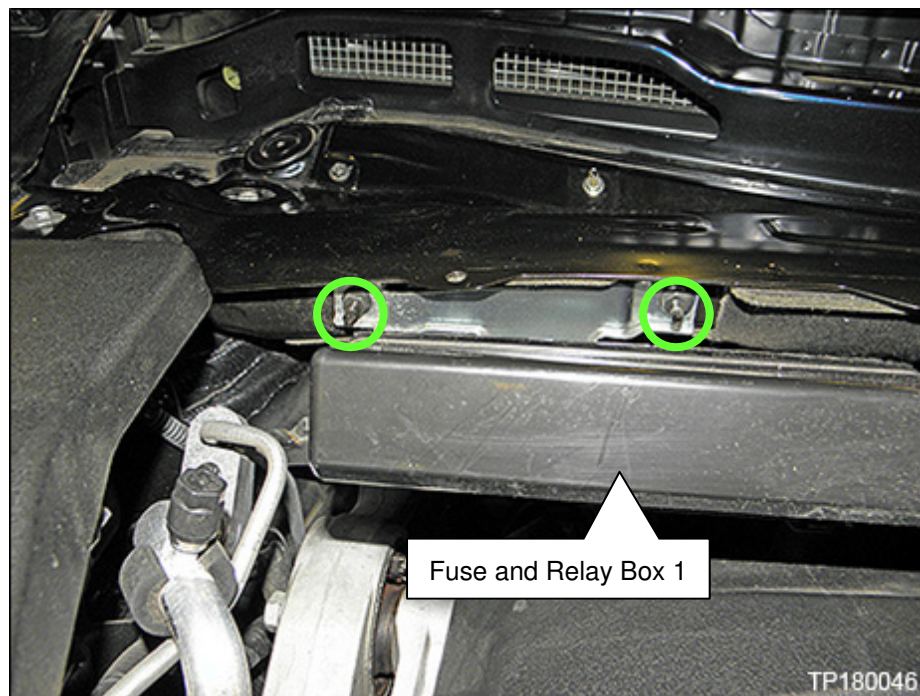
Figure 20

- e. Remove two (2) nuts that attach the Fuse and Relay Box 1 to the cowl top extension.

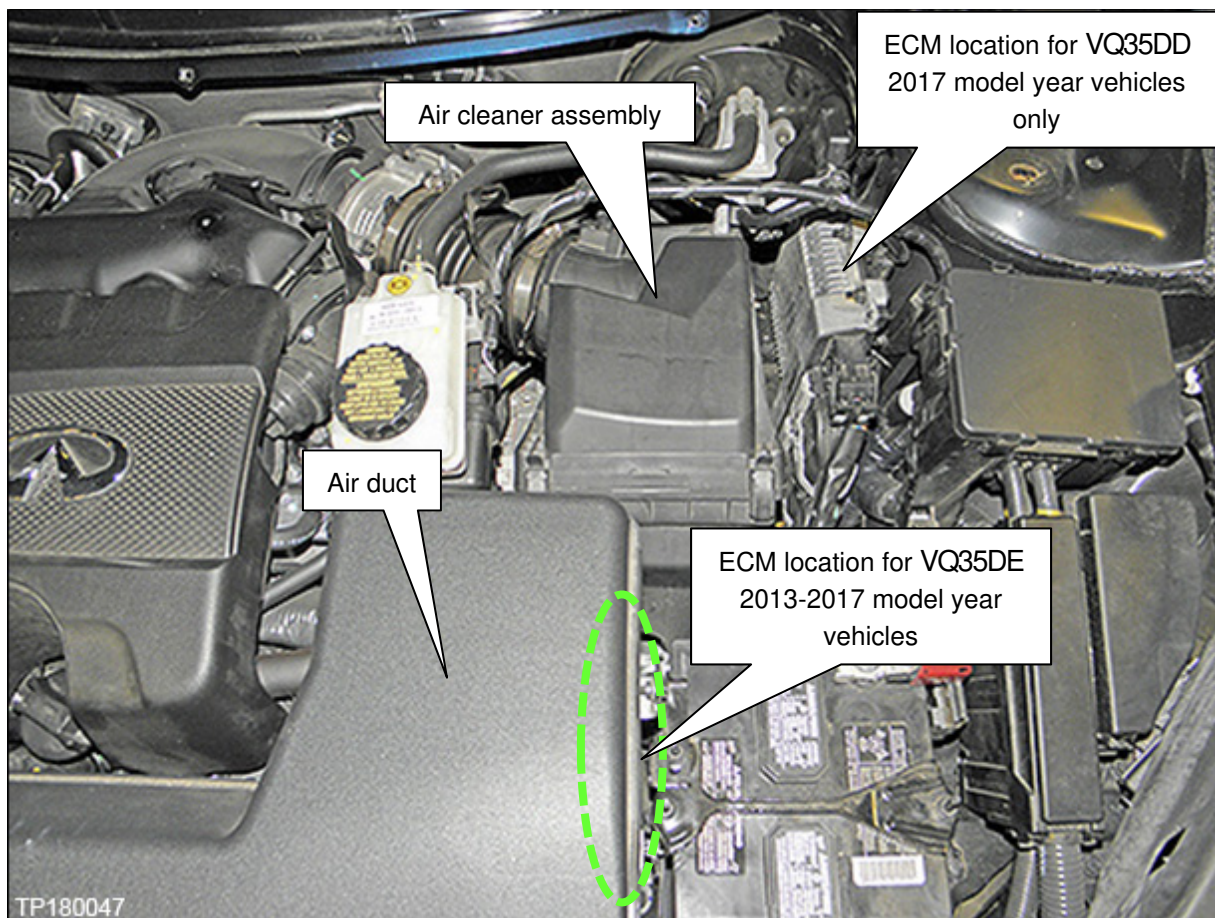
Figure 21

24. Remove the front air duct and the air cleaner assembly (Figure 21).

25. For 2017 model year vehicles with VQ35DD engine, disconnect and remove the ECM shown in Figure 21.

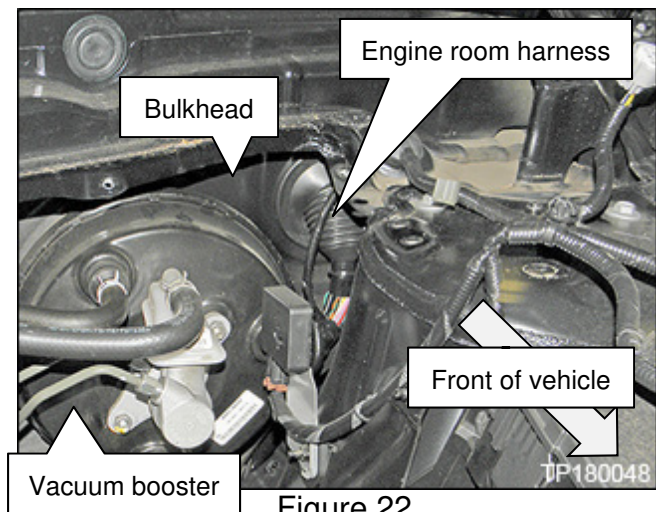
Figure 22

26. Pull the right side engine room harness completely through the Lower Dash Assembly (bulkhead) and into engine room.

**IMPORTANT:** Take care to not damage the harness or harness connectors on the sharp edges of the bulkhead as it is pulled through.

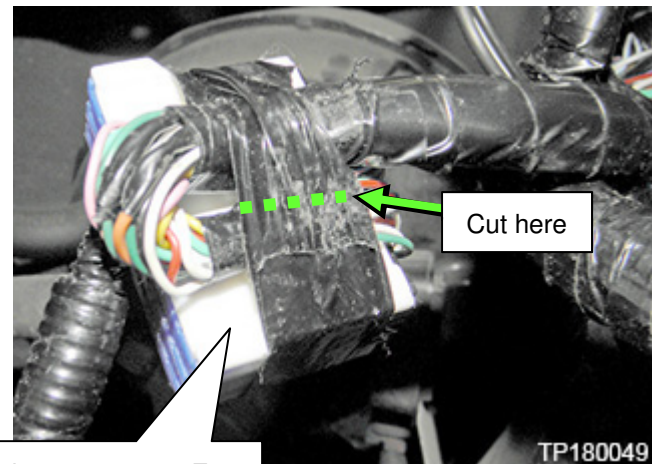
Figure 23

27. Locate "Joint connector – E01" that is attached to the engine room harness.

- This harness connector has blue "shunts" plugged into its terminals.

Joint connector – E01

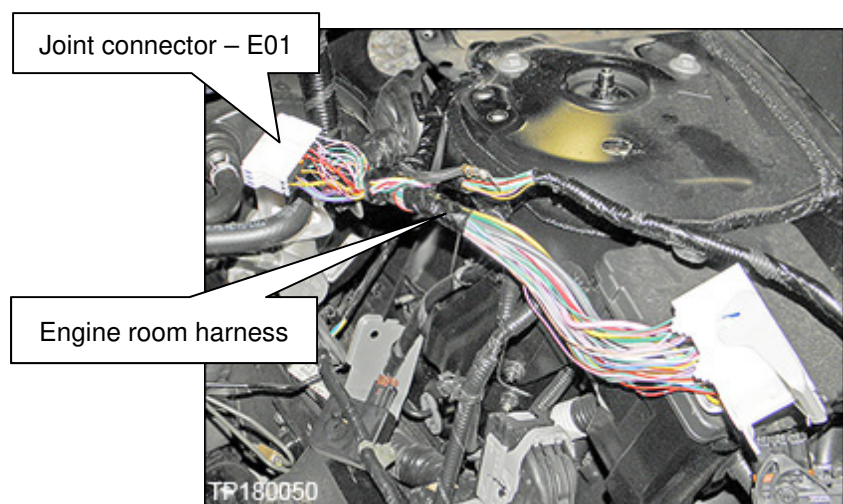
28. Cut the black tape that is attaching Joint connector – E01 to the engine room harness, and remove the black tape from Joint connector – E01.

- Figure 24 shown with Joint connector – E01 black tape removed.

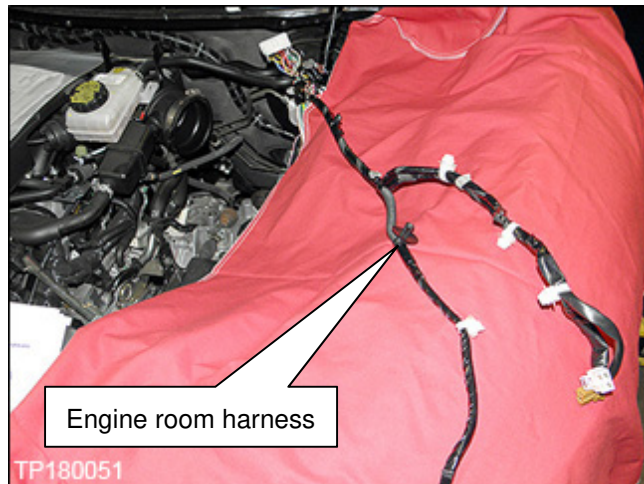
Figure 25

29. Place a fender cover over the driver's side fender and lay out the engine room harness.

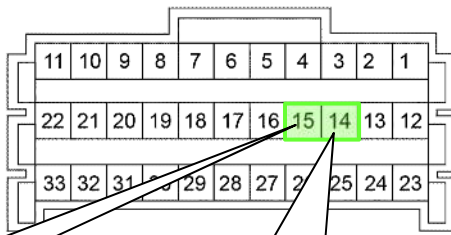
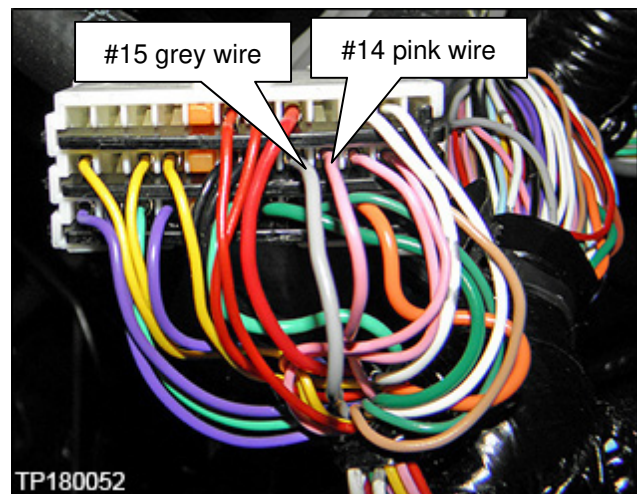
30. Locate the grey and pink wires shown in Figure 26 in Joint connector – E01 (connector number E44).

- Grey wire in position #15 as viewed from the harness side.
- Pink wire in position #14 as viewed from the harness side.

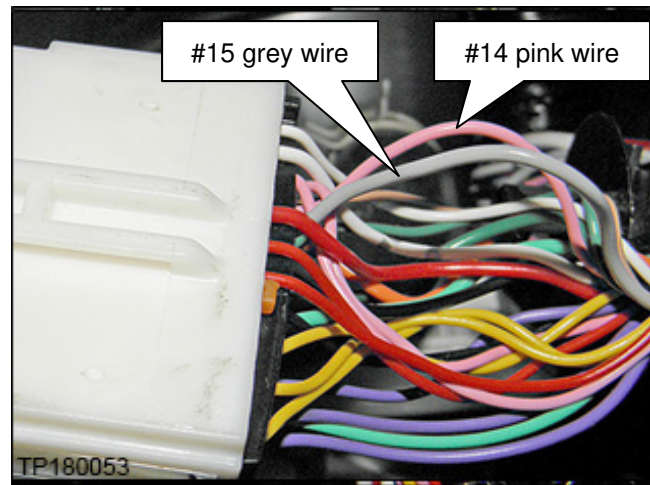
Figure 27

31. Separate the grey and pink wires that have been located from the other wires as shown in Figure 27.

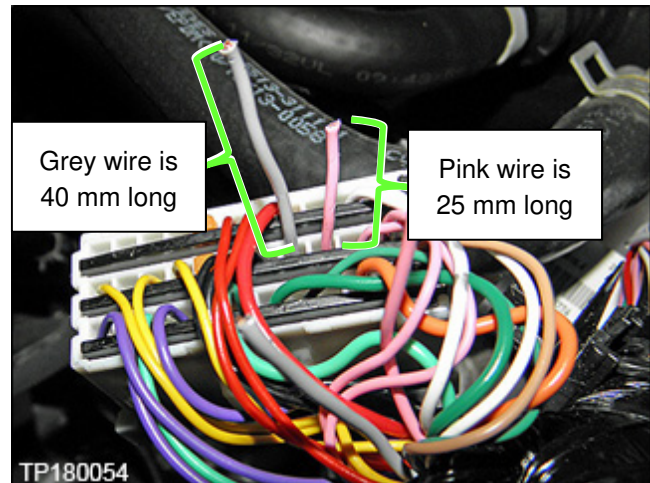
Figure 28

32. Cut the grey wire that was located in steps 30 and 31.

- Measure approximately 40 mm from Joint connector – E01 to point where grey wire is cut.

33. Cut the pink wire that was located in steps 30 and 31.

- Measure approximately 25 mm from Joint connector – E01 to point where pink wire is cut.

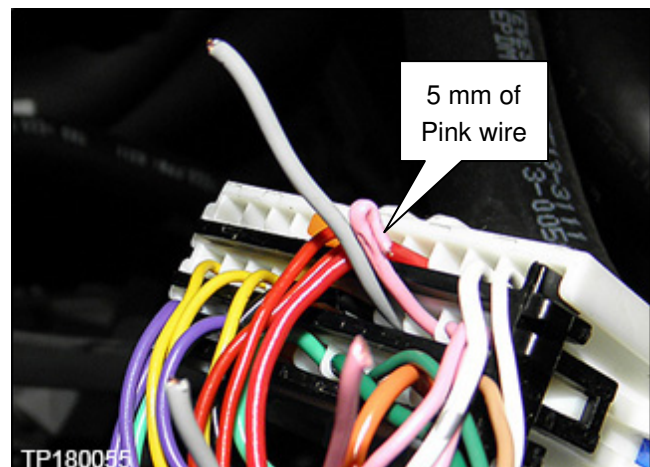
Figure 29

34. Fold over approximately 5 mm of the pink wire that is extending from Joint connector – E01 as shown in Figure 29.

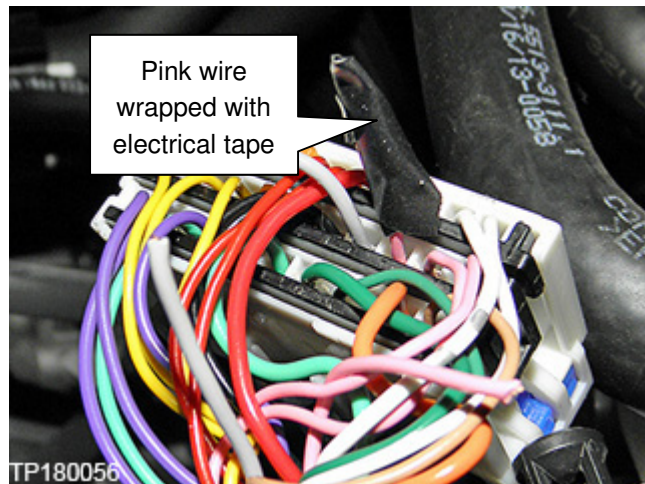
Figure 30

35. Wrap pink wire that was folded over in step 34 with black electrical tape.

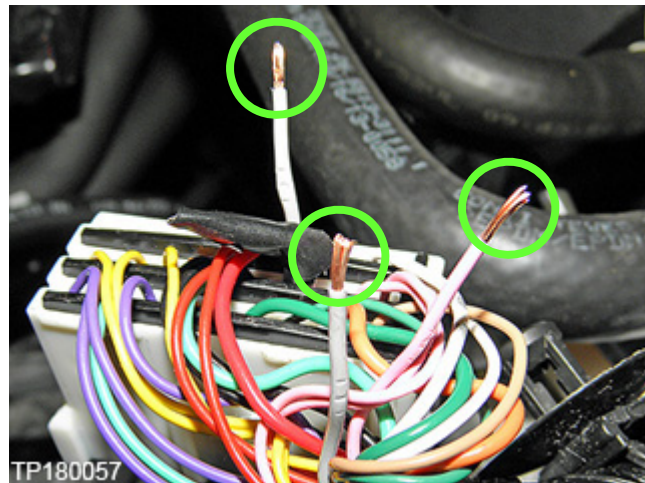
Figure 31

36. Strip approximately 10 mm from the remaining pink wire and the two grey wires.

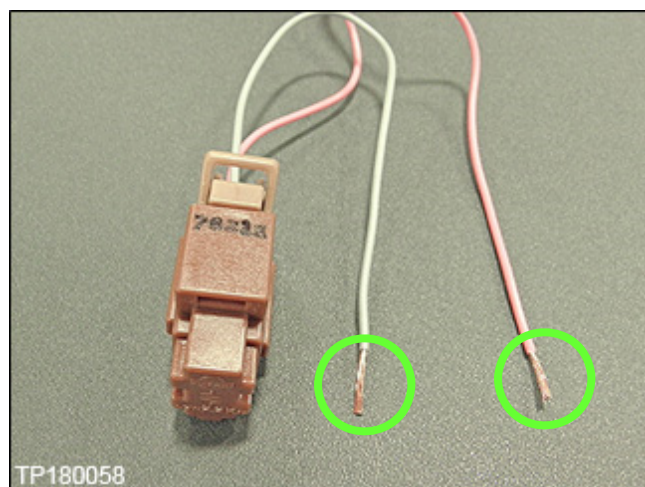
Figure 32

37. Strip approximately 10 mm from the pink and grey wires of the jumper harness.

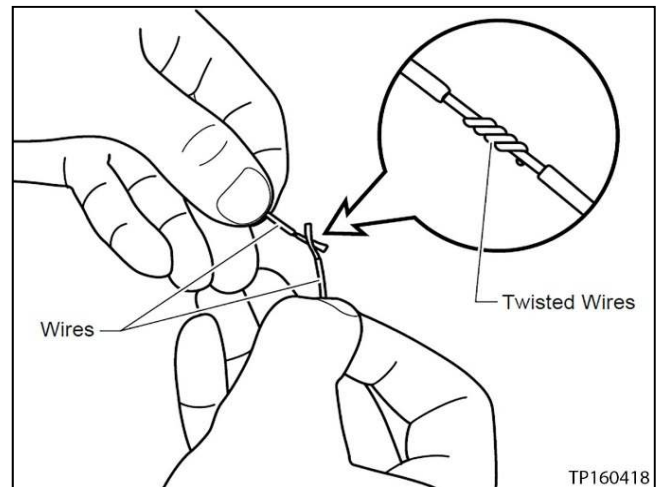
Figure 33

39. Twist together the pink wire of the jumper harness with the remaining pink wire stripped in step 36. (See Figures 33 and 34.)

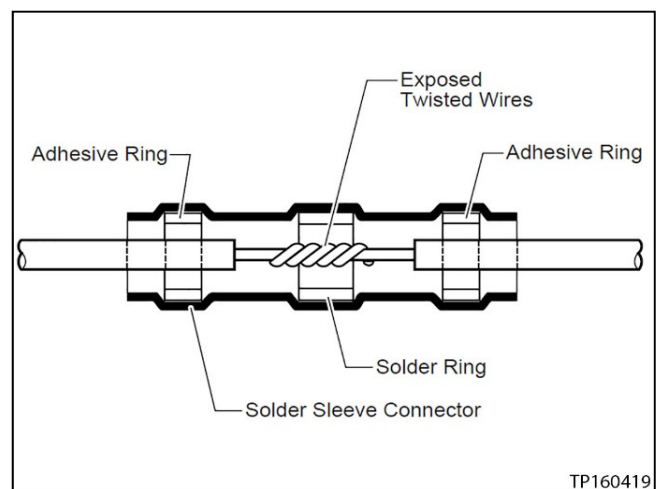
Figure 34

40. Position the solder ring in relation to the twisted wires as shown in Figure 34.

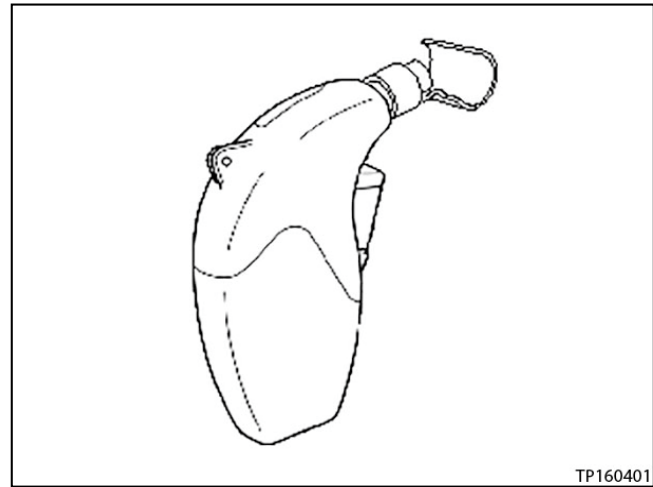
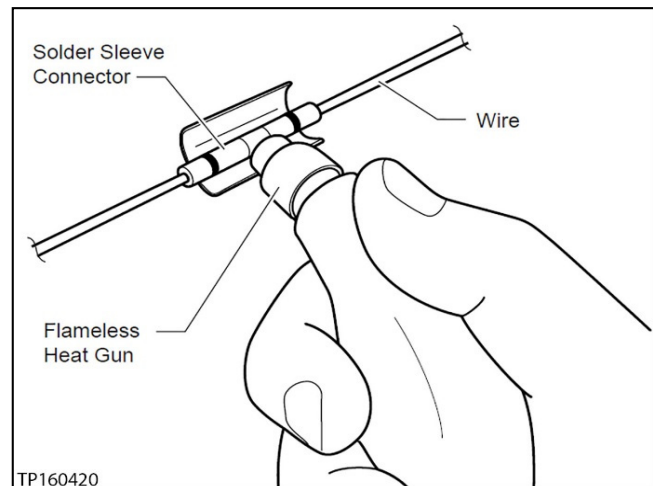
41. "Install" the solder sleeve connector by shrinking it to the wire with essential tool Flameless Heat Gun J-46538 or similar flameless heating tool (see Figures 35 and 36).

- Melt the solder (silver ring inside the solder sleeve connector) into the exposed twisted wire area,
- Melt the sealant (red rings inside the solder sleeve connector) onto the wires, and
- Shrink the remainder of the solder sleeve connector to the wire.

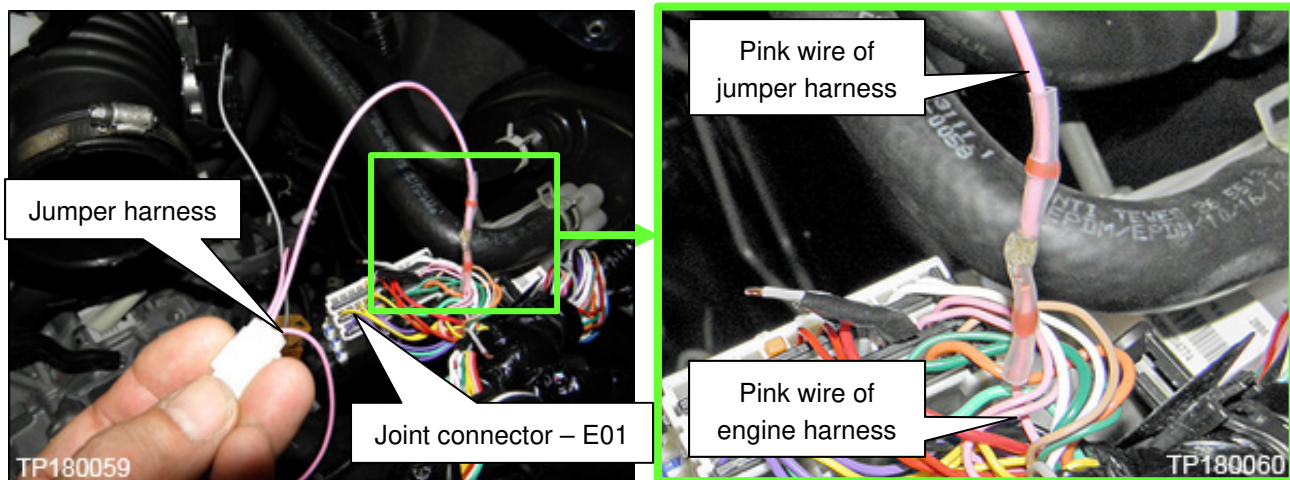
- Figure 37 shown with solder connection of pink wire of jumper harness and pink wire of Joint connector – E01 completed.

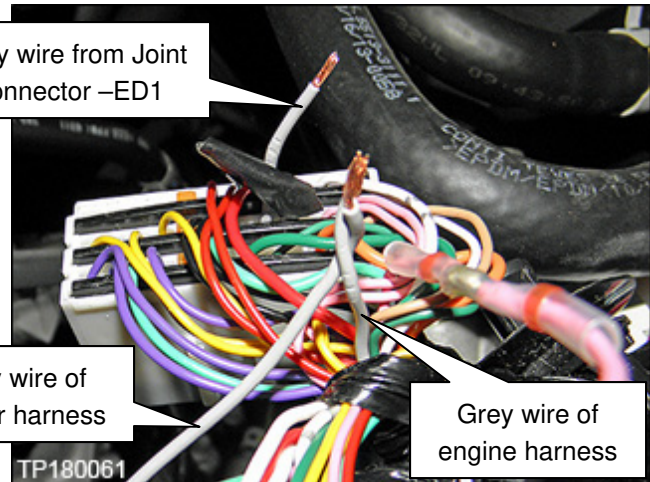
42. Twist together the grey wire of the engine harness that was cut in step 32 with the grey wire of the jumper harness as shown in Figure 38.

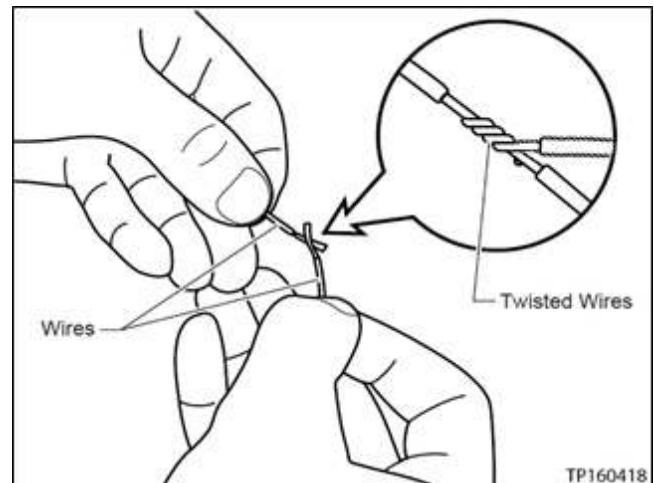
Figure 39

44. Now twist the third grey wire from Joint connector – E01 (Figure 39) that was cut through in step 32 to form a three way connection.

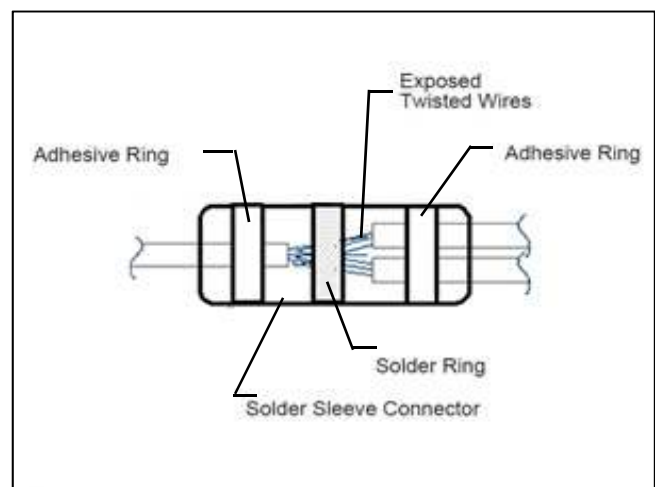
Figure 40

45. Position the blue solder sleeve connector so that the solder ring is in relation to the three twisted wires as shown in Figure 40.

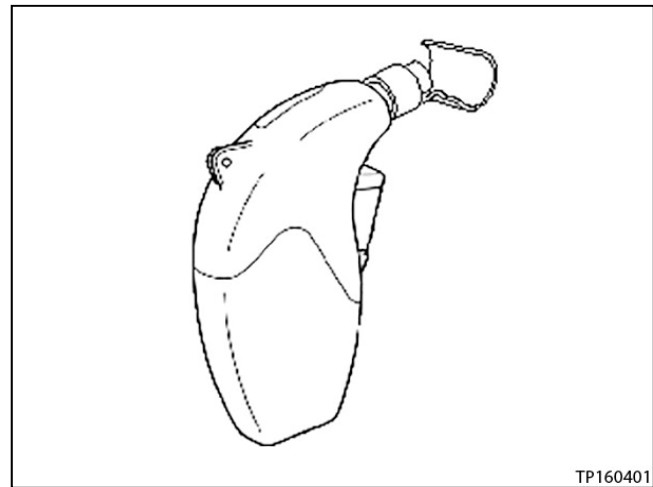
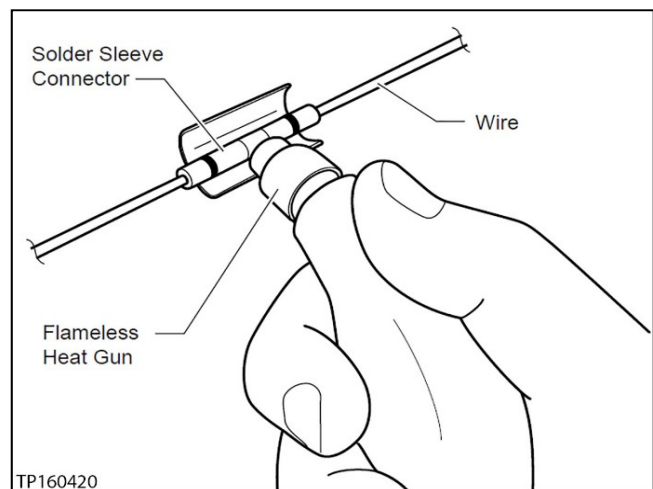
46. "Install" the solder sleeve connector by shrinking it to the wire with essential tool Flameless Heat Gun J-46538 or similar flameless heating tool (see Figures 41 and 42).

- Melt the solder (silver ring inside the solder sleeve connector) into the exposed twisted wire area,
- Melt the sealant (blue rings inside the solder sleeve connector) onto the wires, and
- Shrink the remainder of the solder sleeve connector to the wire.

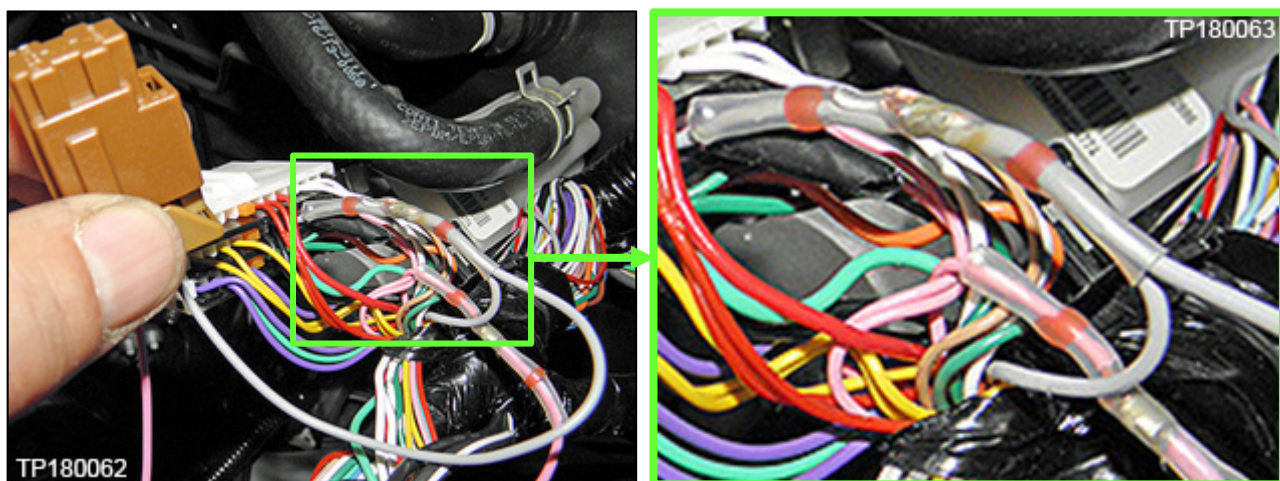
- Figure 43 shown with three way solder connections completed.
