DA17-028B

ITB18-006B

## 2013 JX35 AND 2014-2017 QX60; VDC WARNING LAMP ON WITH DTC C1116 STORED

APPLIED VEHICLES: 2013 JX35 (L50)  
2014-2017 QX60 (L50)  
APPLIED SYSTEM: Without Intelligent Cruise Control ONLY

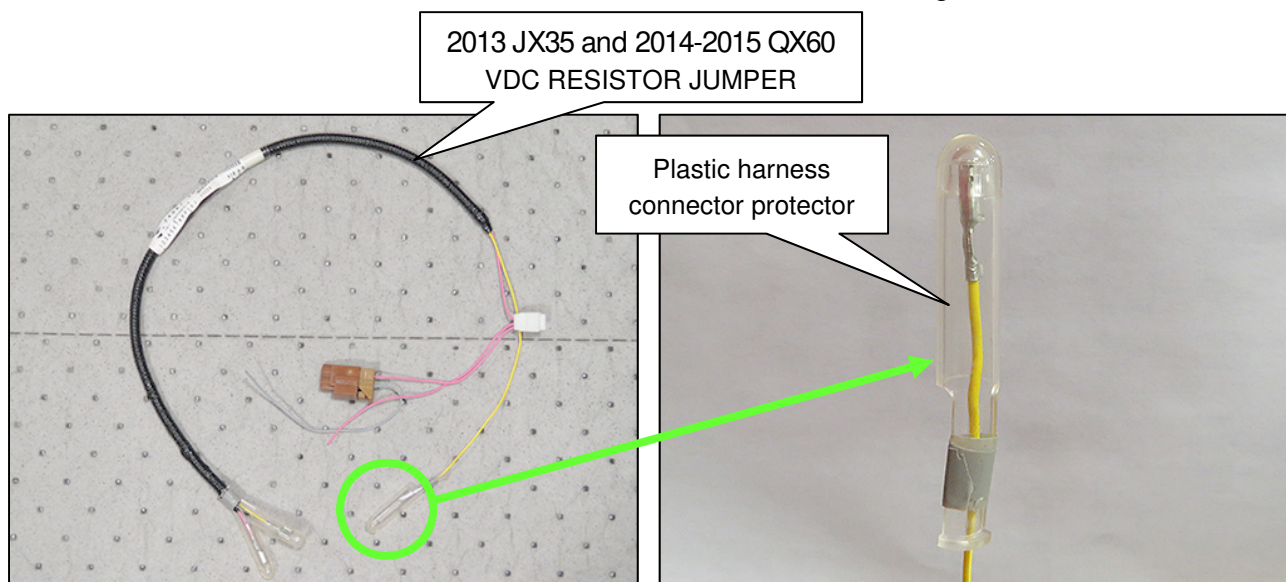
Figure 45

48. Remove the black harness connector retainer clip from the back of Joint connector – E01.
49. Remove the plastic harness connector protector from the end of the yellow jumper harness shown in Figure 45.
  - See the PARTS INFORMATION on page 26 for 2013 JX35 and 2014-2015 QX60 VDC RESISTOR JUMPER kit.

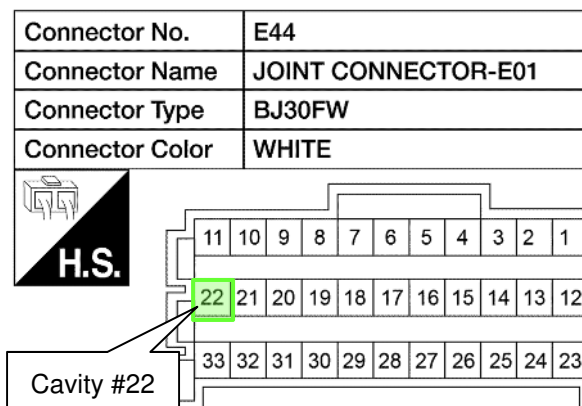
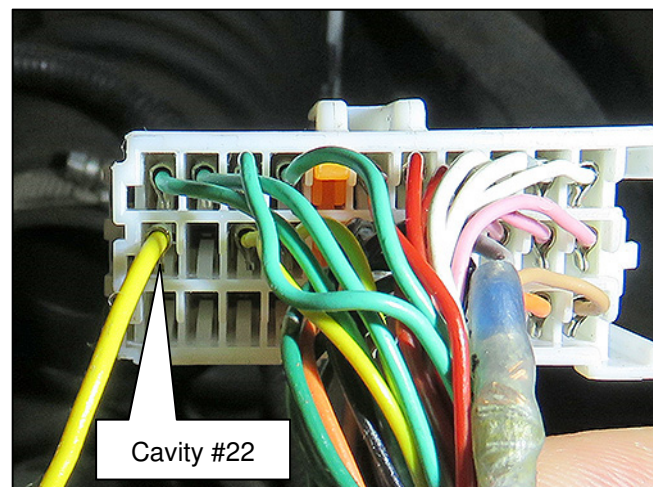
Figure 46

50. Insert the end of the yellow jumper harness into Joint connector – E01, cavity #22.

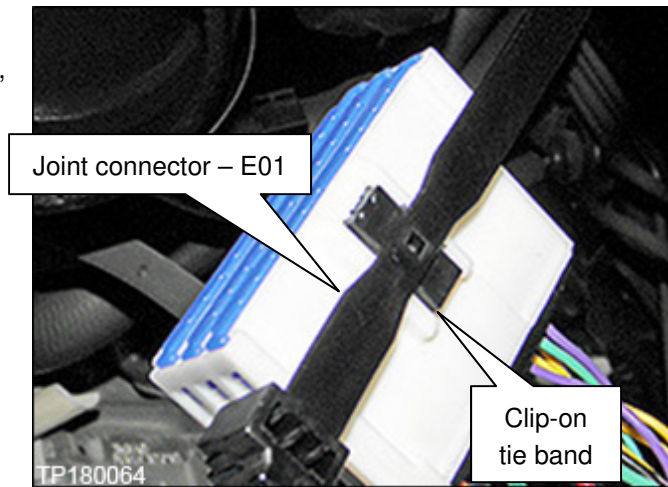
Figure 47

53. Install a new band (clip-on tie band) from the PARTS INFORMATION on page 26 to Joint connector – E01.

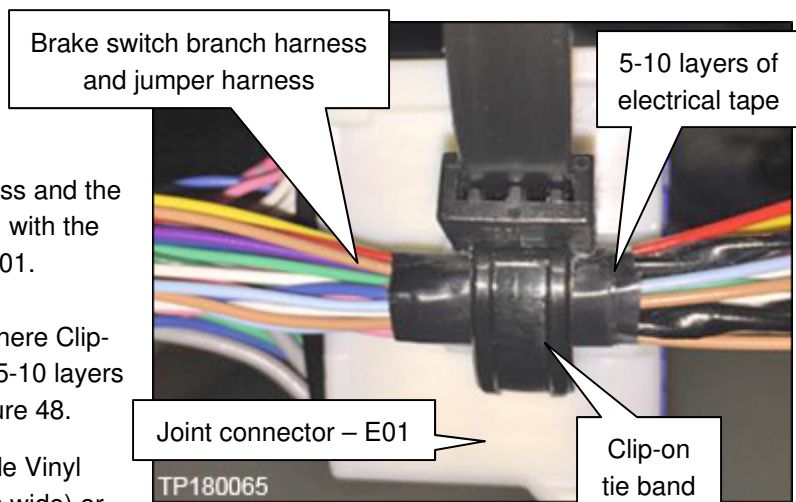
Figure 48

**IMPORTANT:** If tape is not present where Clip-on tie band will be located, wrap with 5-10 layers of electrical tape first as shown in Figure 48.

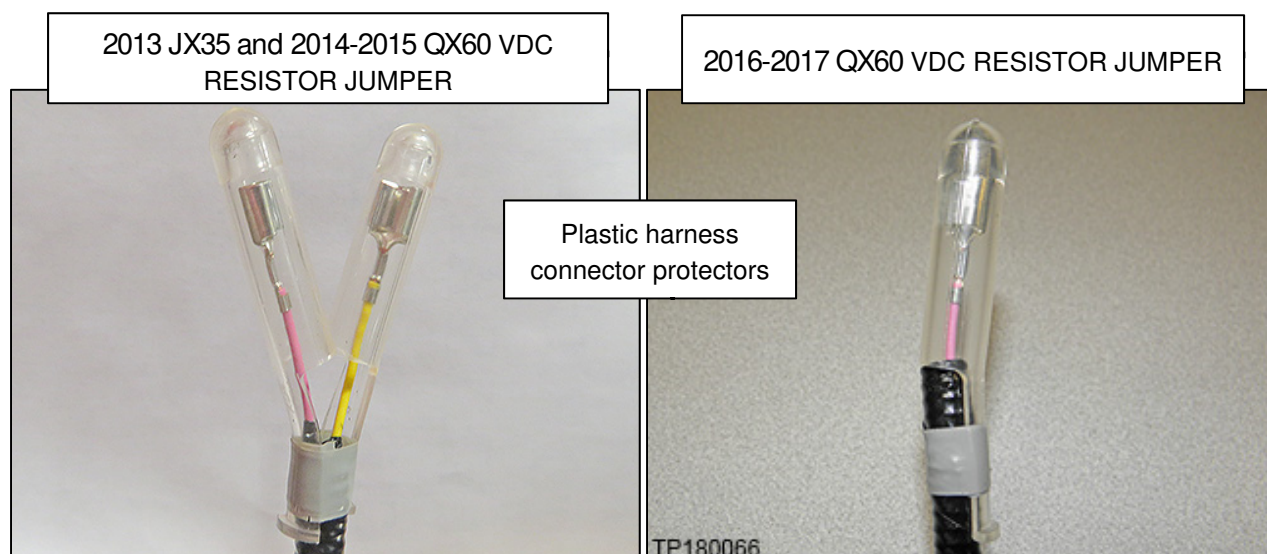
Figure 49

55. Remove any remaining plastic harness connector protector(s) from the jumper harness (Figure 49).

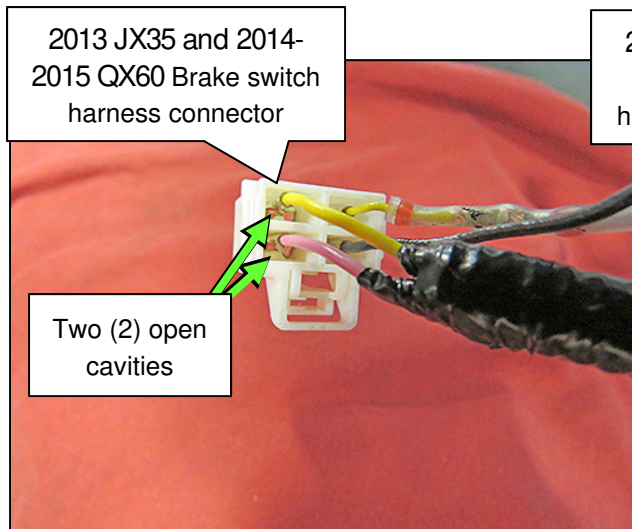
Figure 50

- For 2013 JX35 and 2014-2015 QX60: Insert the pink and yellow jumper wire connectors into the open cavities of the harness side of the brake switch harness connector as shown in Figure 50.
- For 2016-2017 QX60: Insert the single pink jumper wire connector into the open cavity of the harness side of the brake switch harness connector as shown in Figure 51.

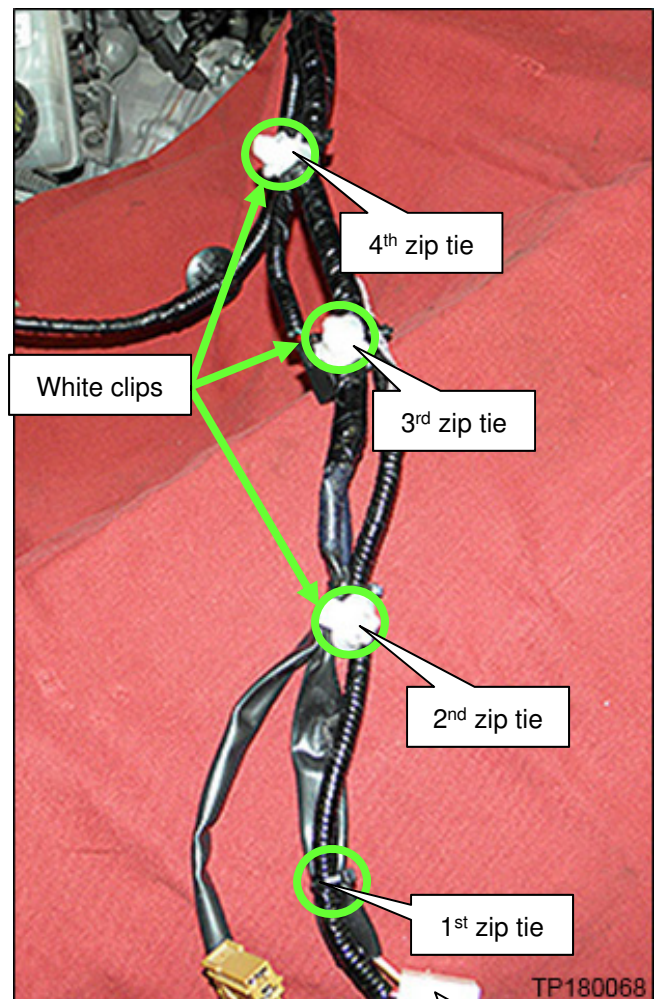
Figure 52

- Lay the new jumper harness next to the brake switch branch harness so that there is no slack at the harness plug end.
- Place the first (1<sup>st</sup>) zip tie approximately 25 mm (1 inch) from the brake switch branch harness connector.
- Place the second (2<sup>nd</sup>) zip tie next to the first white clip.
- Place the third (3<sup>rd</sup>) zip tie next to the second white clip.
- Place the fourth (4<sup>th</sup>) zip tie next to the third white clip.

Harness plug end

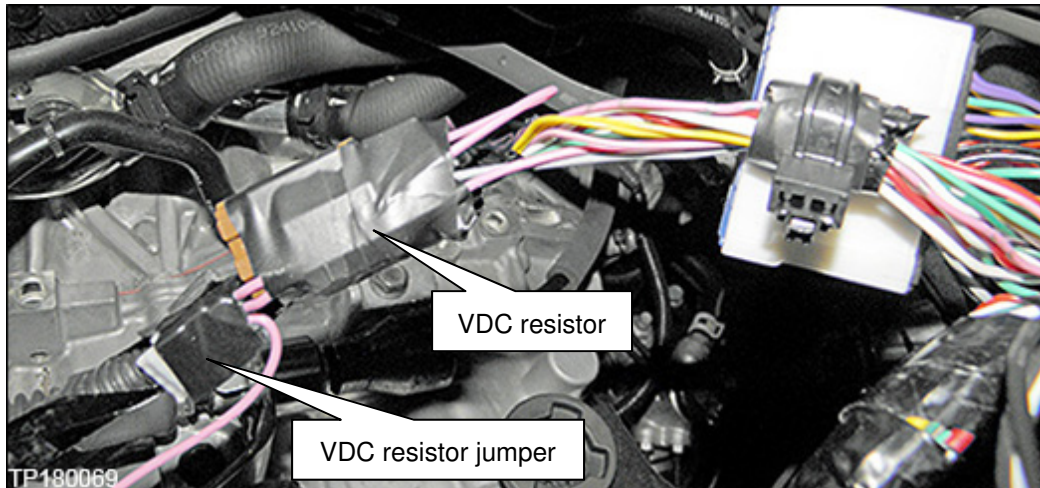
Figure 53

58. Secure the VDC resistor and VDC resistor jumper (both part of jumper harness) to the brake switch branch harness with black electrical tape.

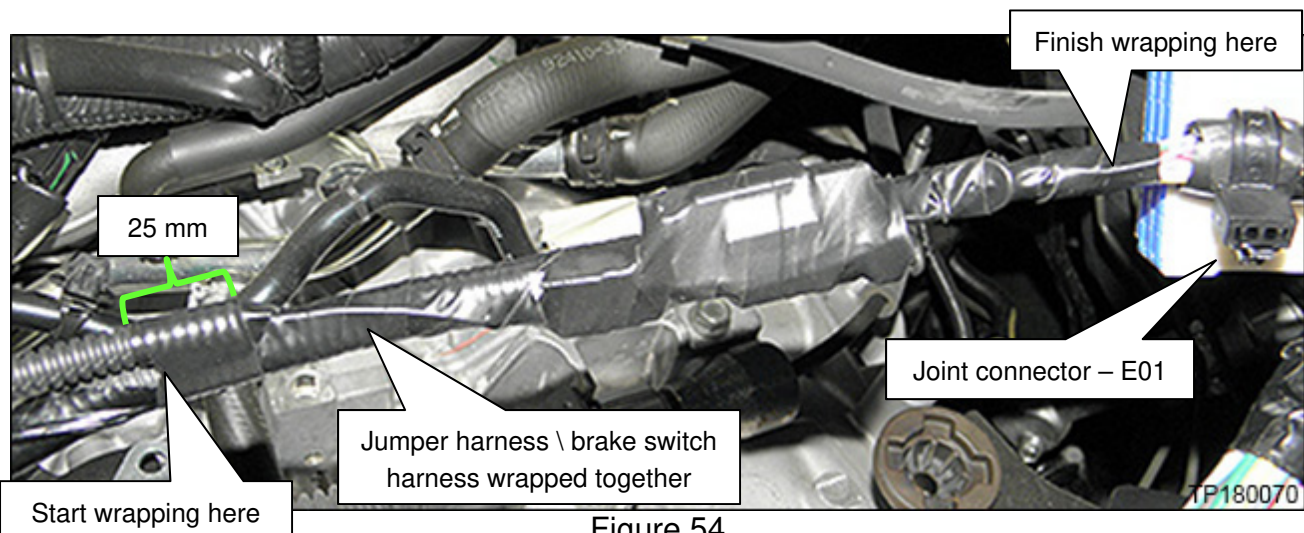
59. Starting at the point shown in Figure 54 wrap the jumper harness and brake switch harness together with black electrical tape as follows:

- Use 3M/Scotch Professional Grade Vinyl Super 88 Electrical Tape (3/4 inch wide) or equivalent.
  - a. Start the wrap approximately 25 mm (1 inch) below where the two (2) corrugated harness protectors of the jumper harness and brake switch harness come together.
    - Wrap only the jumper harness and brake switch harness together.

- b. Wrap over the VDC resistor and VDC resistor jumper.

- c. End the wrap at Joint connector – E01.

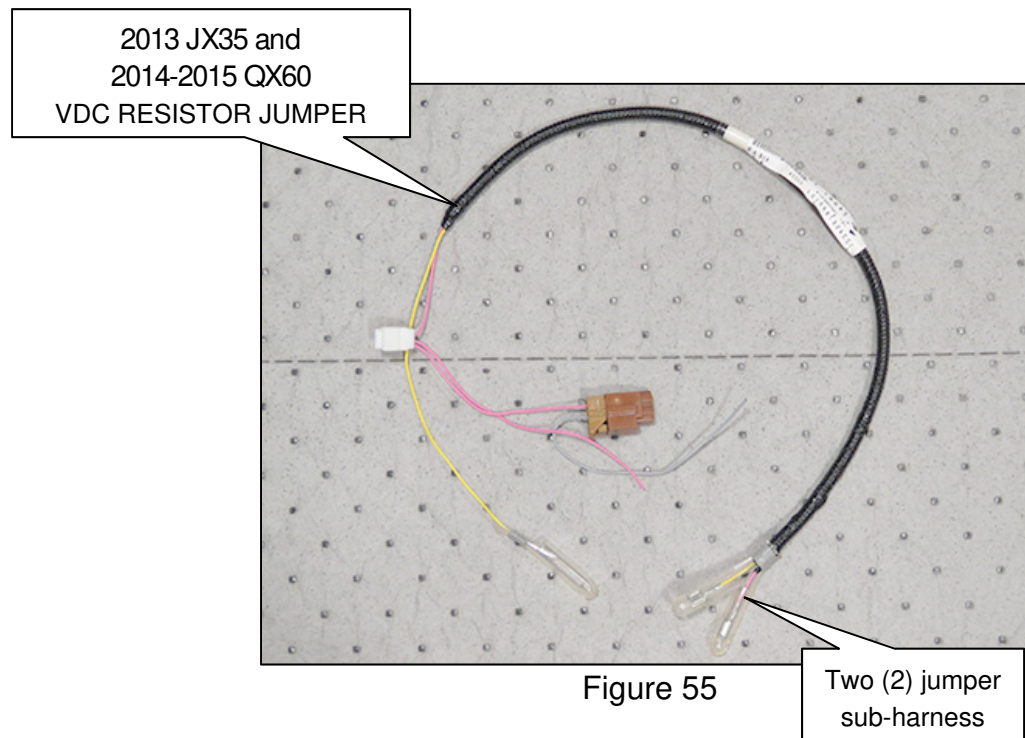
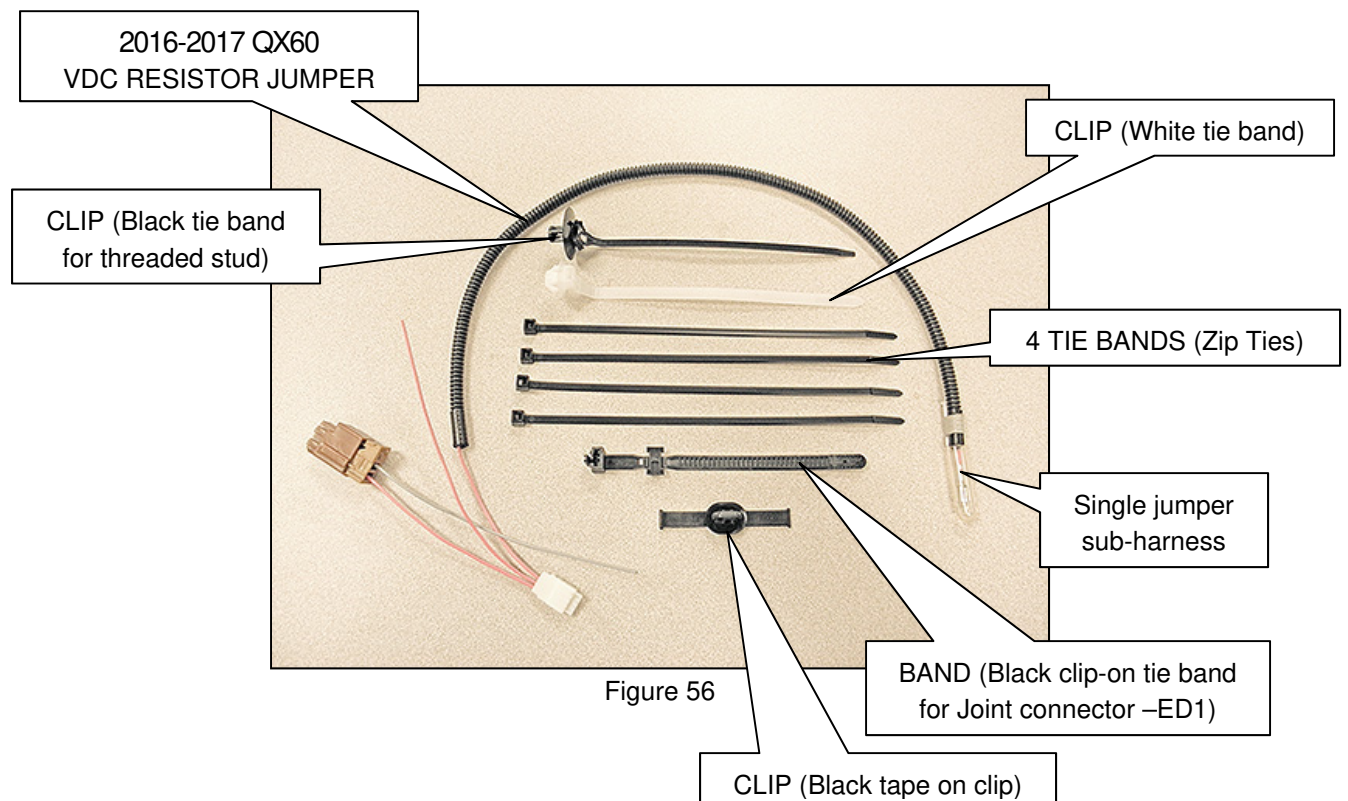
## HARNESS IDENTIFICATION

NOTE: Figure 56 shows all components that are included in both kits. Figure 55 only shows the differences between the two harnesses.
