| <b>HYUNDAI</b><br><b>Technical Service Bulletin</b> | GROUP<br>Campaign | NUMBER<br>21-01-045H-1 |
| | DATE<br>September, 2021 | MODEL(S)<br>Nexo (FE) |
| <b>SUBJECT: STACK COOLANT PUMP REPLACEMENT<br/>(SERVICE CAMPAIGN T6A)</b> | | |

***This TSB supersedes 21-01-045H by adding an updated coolant part number 00232-19080.***

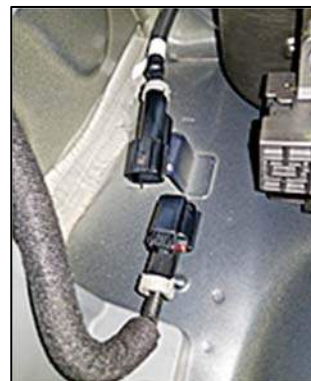
1. Ensure the Push Button Start Stop (PBSS) is off, and the fuel stack is not in Ready Mode. Wait at least 3 minutes before continuing with the procedure.
2. From the vehicle cargo area, remove the floorboard and cargo tray to access the 12V battery connector and high voltage safety plug.
3. Disconnect the auxiliary 12V battery negative (-) connector.

- Be sure to record the radio presets prior to battery disconnection.

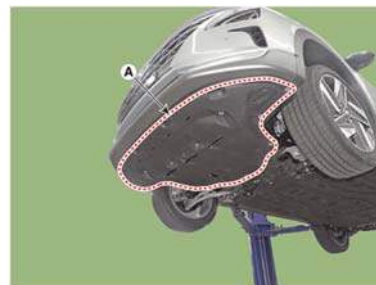
6. Remove the fuel cell stack room undercover.

**Fuel Cell System > Fuel Cell Stack > Fuel Cell Stack Room Under Cover**

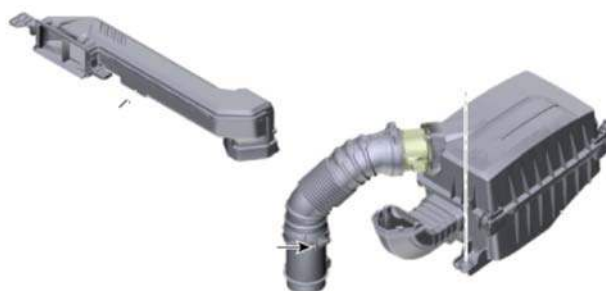
8. Remove the air cleaner assembly.

**Fuel Cell System > Air Processing System > Air Cleaner.**

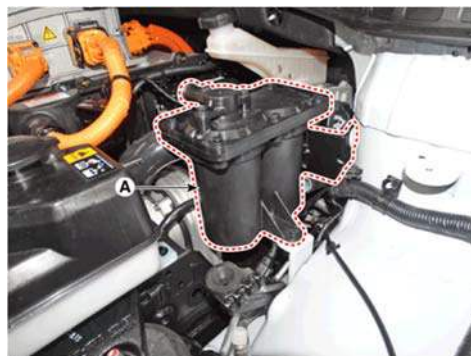
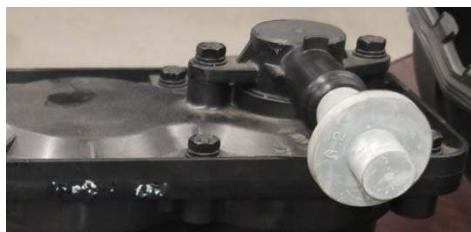
10. Remove the stack coolant ion filter as an assembly (A). DO NOT remove filters from canister.

To prevent loss of coolant from filter canister. Insert a tapered plug into the upper hose fitting on the filter canister then remove the lower hose from filter canister and insert a tapered plug into lower hose fitting on the filter canister.

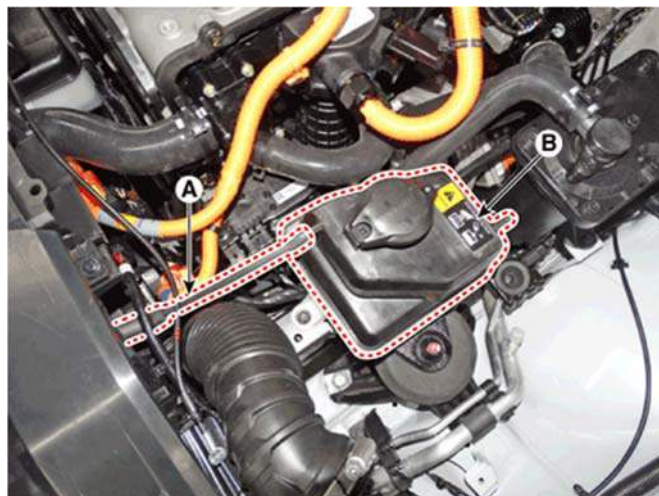
11. Remove the stack coolant reservoir, (B) do not allow coolant to drain out of reservoir.

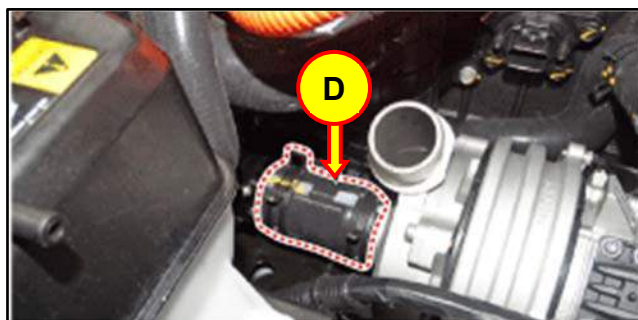
14. Disconnect the stack coolant pump inlet hose clamp (D).

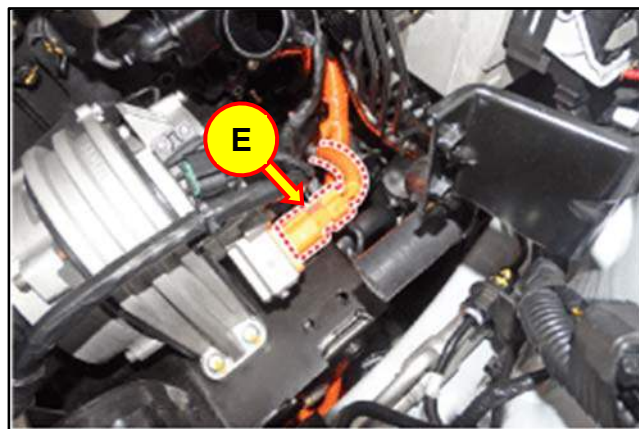
15. Disconnect the stack coolant pump high voltage cable connector (E).

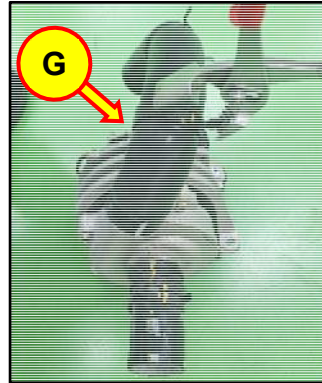
1. Remove the stack coolant pump hose (G).

Remove the inlet and outlet hose (H).

**Do not discard the stack coolant pump hose. The pump hose will be installed onto the replacement stack coolant pump.**

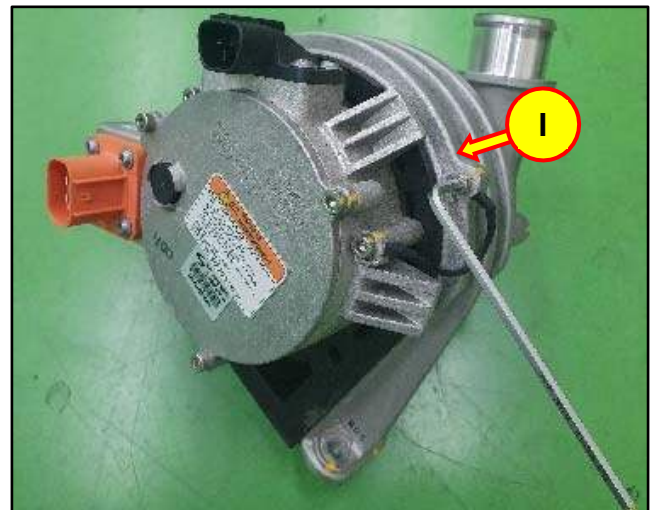
2. Remove the ground wire (I) from the bracket.

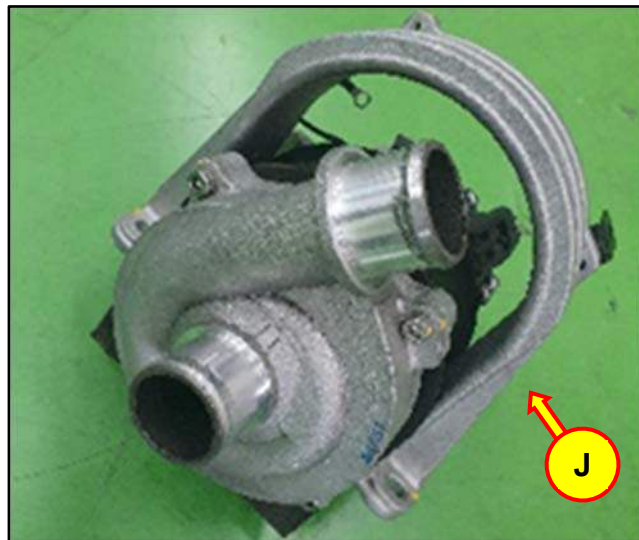
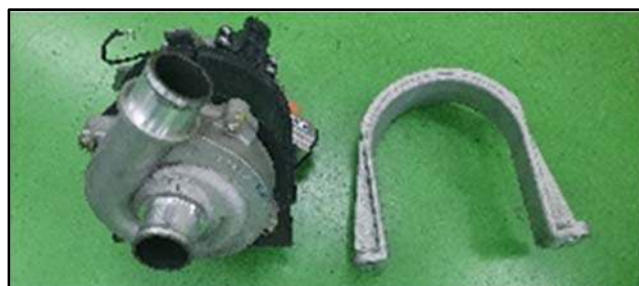
3. Remove the pump bracket (J).

Do not discard the pump bracket. The pump bracket will be installed onto the replacement stack coolant pump.

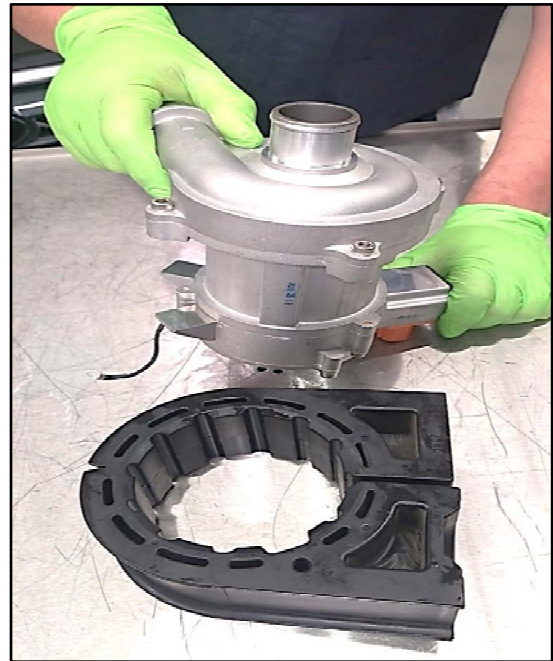
5. Attach the rubber bushing to the new stack coolant pump.

The rubber bushing and stack coolant pump housing are indexed with a land and groove.

Align the groove in the rubber bushing with the land on the stack coolant pump housing.

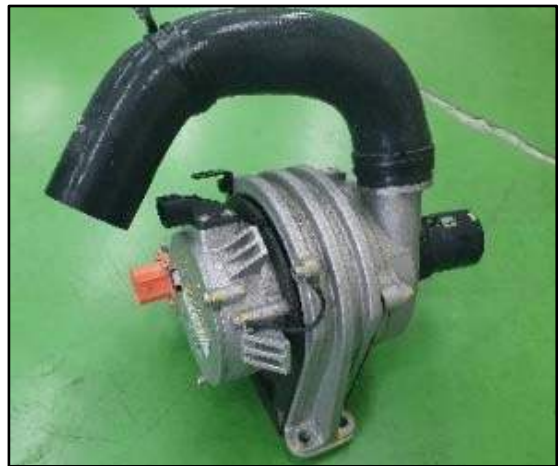
6. Attach the pump bracket and hose from the original stack coolant pump to the new stack coolant pump.
