# Technical Service Bulletin

## 19 MIL on, DTCs P218100, P017B00, P308100, and/or P01E400 are stored in the ECM

19 22 29 2058767/8 March 7, 2022. Supersedes Technical Service Bulletin Group 19 number 21-13 dated March 2, 2021, for reasons listed below.

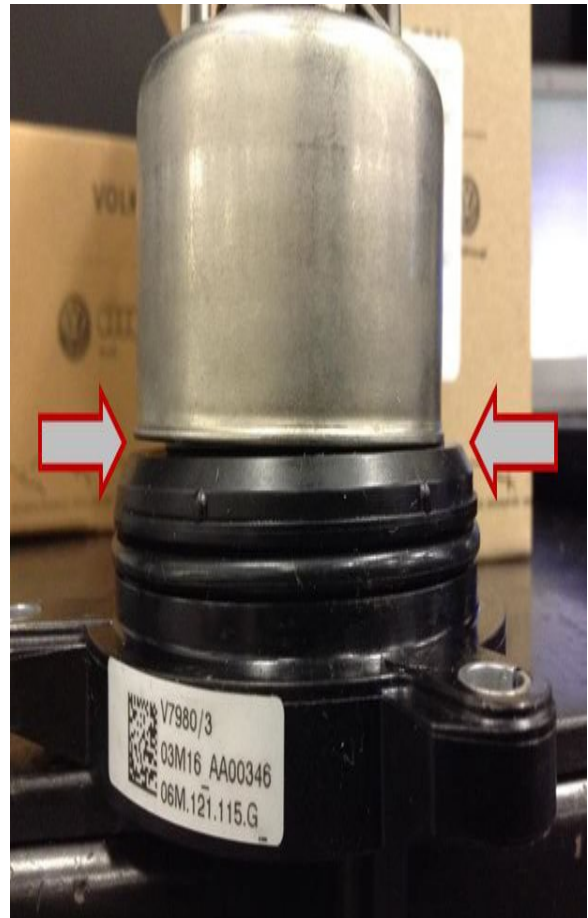
1. Remove the thermostat and check whether it closes completely. If the coolant is still warm, put the thermostat in cold water to restore its original condition. If there is a gap between the chamber and seal, the thermostat is faulty and needs to be replaced.

*Figure 1. Gap between chamber and seal.*

2. Attach photos to the repair order which clearly shows that the thermostat does not close neatly.

After the repair, fill with G12evo coolant in the coolant circuit.
