# Technical Service Bulletin

**AIR BAG WARNING LIGHT ON WITH DTC B1126:13 OR B1127:13**

**Bulletin No.: 08-001/22**

2019-2022 Mazda3

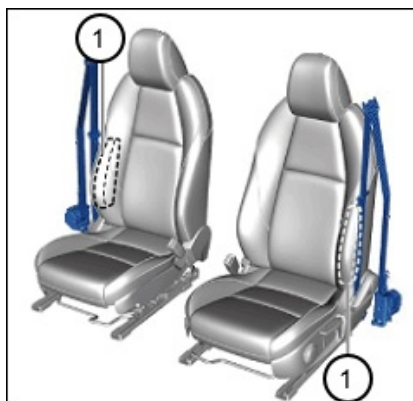
1. Remove the seat back trim and the urethane foam pad.
2. Remove the side air bag module (1) by loosening the nuts.
3. Partially remove the side air bag harness.
4. Remove the plastic cover.
5. Perform the following (may be done in different order).
  - a. Work on the plastic cover.
  - b. Work on the urethane foam pad.
  - c. Work on the harness connector.
6. Install the side air bag module and the harness.
7. Install the seat back trim and the urethane foam pad.

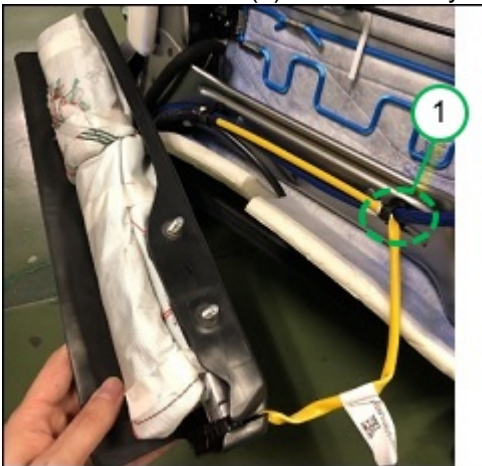
2. Remove the band (1) that fixes the yellow harness for the side air bag module.

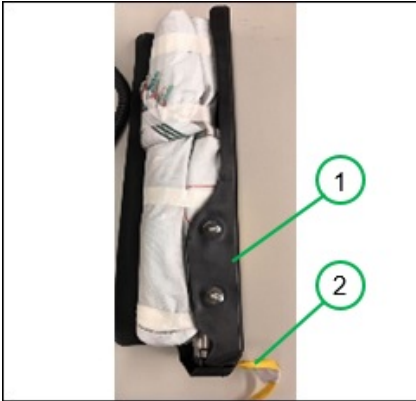
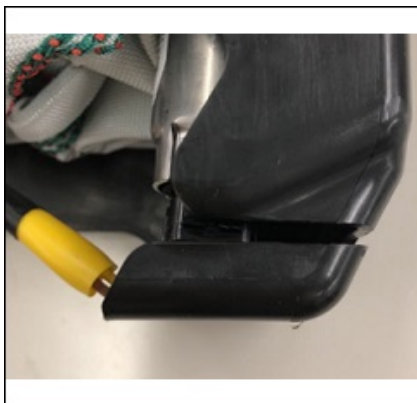
3. Remove the harness (2) from the hole and slit of the plastic cover (1).

Remove the harness from the hole (3) and slit (1).

(1) Slit

View from (2)  
(3) Hole (diameter 5 mm)

After removal of the harness

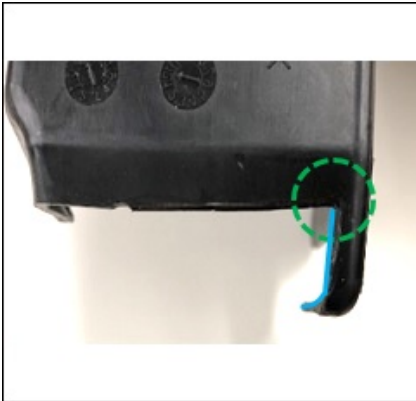
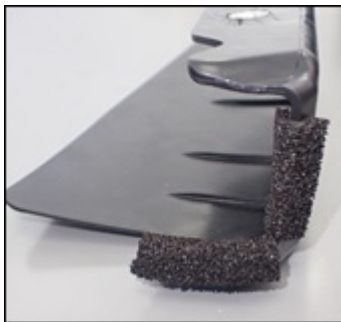
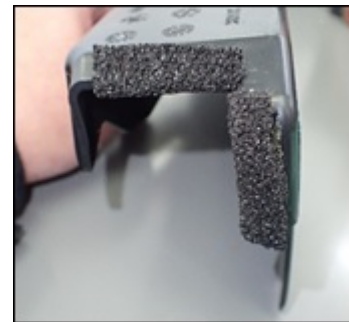
- Align the edge (red line in the figure) of the sheet to the corner (green circle in the picture).
- Align the center line of the sheet to the edge (blue line in the picture).

Finished

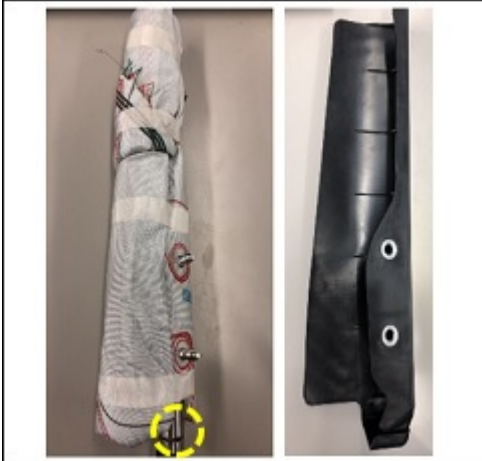
1) Unlock the connector lock (yellow part).

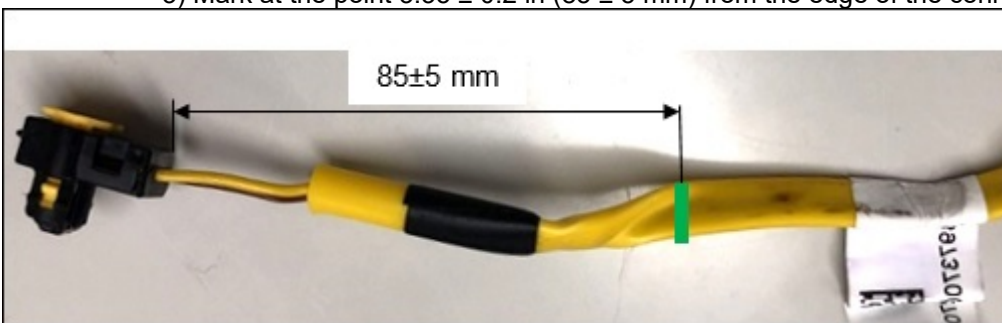
3) Mark at the point  $3.35 \pm 0.2$  in ( $85 \pm 5$  mm) from the edge of the connector.

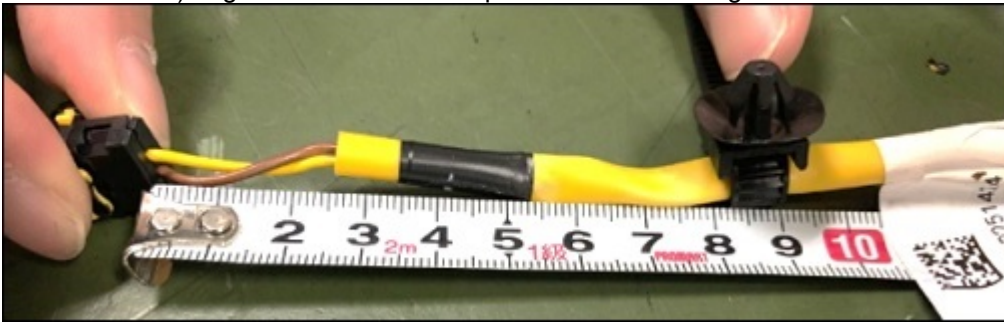
4) Align the center of the clip band to the marking and fix it to the harness (Clip band: H430-67-C91).

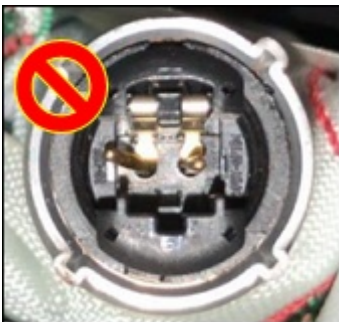
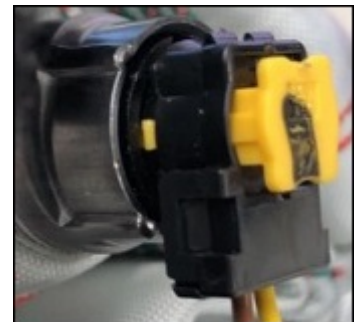
6) Before connecting, confirm that there is no deformation on two connector pins at the inflator side, then connect the connector.

**NOTE:** DO NOT use the part if the pin(s) are deformed.

Deformed pins

Normal (no deformation)

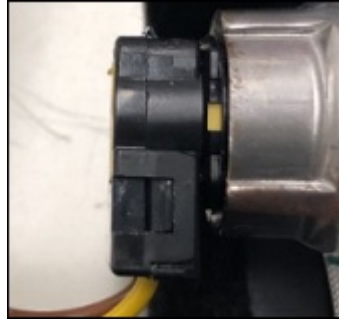
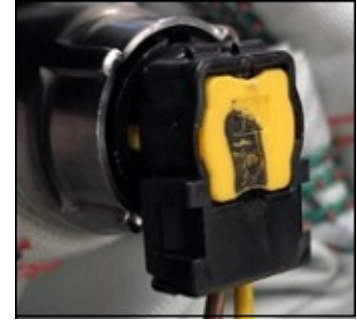
7) Lock the connector.

**NOTE:** Press the lock part of the connector until it aligns to the connector.

Before locking

Locked

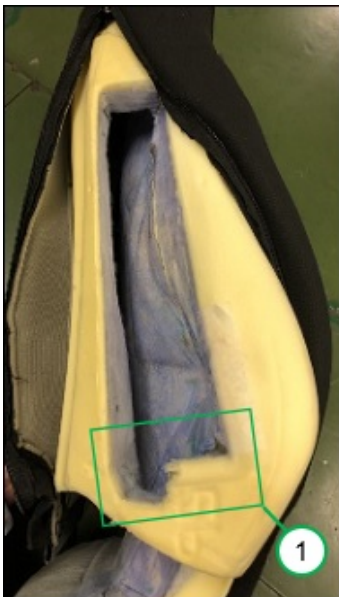
1) Mark the cutting line to the urethane foam pad.

**NOTE:** Allowance of the cut is + 0.12 in (5 mm) and -0 in (0 mm) both for height and width.

- If the pad is removed less than specified size, the pad may interfere with the connector and result in a secondary problem.

Detail of (1)

Left front view of (1)

2) Cut the pad along with the marking and remove the pad.

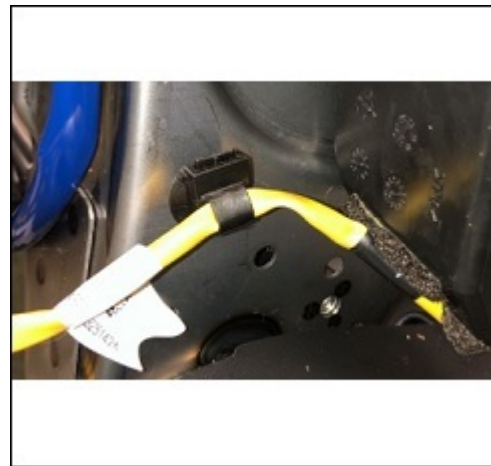
- d. Install the clip band (newly assembled to the harness) to the seat frame.

Before removing the side air bag module

Clip installed
