# Technical Service Bulletin

## 69 Airbag warning light on, DTC B1225F1 stored in the airbag control module

69 22 86 2051242/6 May 4, 2022. Supersedes Technical Service Bulletin Group 69 number 19-41 dated July 24, 2019, for reasons listed below.

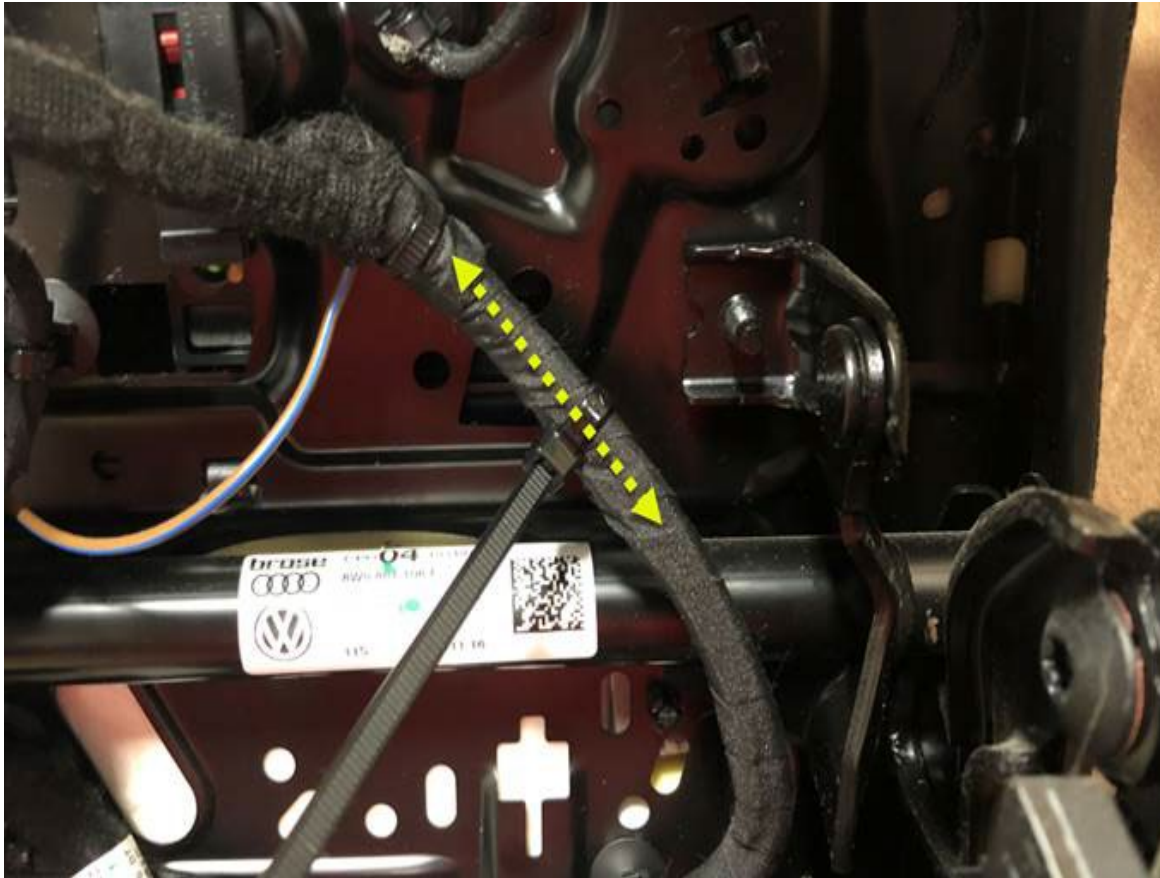
2. You will attach the first cable tie in the yellow marked area on the harness between the cable tie clip and the crossbar tube as shown below (Figure 2).

*Figure 2. Attach the first cable tie in the yellow area.*

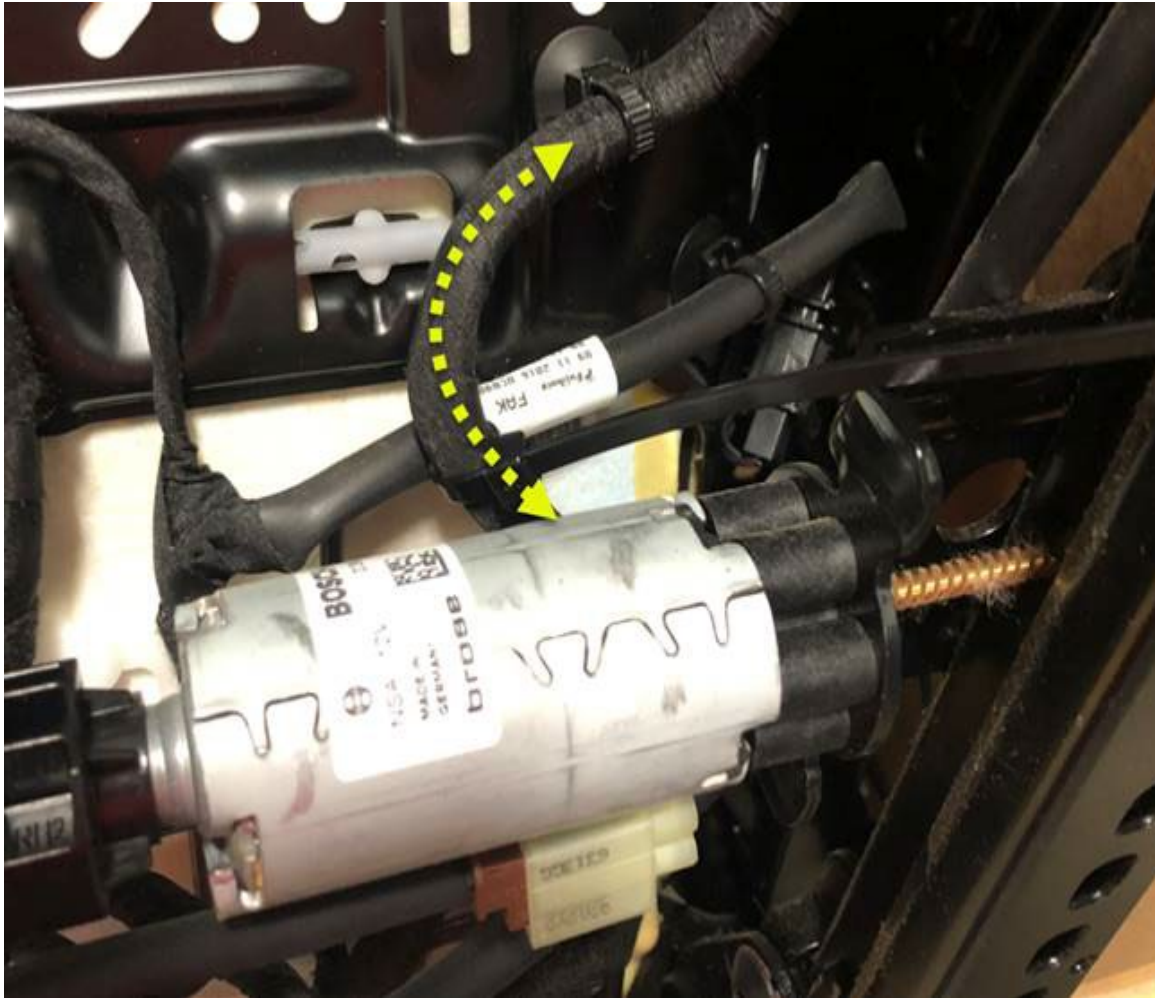
3. The second cable tie position is to the rear of the crossbar tube where the harness drops down from the frame. Place the cable tie in the yellow marked area shown below (Figure 3).

*Figure 3. Attach the second cable tie to the yellow marked area.*

When tightening the cable ties, only tighten them with your hands, do not use any tools to tighten the cable tie as this can damage the harness. Check that the cable ties cannot be rotated on the harness by hand, to ensure that proper tension is achieved. Then cut off the excess length from the tie wrap.
