# Technical Service Bulletin

## 87 Air Conditioning is inoperative, DTC B11AE15

97 22 84 2067362/1 June 22, 2022.

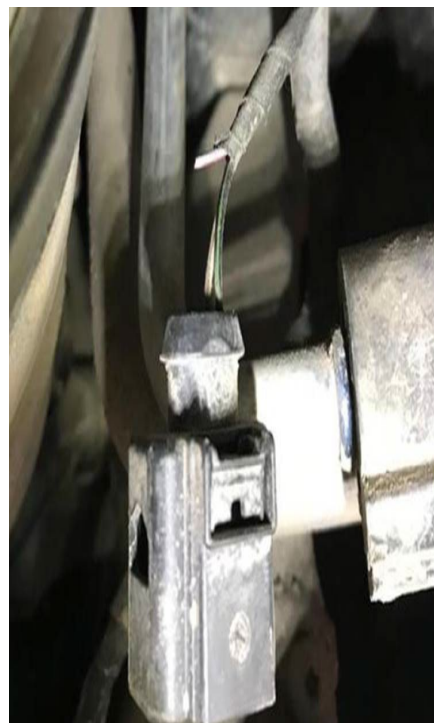
The wiring to the A/C compressor connector T3r is not long enough. Wires may become stretched, break, or pulled from the connector as a result.

If DTC B11AE15: A/C compressor regulator valve Open circuit/short circuit to B+ is stored in the onboard supply control unit J519 diagnostic address 0009, inspect the wiring at connector T3r in the area of the A/C compressor as seen in Figure 1.

**Figure 1.** N280 control wire damaged at T3r connection

If damage is found in this area all 3 wires will need to be extended following the directions below.

1. Cut back the damaged wire(s) until the wires are clean and free of any corrosion.
2. Extend all 3 wires so that a length of approximately 110 mm is achieved when measuring from the base of the connector to the first branch in the harness. See Figure 2.
3. Ensure there is enough slack to keep the harness from stretching however not so much the wires hang down.
4. Repair and modify the harness using VAS 1978 B
5. Wrap the harness section using fabric adhesive tape **N 107 920 02**.  
Wrap wires up to 20 mm from the base of the connector housing, as seen on the original harness in Figure 1.

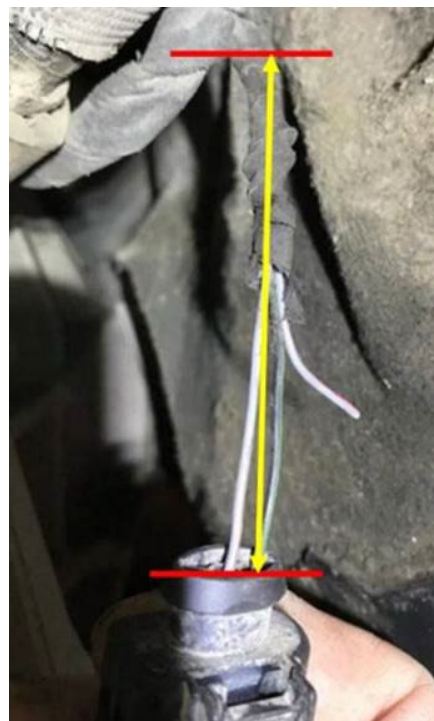
**Figure 2.** Measure 110 mm from T3r to the first harness branch
