# VOLUNTARY SERVICE CAMPAIGN

| RS22-003 | NTB22-063 | July 25, 2022 |

## VOLUNTARY SERVICE CAMPAIGN PASSENGER SIDE SEAT BELT RETRACTOR AND AIRBAG MODULE

**CAMPAIGN ID #:** P2A08  
**APPLIED VEHICLES:** 2021 Rogue (T33)  
**APPLIED VINS:** 11<sup>th</sup> character of VIN is W  
**APPLIED DATES:** Built before January 28, 2021

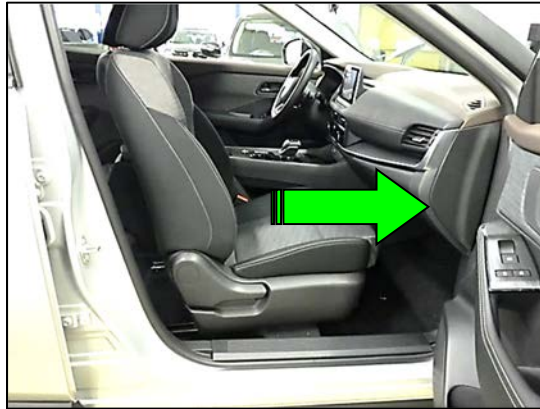
Figure 1

1. Open the front and rear passenger (RH) side doors, and then slide the front passenger seat to the forward-most position, as shown in Figure 1.

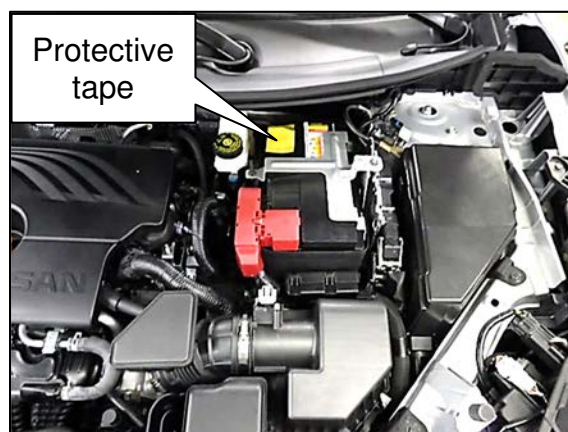
Figure 2

2. Open the hood and disconnect the negative battery terminal.
  - Verify the ignition is OFF before disconnecting the terminal.
  - Install protective tape over the negative battery terminal.
  - Wait a minimum of 3 minutes before proceeding, so that the air bag diagnosis unit may fully discharge any remaining electricity.

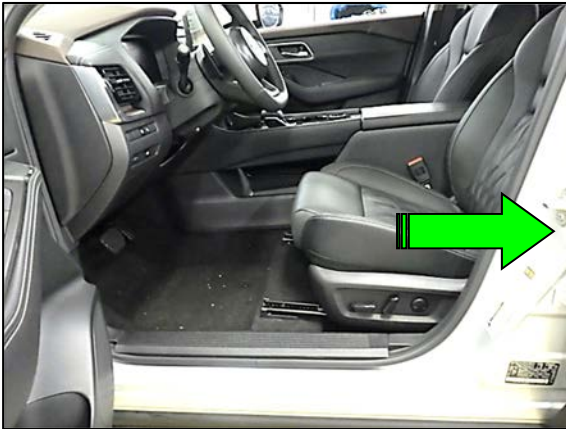
19. Open both front doors, and then slide both front seats to the rear most position, as shown in Figure 22 and Figure 23.

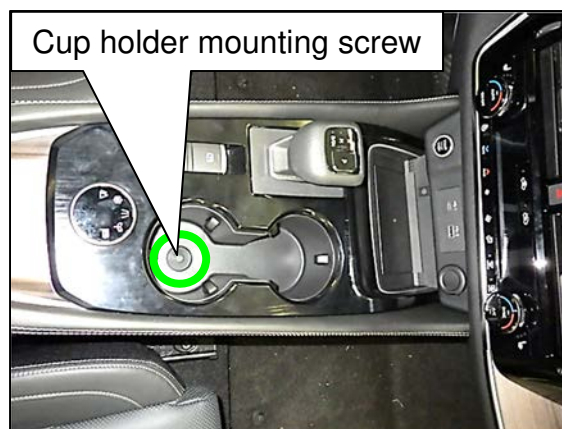
Figure 29

22. Remove the cup holder mat, and then remove the cup holder mounting screw.

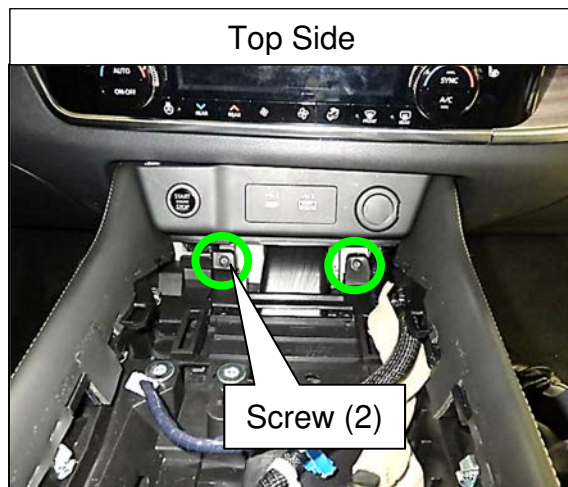
31. Remove the four (4) screws, two (2) bolts, and two (2) nuts securing the center console assembly, as shown in Figure 42 - Figure 45.
