# Technical Service Bulletin

AIR BAG WARNING LIGHT ON WITH DTC B1126:13 OR B1127:13

Bulletin No.: 08-001/22

2019-2022 Mazda3

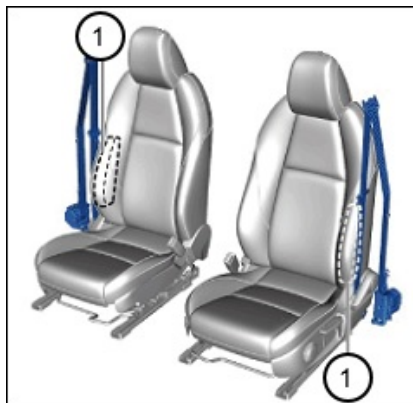
1. Remove the seat back trim and the urethane foam pad, then remove the side air bag module (1).
2. Partially remove the side air bag short cord.
3. Remove the plastic cover.
4. Perform the following (may be done in different order).
  - a. Work on the plastic cover.
  - b. Assemble a clip band to the short cord
  - c. Work on the urethane foam pad.
5. Assemble the removed parts.
6. Install the seat back trim and the urethane foam pad.
7. Confirm the air bag warning / pre-tensioner warning light s do not stay on.

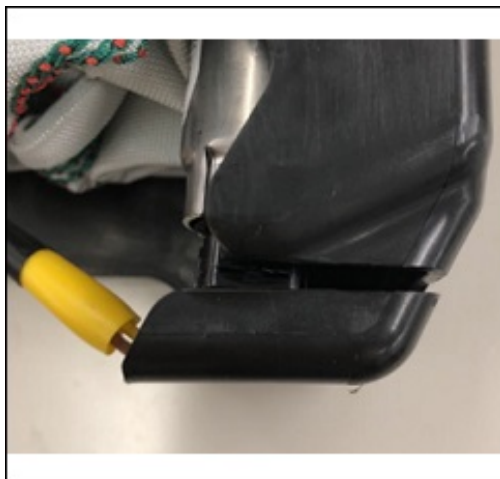
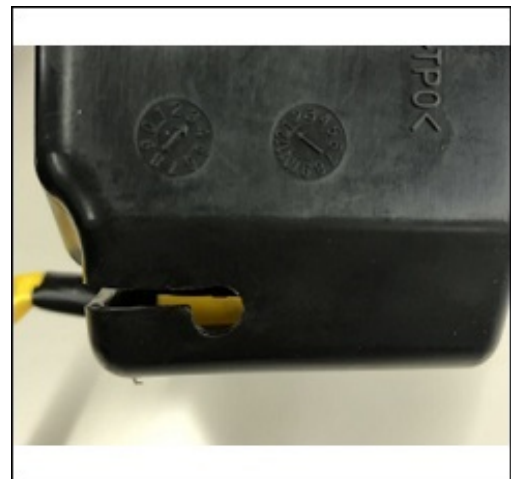
After removal of the **short cord**

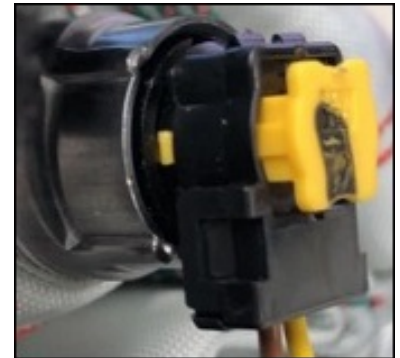
Before locking

Locked

7) Lock the connector.

**NOTE:** Press the lock part of the connector until it aligns to the connector.
