# TECHNICAL SERVICE BULLETIN

| BR22-001 | NTB22-084 | September 29, 2022 |

## DTC C1116 AND/OR C1142 STORED IN THE ABS CONTROL MODULE

**APPLIED VEHICLES:** 2022-2023 Frontier (D41)  
**APPLIED DATES:** Built Between July 13, 2021 and October 10, 2022

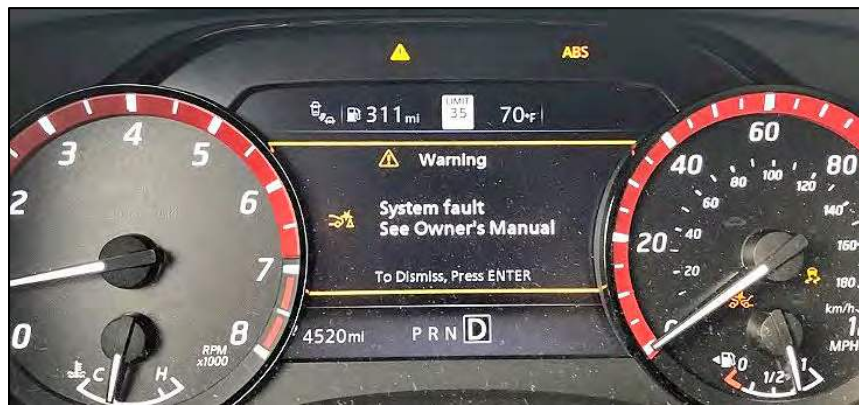
Figure 1

Customer states the ABS warning light is ON and “System fault See Owner’s Manual” appears in the message center (Figure 1),

DTCs C1116 (Stop Lamp Switch) and/or C1142 (Press Sen Circuit) are stored in the ABS Control Module.

1. Install the Center High Mount Stop Lamp (CHMSL) Relay and Jumper Harness.
2. Install a new Stop Lamp Switch.
3. Reprogram the ABS Control Module.

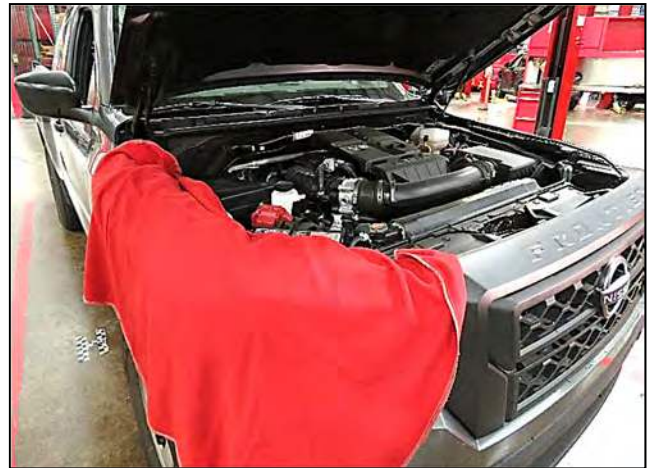
Figure 4

2. Open the vehicle's hood and place a fender cover or clean shop cloth on the passenger (RH) side fender.

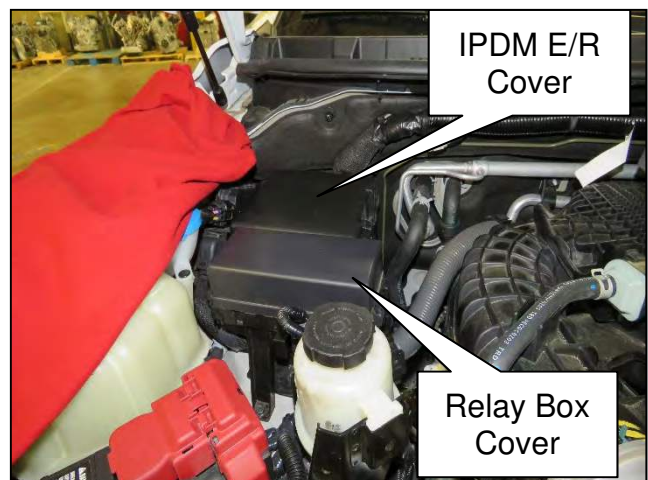
Figure 5

3. Disconnect the negative battery cable.
4. Remove the IPDM E/R and Relay Box covers.

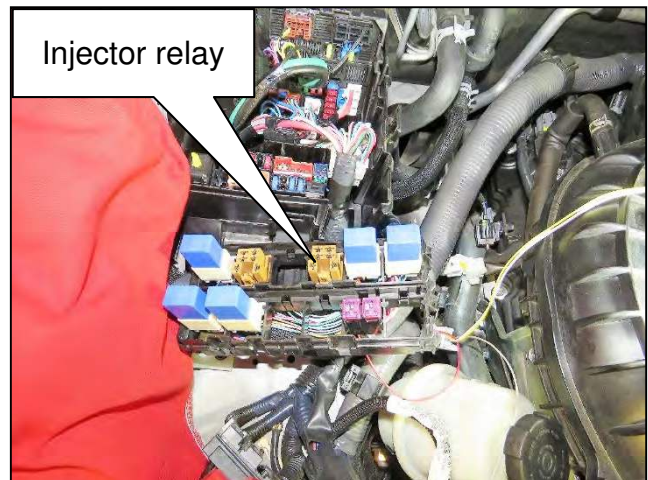
15. Remove the injector relay from the relay box.

- Figure 19 shown with relay removed.

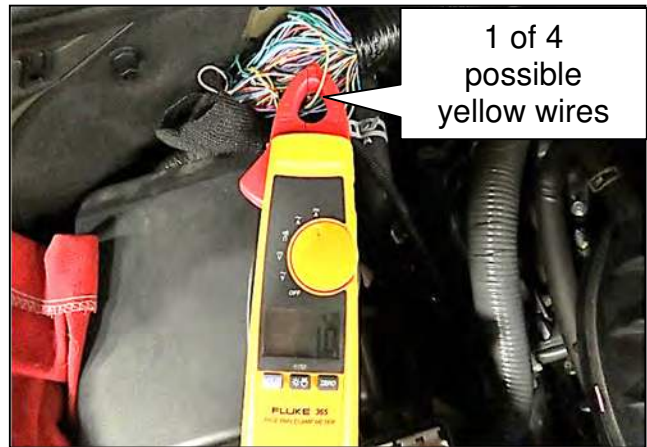
Figure 36

- d. Place one of the yellow wires in the ammeter's circumferential clamp, and then have a helper depress the brake pedal.

- The ammeter should have a reading of 0.8A – 1.0A with the brake pedal depressed.

**NOTE:** If there is not a reading of 0.8A – 1.0A, try a different yellow wire from the wire harness until the correct wire is located.

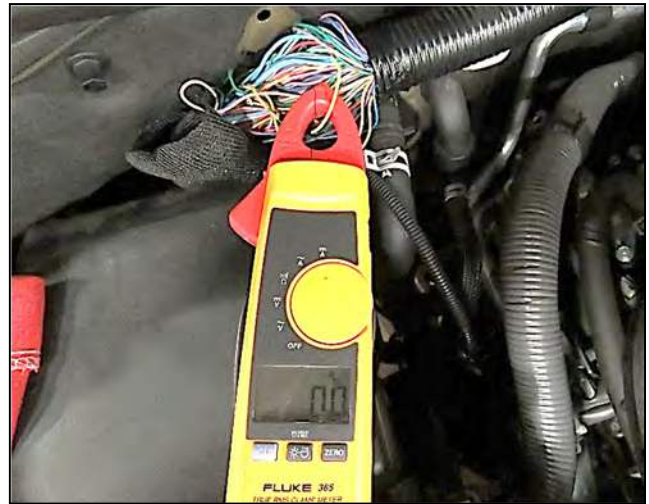
Figure 38

32. To validate the correct yellow wire has been identified in step 29 on page 12:

- a. Have a helper depress the brake pedal.
- b. The ammeter should now have a reading of zero or near zero amps with the brake pedal depressed and the high-mounted stop lamp assembly light bulb removed.

**NOTE:** If there is not a reading of zero or near zero amps, try a different yellow wire from the wire harness until the correct wire is located.

- c. Using a suitable marker or tape, mark the wire.

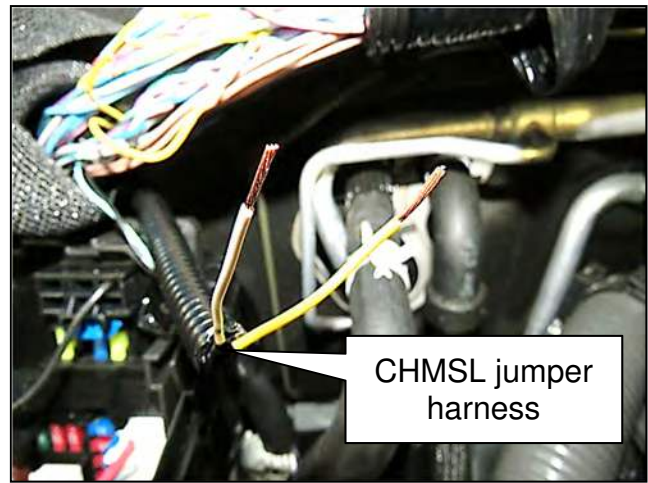
Figure 40

35. Remove 10 mm (**0.4 in.**) of insulation from the white and yellow wire ends from the CHMSL jumper harness.

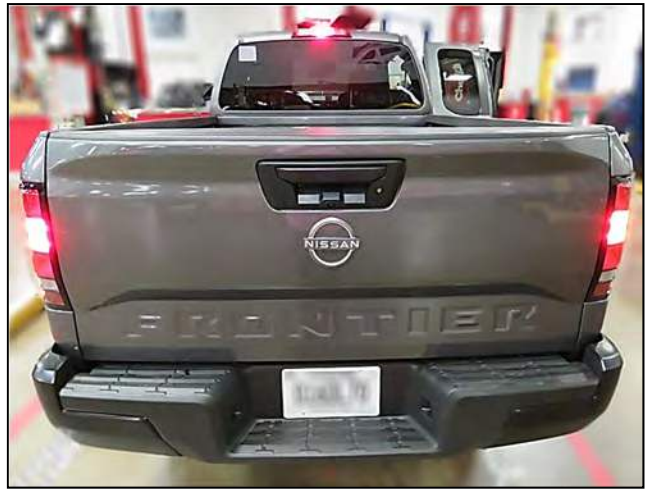
Figure 45

42. Verify both tail lamps and the high mounted stop lamp assembly illuminate when the brakes are depressed.
- If all brake lights illuminate when the brake pedal is depressed, proceed to step 43.
  - If all the brake lights do not illuminate when the brake pedal is depressed, the incorrect yellow wire was cut.
    - a. Remove the CHMSL jumper harness solder sleeve connectors.
    - b. Reconnect the 2 yellow wire ends using a solder sleeve connector.
    - c. Perform steps 29 - 32 on pages 12 and 14, to determine the correct yellow wire to cut.
