## Technical product information

| <b>Topic</b> | New Continental GT and GTC - Window drop glass concerns |
| <b>Transaction No.</b> | 2067436/4 |

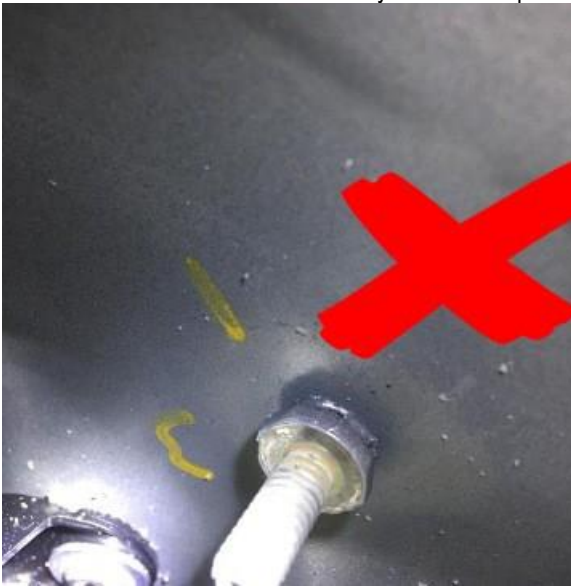
- Earth point 736 RHR and Earth point 738 LHR
- Check for cleanliness and security of both earth points Figure 2 shows an example of a contaminated earth point (dirt/paint/debris)

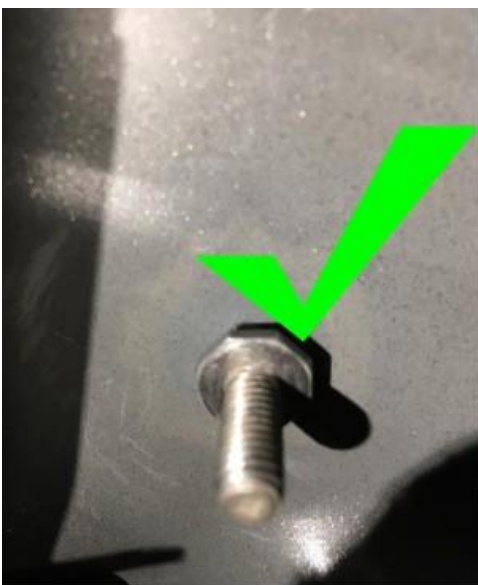
- Remove any dirt/paint/debris from the earth points using suitable abrasives/wire brush ensuring no damage is caused to the earth stud threads as shown in Figure 3

- Secure the earth point fixings to

(9Nm) Comments

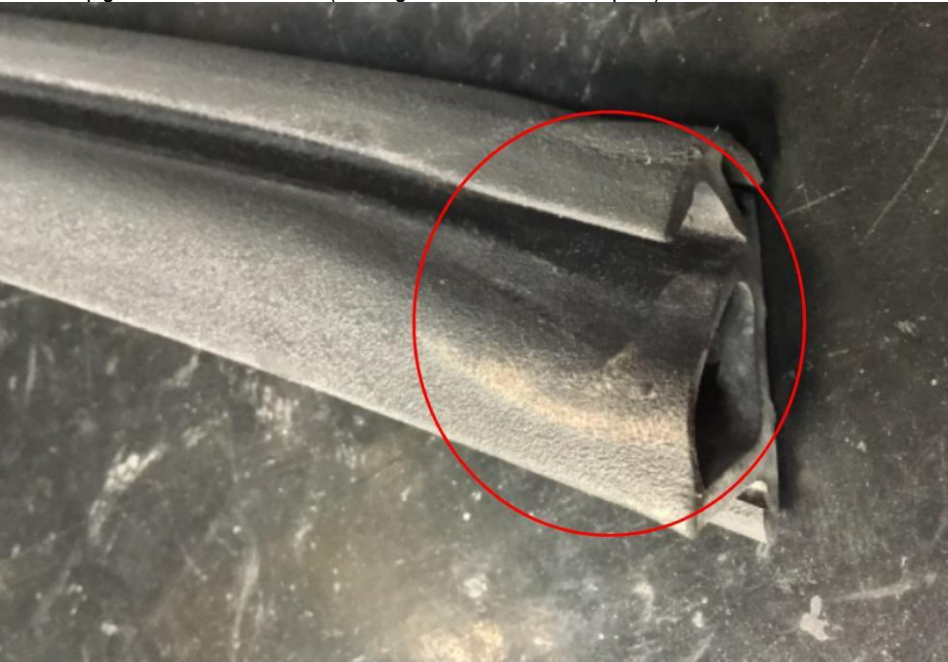
Figure 4

- Damage
- Splits
- Tears
- Misalignment
- Incorrectly fitted/located
- Drop glass seal deformation (see Figures 4 and 5 as examples)

NOTE: Any issues found with the window seals must be rectified before conducting the remaining steps
