# Technical Service Bulletin

## PSS 01 MIL on, fuel rail pressure low (P0087)

01 13 82 2033211/4 March 28, 2013. Supersedes Technical Service Bulletin Group 01 number 13-81 dated March 28, 2013 for reasons listed below.

| Model(s) | Year | VIN Range | Vehicle-Specific Equipment |
|---|---|---|---|
| A4, allroad, A5, A5 cab, Q5, A6 | 2013 | All | 2.0 TFSI |

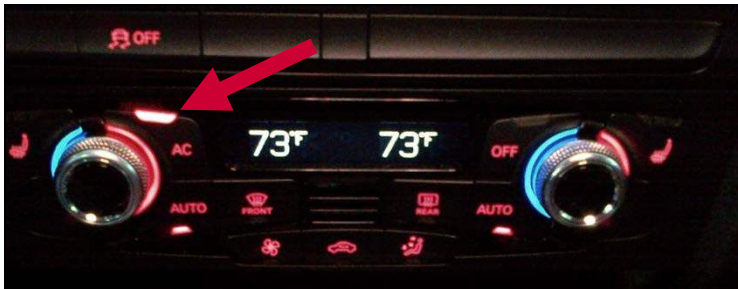
*Figure 1: Climate control with A/C LED on*

A: You can use other settings for climate control as long as the LED for A/C is illuminated (*Figure 1*).

A: Leaving the A/C on auto will activate radiator fans on low speed, allowing lower temperatures in the engine bay and minimizing fuel pressure fluctuations through heat buildup.
