# Technical Service Bulletin

AIR BAG WARNING LIGHT ON WITH DTC B1126:13 OR B1127:13

Bulletin No.: 08-003/23

Last Issued : 07/26/2023

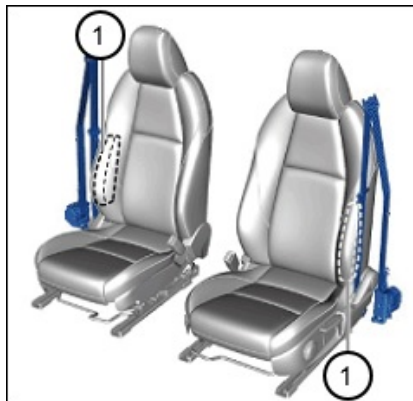
1. Remove the seat back trim and the urethane foam pad, then remove the side air bag module (1).
2. Partially remove the side air bag short cord.
3. Remove the plastic cover.
4. Perform the following (may be done in different order).
  - a. Work on the plastic cover.
  - b. Assemble a clip band to the short cord
  - c. Work on the urethane foam pad.
5. Assemble the removed parts.
6. Install the seat back trim and the urethane foam pad.
7. Confirm the air bag warning / pre-tensioner warning light s do not stay on.

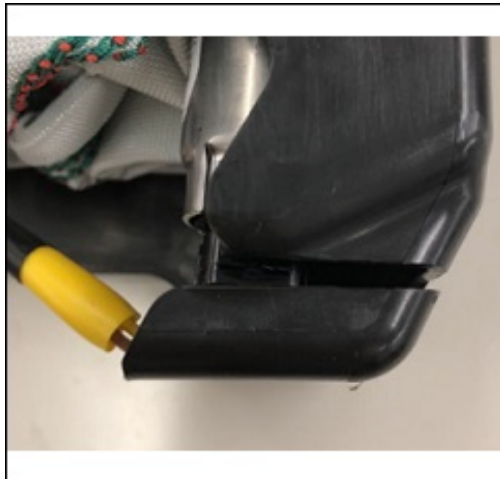
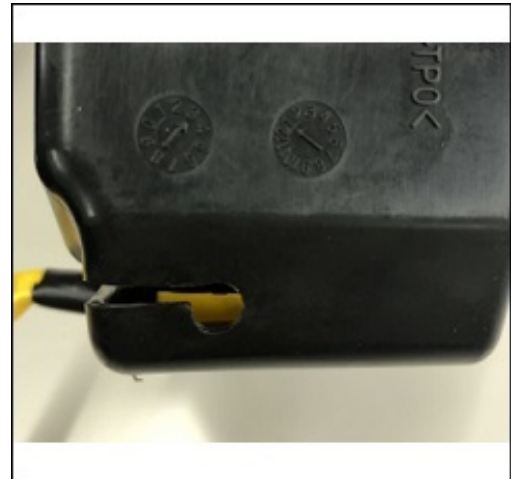
After removal of the short cord

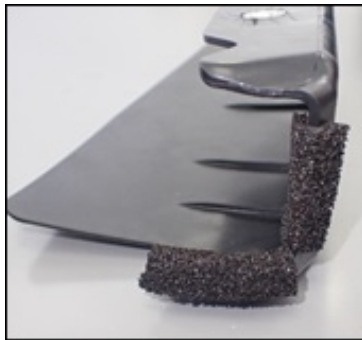
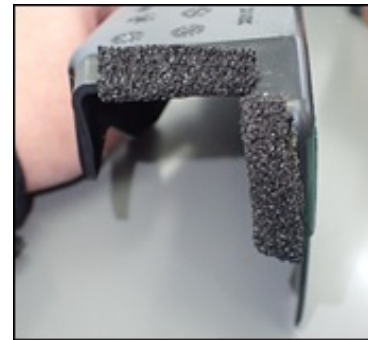
Finished

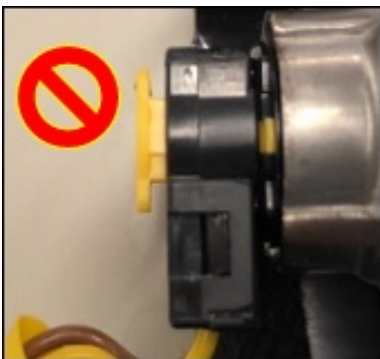
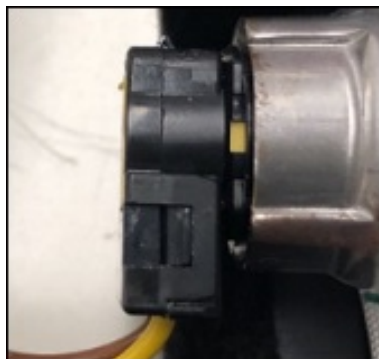
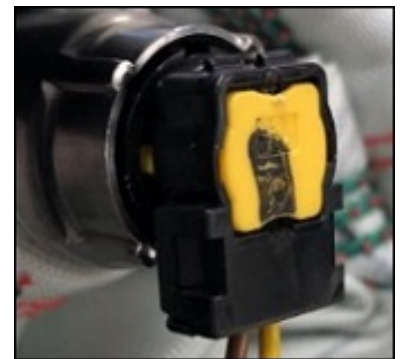
Before locking

Locked

7) Lock the connector.

**NOTE:** Press the lock part of the connector until it aligns to the connector.

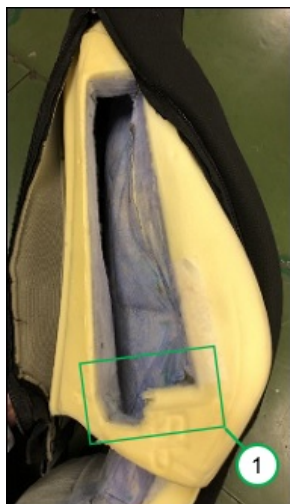
Detail of (1)

Left front view of (1)

1) Mark the cutting line to the urethane foam pad.

**NOTE:** Allowance of the cut is + 0.12 in (5 mm) and -0 in (0 mm) both for height and width.

- If the pad is removed less than specified size, the pad may interfere with the connector, resulting in less than expected result.

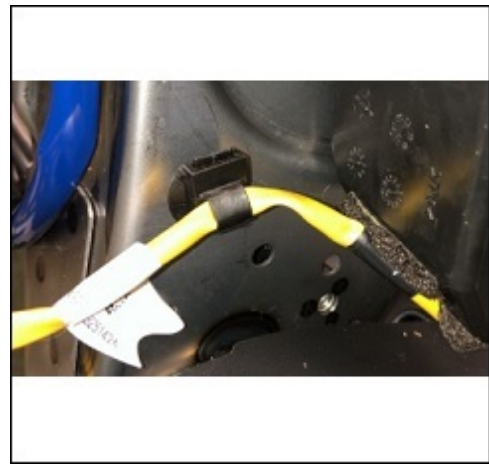
Before removing the side air bag module

Clip installed

d. Install the clip band (newly assembled to the short cord in step 6-b-4) to the seat frame.
