## STAR ONLINE PUBLICATION

**Case Number:** S2308000109

**Symptom/Vehicle Issue:** Check Engine Light On, DTC's P2008 P2016 P2017 Circuit F342, Spread Terminal At Solenoid Short Runner Valve Connector

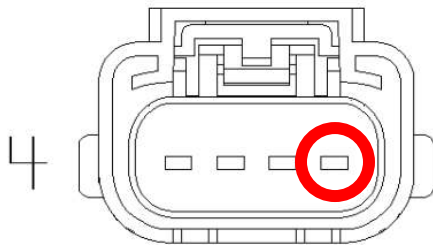
**Diagnosis:** Inspect cavity 1 of connector D2549A Solenoid Short Runner Valve for a spread terminal.

**Terminal Side**

**Wire Side**

**Repair:** If a spread terminal is found, use repair kit 68064996AA to replace the terminal.
