# Technical Service Bulletin

## 01 Engine speed sensor G28 - engine starts poorly, emissions warning lamp lights up - P0321 - 2.5 ltr. 5 cyl TFSI

01 23 03 2072326/1 December 13, 2023.

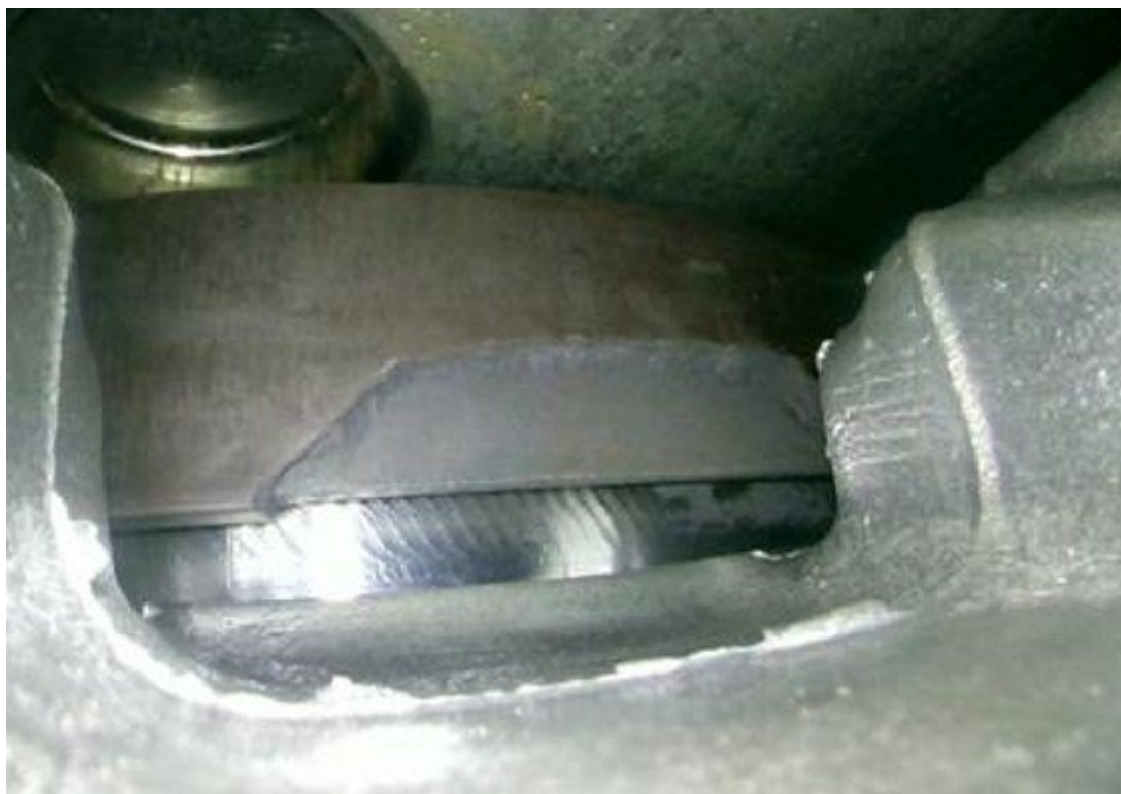
Check the crankshaft speed sensor wheel for damage. Compare the following example images:

**Figure 1.** *Damaged sensor wheel in installed position.*

Please replace the crankshaft speed sensor wheel if it is damaged. Also check the crankshaft speed sensor G28 for external mechanical damage and replace the sensor if it is damaged.

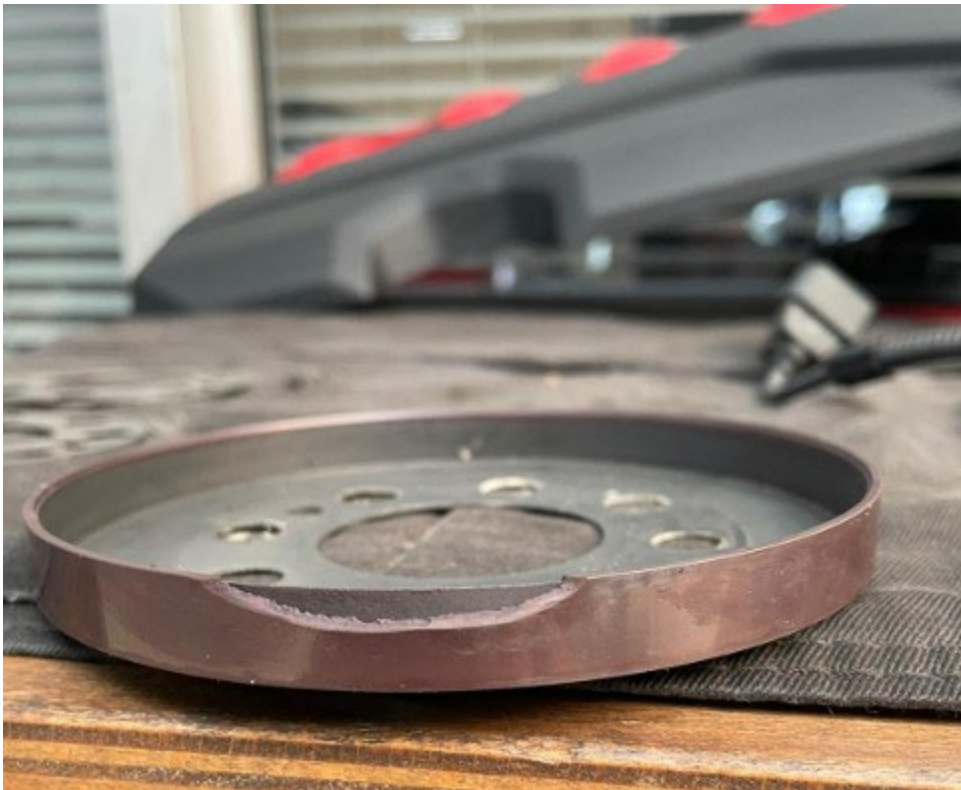
**Figure 2.** *Damaged sensor wheel uninstalled.*
