# Technical Service Bulletin

**45 MIL on - DTC P258B00 or P055600**  
45 23 35 2072305/1 December 13, 2023.

| Model(s) | Year | VIN Range | Vehicle-Specific Equipment |
|---|---|---|---|
| Q3 | 2021 – 2024 | All | Not Applicable |

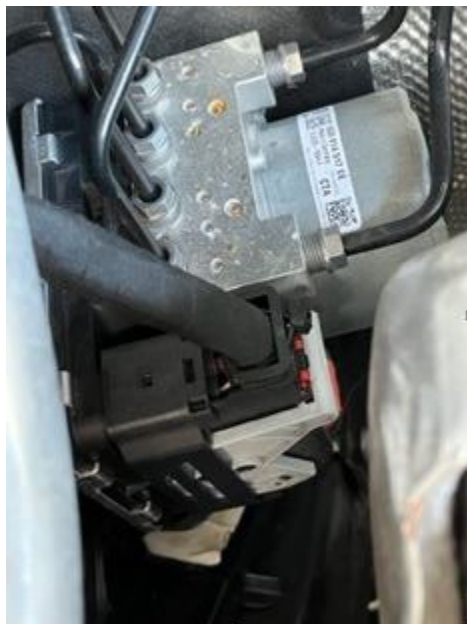
The analyses have shown that the vacuum pump fuse was blown due to the connector of the ABS control unit being improperly disconnected. The improper separation of the ABS connector and the subsequent running of the engine / driving operations meant that the vacuum pump exceeded certain internal parameters. As a result, the vacuum pump fuse blows and the vacuum pump itself can become irreparably damaged / can fail.

**Figure 1:** ABS hydraulic unit / ABS control unit connector.

- Check if the connector has been unplugged from the ABS control unit, or if there are any signs of tampering (e.g., scratches on the connector).
- If the connector has been unplugged from the ABS control unit or if tampering has been determined, the repair cannot be billed under warranty.
- Replace triggered / blown vacuum pump fuses according to *ELSA>>Repair Manual>>Electrical System>>Electrical Equipment>>97 Wiring>>Relay Panels, Fuse Panels and E-Box>>Component Location Overview*.
- Check if the vacuum pump works and runs properly as per *ELSA>>Repair Manual>>Chassis>>Brake System>>47 Hydraulic Components>>Vacuum System>>Overview Vacuum Pump*.
- If vacuum pump does not run properly, the required repair must be carried out.

- If the connector has been unplugged from the ABS control unit or if tampering has been determined, the repair cannot be billed under warranty.
- If the connector has not been unplugged from the ABS control unit and no tampering has been determined, this TSB does not apply!
