Red display in Charging status indicator

| Topic number | LI47.70-P-077900 |
| Function group | 47.70 - Powertrain energy supply |
| Validity | 206,223,254 and 214 Plug-in Hybrid vehicles |

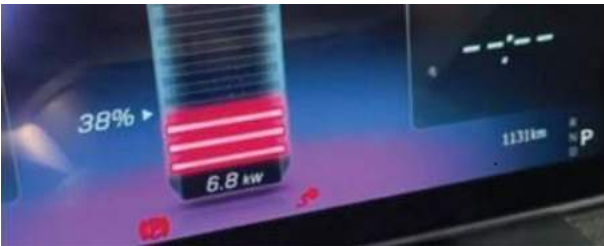
- Red display in the Charging indicator status in MBUX during AC Charging.
- Error message in Mercedes Me App.
- Fault code P0E5F97 exists in N83 (AC charger for high-voltage battery (SG-LG))

The message/indicator status appears when the vehicle is parked outside, under direct sunlight or in higher temperature regions.

- Not an error. Vehicle charging continues and does not abort. Charging power might be reduced temporarily until the temperature comes within threshold.

- Do not replace any components.
- Please inform the customer: Park the vehicle in the shade during charging where the outside temperature is lower.
