# Technical Service Bulletin

## 35 Gearbox Malfunction Warning, DTC P0C2900 in the TCM

35 24 51 2050723/6 May 22, 2024. Supersedes Technical Service Bulletin Group 35 number 24-48 dated March 12, 2024 for reasons listed below.

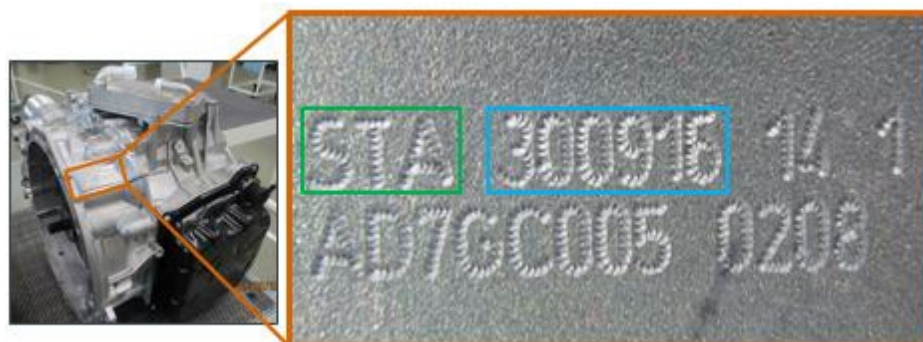
**Figure 2.** Transmission identification example.

Obtain the transmission identification information from the bell housing (Figure 2).

Gearbox code: STA (green box)

Gearbox Production Date: **300916 = 03.09.2016** (blue box).

Date format: Day/Month/Year

- If the gearbox production date is after 26.09.2017, this TSB does not apply. Proceed according to Guided Fault Finding. Please note that in this case, the costs for the repair cannot be billed under this TSB.
- If the gearbox production date is on or before 26.09.2017, continue as described below.
