# Technical Service Bulletin

## 93 Q4 e-tron cannot be charged - connector does not lock/unlock - charge connector lock, blocked P1CF400 in DA 00C6

93 24 74 2074617/1 July 19, 2024.

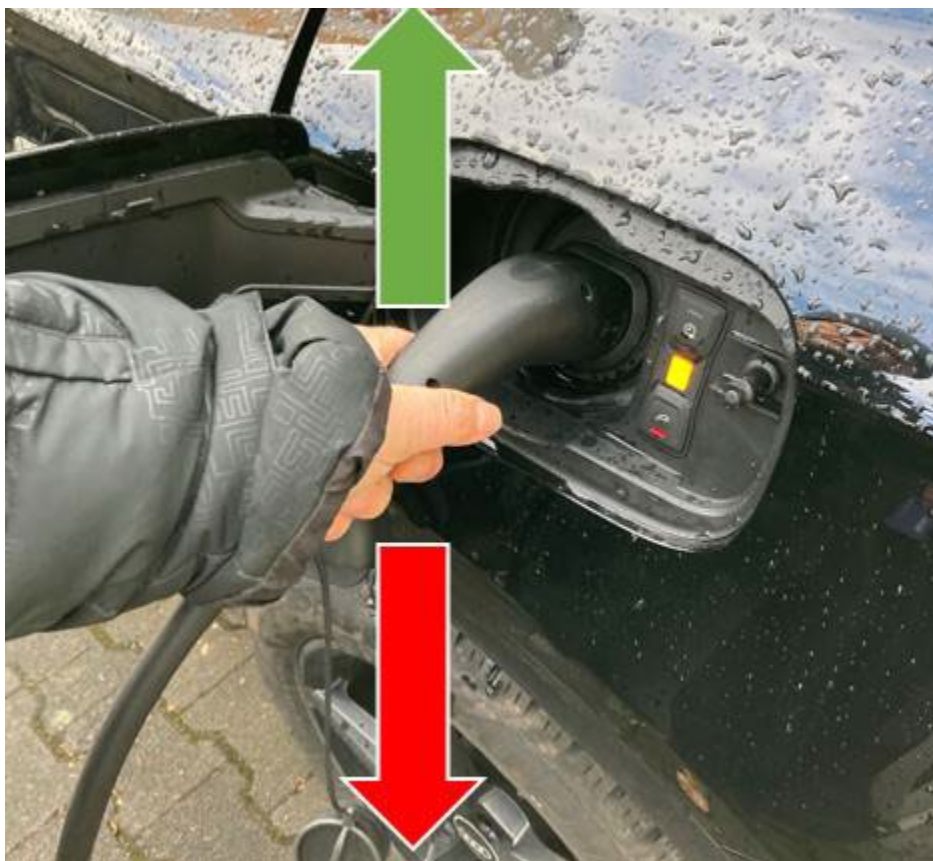
Charging connector lock OK if connector is lifted during locking procedure.

Charging connector lock not OK if pushed downwards during locking procedure.

(Example image from a Q5 PHEV)

Please inform the customer that lifting the charging connector slightly immediately after plugging it in until it is locked causes the pin to enter the charging connector without any problems.

This will prevent the connector from dropping (see example image from Q5 PHEV).
