## Technical Service Bulletin (TSB)

### Replace K1 Clutch / Input Shaft Assembly

| REFERENCE: | TSB: 21-051-24<br>GROUP: 21 - Transmission and Transfer Case | Date: | September 27, 2024 | REVISION: | 21-002-23 REV. B |
| VEHICLES AFFECTED: | 2019 - 2023 (DD) RAM 3500 Cab Chassis<br>2019 - 2023 (DP) RAM 4500/5500 Cab Chassis<br>2019 - 2023 (D2) RAM 3500 Pickup<br>This bulletin applies to vehicles built on or before December 01, 2022 (MDH 1201XX) equipped with a 6SPD Auto Aisin AS69RC HD Transmission (Sales Code DF2) or a 6SPD Auto Aisin AS66RCHD Trans (Sales Code DF3).<br>For 2019 - 2021 MY vehicles, this Technical Service Bulletin (TSB) only applies to vehicles that have had a complete NEW transmission replaced between 02/01/2022 and 12/18/2022. | | | MARKET APPLICABILITY:<br><input checked="" type="checkbox"/> NA<br><input type="checkbox"/> SA<br><input type="checkbox"/> EE<br><input type="checkbox"/> MEA<br><input type="checkbox"/> IAP<br><input type="checkbox"/> CH | |

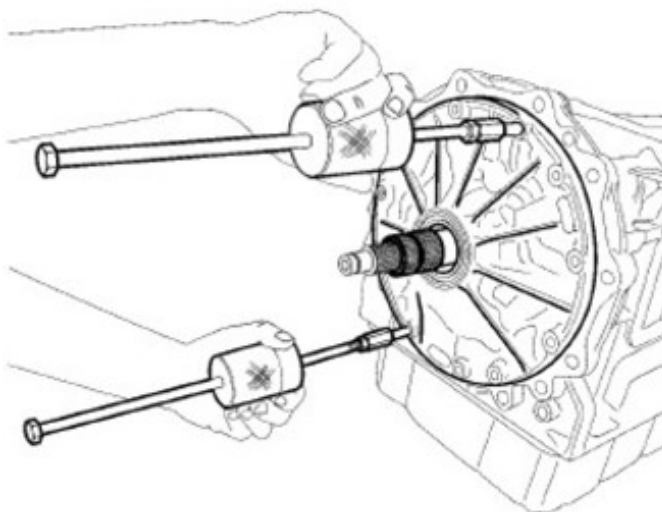
**Fig. 5**

8. Remove the bolts securing the oil pump to the transmission case and use Slide Hammers C-3752 with Adapters 9981 to remove the oil pump assembly from the transmission spline [Fig. 5](#).

Slide Hammers C-3752 And 9981 Adapters

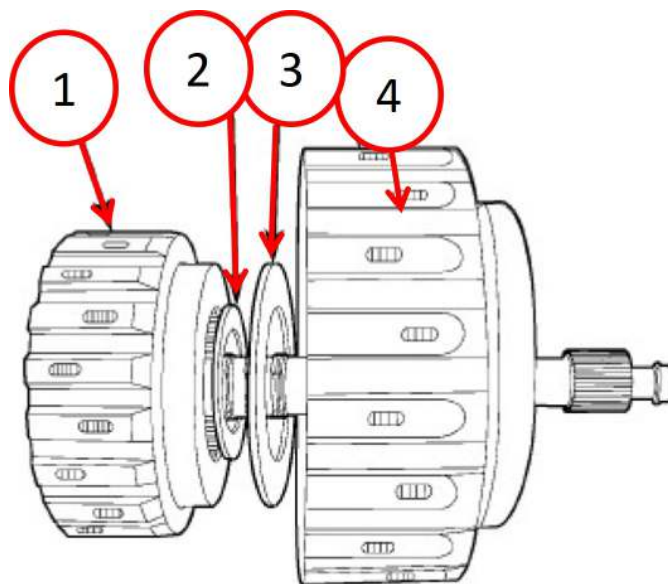
**Fig. 7**  
K1 And K2 Clutch Assemblies

10. Remove the K2 clutch assembly and the selectable input shaft end-play thrust bearing number one and thrust washer from the K1 clutch/input shaft assembly [Fig. 7](#).

- 1 - K1 Clutch/Input Shaft Assembly
  - 2 - Thrust Bearing Number One
  - 3 - Thrust Washer
  - 4 - K2 Clutch Assembly
-

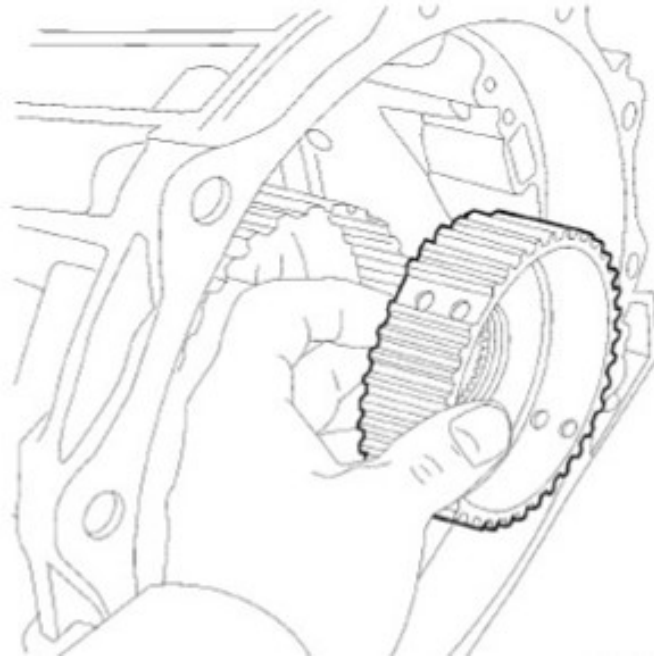
**Fig. 8**  
K1 Clutch Hub

11. Remove and inspect the K1 clutch hub [Fig. 8](#) and [Fig. 9](#). **Replace only if needed.**

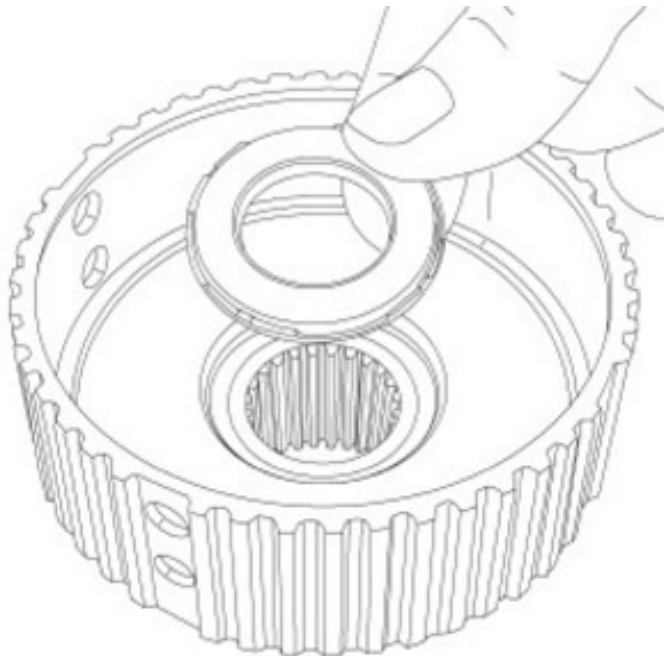
**Fig. 9**  
K1 Thrust Bearing Number Two

12. Remove and inspect the K1 thrust bearing number two [Fig. 10](#). **Replace only if needed.**

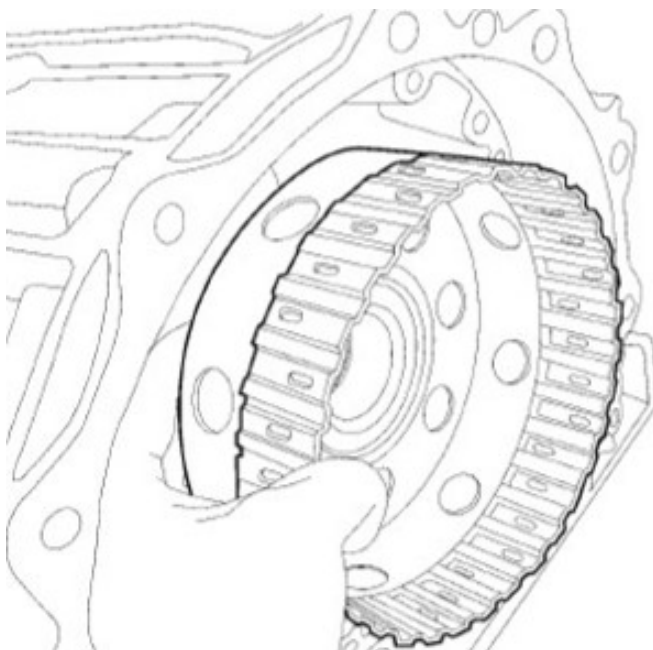
**Fig. 10**  
K2 Clutch Hub

13. Remove and inspect the K2 clutch hub [Fig. 11](#). **Replace only if needed.**

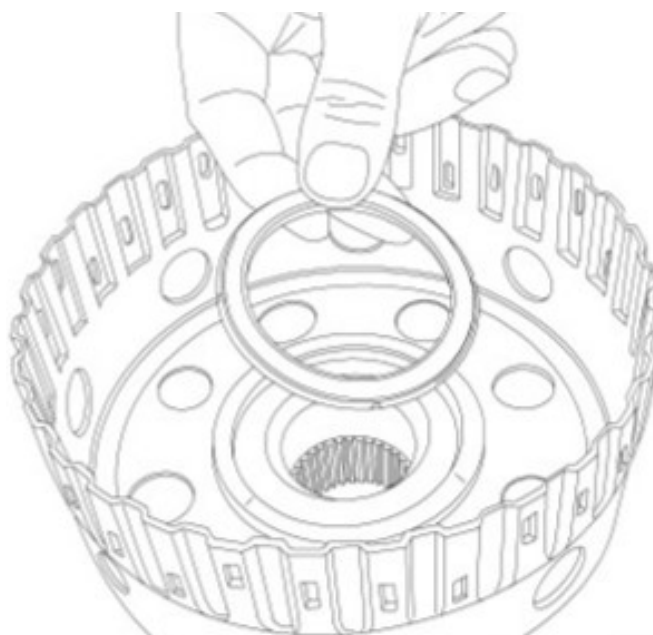
**Fig. 11****K2 Hub Thrust Bearing Number Three**

15. Lubricate with trans jel or petroleum jelly and install K2 thrust bearing number three [Fig. 12](#).

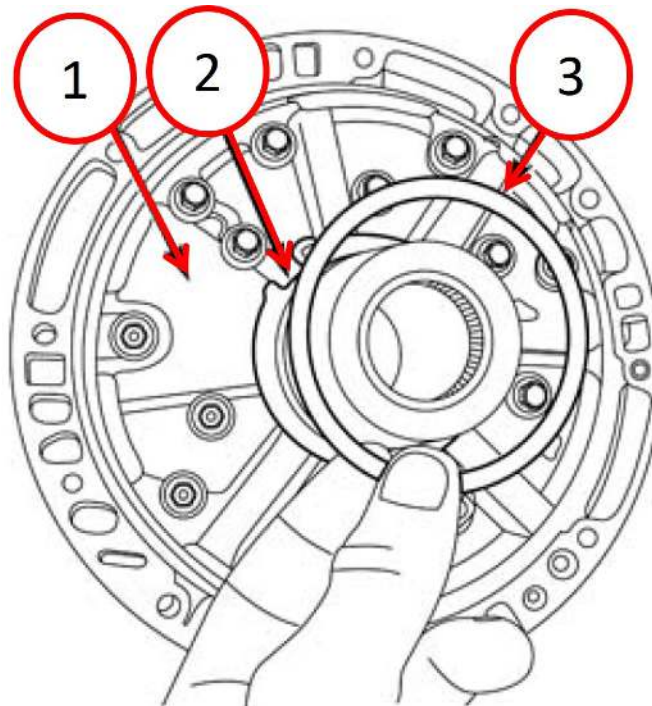
**Fig. 12****Oil Pump Assembly**

21. Lubricate with trans jel or petroleum jelly and install the nylon thrust washer onto the oil pump [Fig. 12](#).

**NOTE: The nylon thrust washer is keyed to the oil pump [Fig. 12](#).**

**NOTE: Two pin punches inserted through the oil pump mounting holes will aid in the installation of the oil pump [Fig. 12](#).**

- 1 - Oil Pump
- 2 - Nylon Thrust Washer
- 3 - Input Shaft Seal Ring

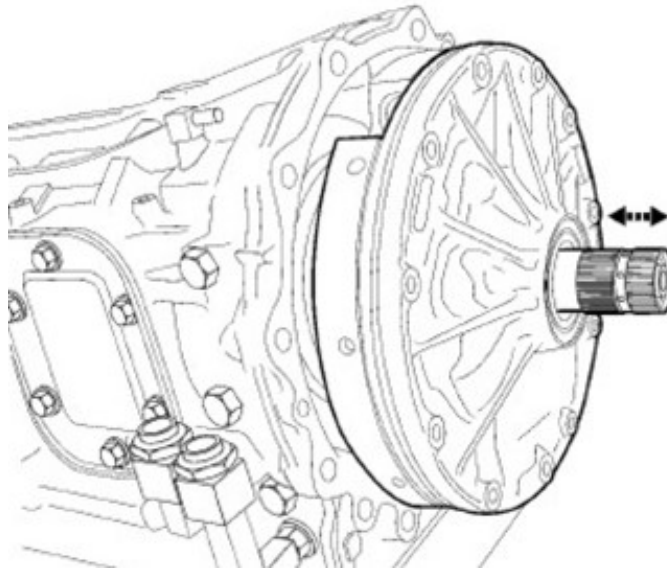
**Fig. 13**

23. Install the oil pump with a **NEW** gasket onto the transmission case [Fig. 13](#).

Oil Pump Assembly On Transmission Spline Shaft

24. Apply a light coating of MOPAR thread sealant onto the oil pump bolts and install the bolts. Tighten the bolts in a crisscross pattern to 21 N·m (15.5 ft. lbs.).
