PI2002Y/Z (Rev 3, 11/07/2024)

## PRODUCT IMPROVEMENT CAMPAIGN

ENGINE REPLACEMENT INSTRUCTIONS  
FOR DTC P1326 (PI2002Y/Z)

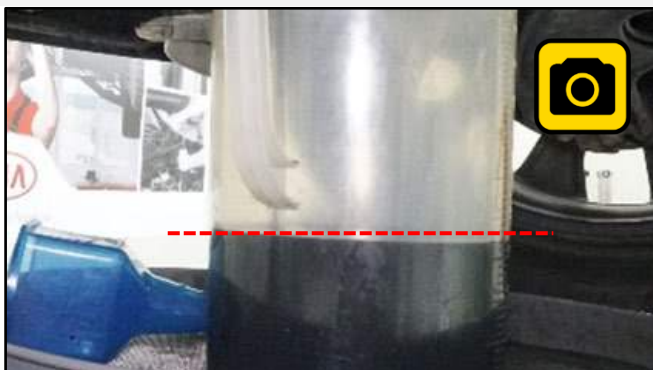
**Oil Level Measurement: (Main Flowchart → PWA Request) NO OIL READING ON DIPSTICK**

1. Remove oil filler cap, remove oil drain plug and drain oil into the measuring container SST067BUCK and check oil level.
2. Record oil level reading on the RO.
3. Take photo of the drained oil container using KDS and attach to warranty claim PWA request.

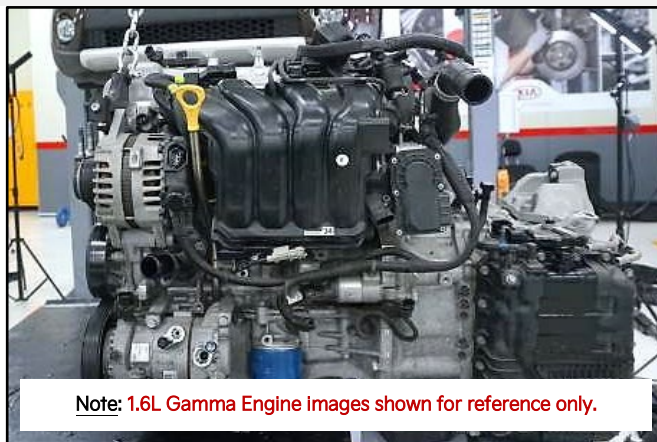
1. Replace the engine assembly by referring to the "Engine Mechanical System → Engine And Transmission (Transaxle) Assembly → Sub & Long Engine Assembly → Repair procedures" chapter in the applicable Shop Manual on KGIS.

**Note:** 1.6L Gamma Engine Images shown for reference only.

2. After removal of the engine from the vehicle, remove all components that will need to be transferred by referring to the applicable Shop Manual on KGIS.
3. **Install all removed components from the old engine block onto the new engine block utilizing all parts from Service Kit(s).**

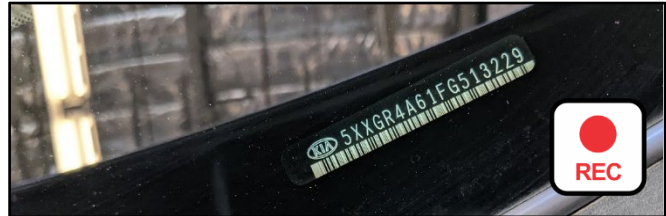
1. Start video showing the vehicle being worked on and move the camera in towards the dash VIN tag.

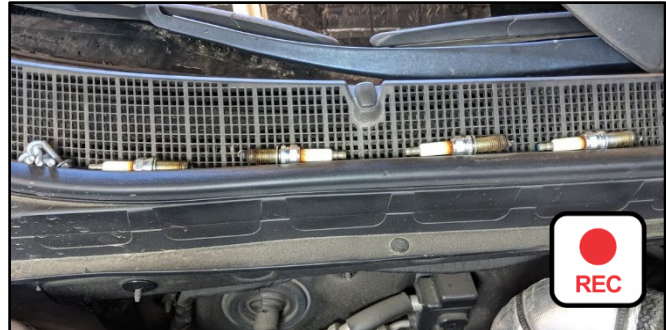
2. Show the removed spark plugs.

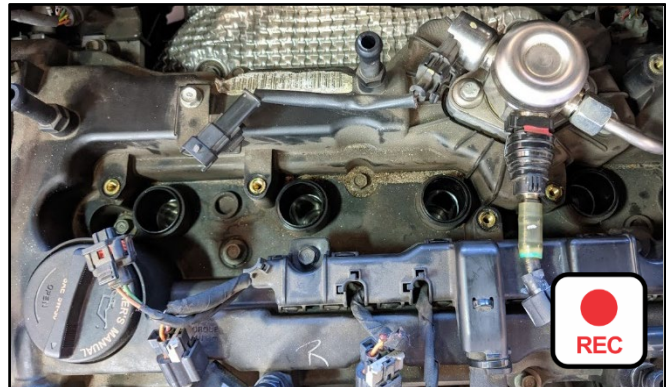
3. Show the empty spark plug holes from the engine.

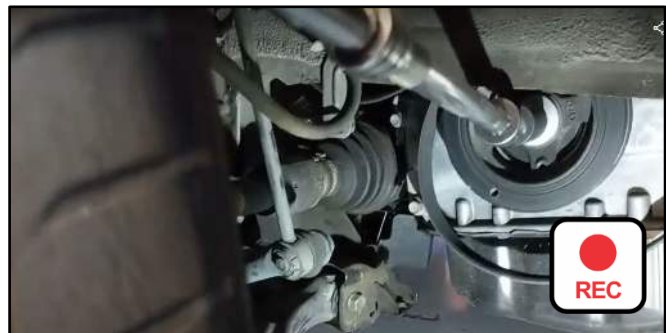
5. Show the removed drive belt and attached torque wrench to crank bolt.

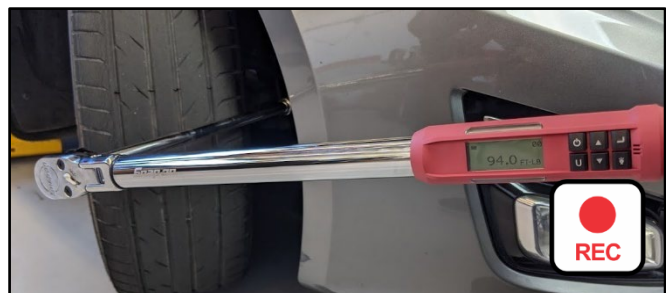
6. Show the engine being cranked and torque specification exceeding 94 lb.ft. torque.
