2011MY  
Sorento (XMa)  
w/2.4L MPI

PI2101Y/Z (Rev 1, 11/07/2024)

ENGINE REPLACEMENT INSTRUCTIONS  
FOR DTC P1326 (PI2101Y/Z)

This bulletin provides information related to the Technical Service Bulletin previously published in (PI2101) titled "Knock Sensor Detection System - ECU Logic Improvement" for 2011MY Sorento (XMa) vehicles equipped with Theta 2.4L MPI engine, produced from October 24, 2009 through June 24, 2011. Specifically, this bulletin provides instructions on which procedures to follow if, after installation of the KSDS, any one of the subject vehicles below return to the dealer with Diagnostic Trouble Code (DTC) P1326 (Knock Signal Range/Performance).

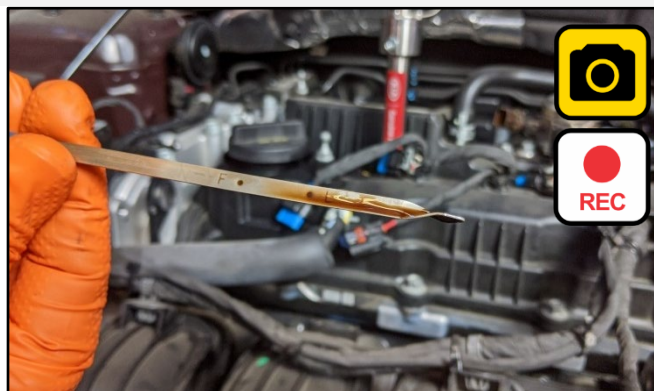
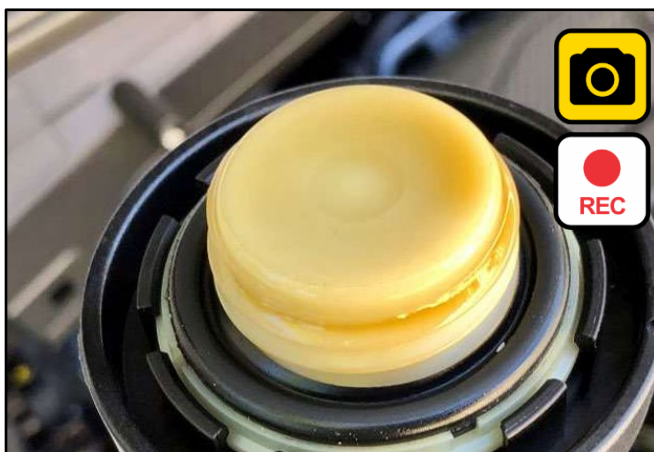
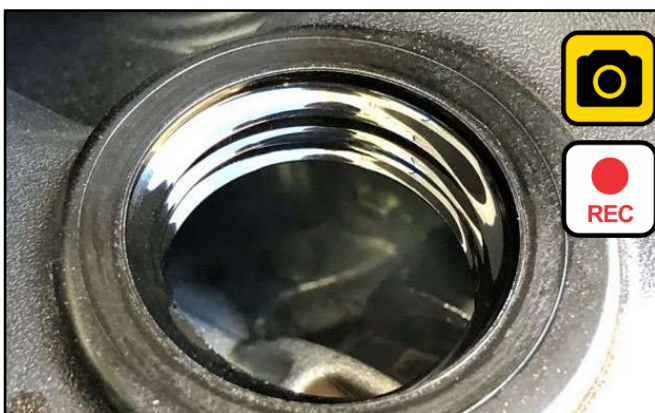
**Oil Condition and Oil Level Inspection: (Main Flowchart)**

1. Start video showing vehicle and move in towards the dash VIN tag.
  2. Measure and record oil dip stick level.
  3. Note oil dip stick reading on the RO.
  4. Take a picture of the oil reading on dipstick.
- Inspect the inner/bottom of the oil cap and inside oil filler opening.
- 5.
  6. Take a picture of both, the bottom of the oil cap and oil filler opening.

**Record/Note findings:** No oil, oil sludge, varnish, burnt oil smell condition(s) found.

If NO oil is registered on the dipstick, or oil lacquering, oil sludge and/or oil varnish is present (NG), then the engine is therefore suspect to maintenance neglect. Review of the vehicle's maintenance history is required.

If suspect, proceed to the 'Oil Level Measurement' instructions below and submit with the Techline case.

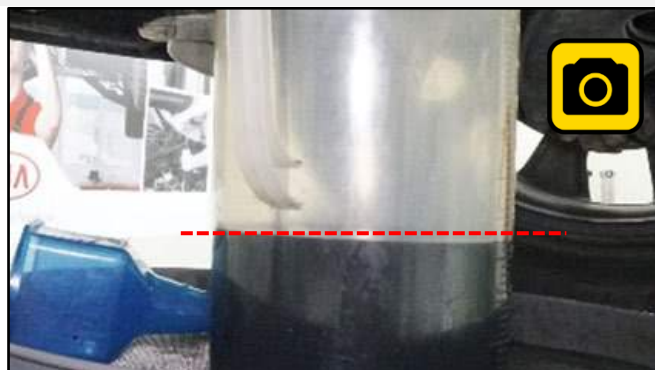
**Oil Level Measurement: (Main Flowchart → PWA Request) NO OIL READING ON DIPSTICK**

1. Remove oil filler cap, remove oil drain plug and drain oil into the measuring container SST067BUCK and check oil level.
2. Record oil level reading on the RO.
3. Take photo of the drained oil container using KDS and attach to warranty claim PWA request.

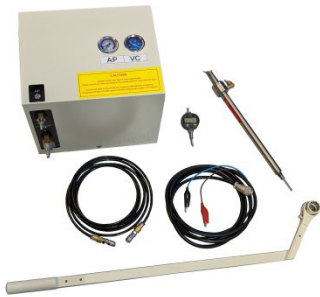
| Tool Name | Part Number | Figure | Comments |
|---|---|---|---|
| Bearing Clearance Tester Kit | KQ231 2T110QQK | | Auto-shipped to Dealers<br><b>For troubleshooting assistance contact the GITA Support Line at: (888) 542-4371.</b><br><br><b>For replacement parts, contact Snap-On Tools at: (888) 542-1011.</b> |

If DTC P1326 is present, first perform the bearing clearance inspection with the Engine Bearing Clearance Tester device (SST KQ231-2T110QQK). This device checks the rod bearing clearance by placing air and vacuum into the cylinder block. Measure the bearing clearance and follow the instructions in this bulletin. Refer to the flow chart found on pages 2-4, then follow the appropriate procedure as outlined in this bulletin. Before conducting the procedure, verify the vehicle is included in the list of affected VINs.

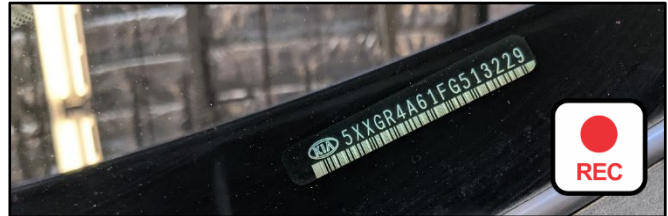
1. Start video showing the vehicle being worked on and move the camera in towards the dash VIN tag.

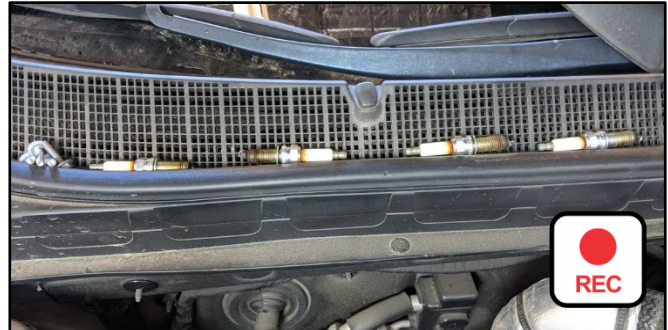
2. Show the removed spark plugs.

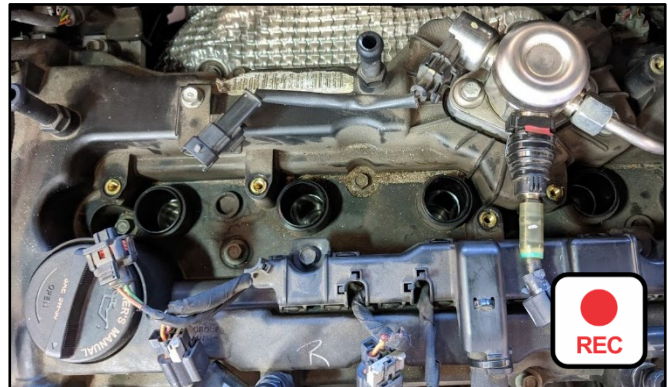
3. Show the empty spark plug holes from the engine.

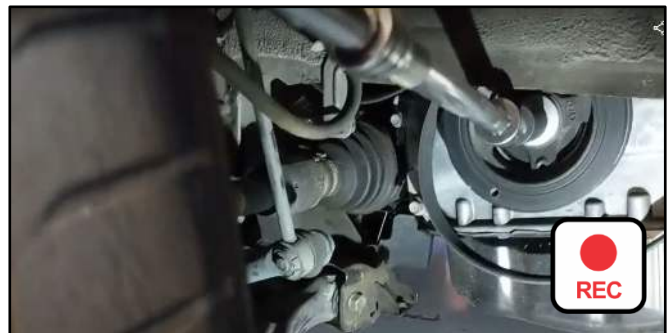
5. Show the removed drive belt and attached torque wrench to crank bolt.

**Prepare the vehicle prior to the video by removing the spark plugs and drive belt as well as setting the torque wrench to 94 lb.ft.**

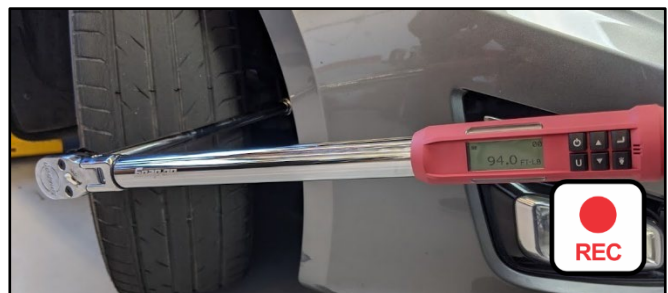
6. Show the engine being cranked and torque specification exceeding 94 lb.ft. torque.
