## TECHNICAL SERVICE BULLETIN

### Illuminated Airbag Warning Indicator Lamp With DTC B0004:1A, B0013:1A, B1405:1A, And/Or B1408:1A Stored In The RCM

24-2444

| <b>Ford</b><br>2024 Ranger | Built on 01-Apr-2024 and through 16-Jul-2024 |

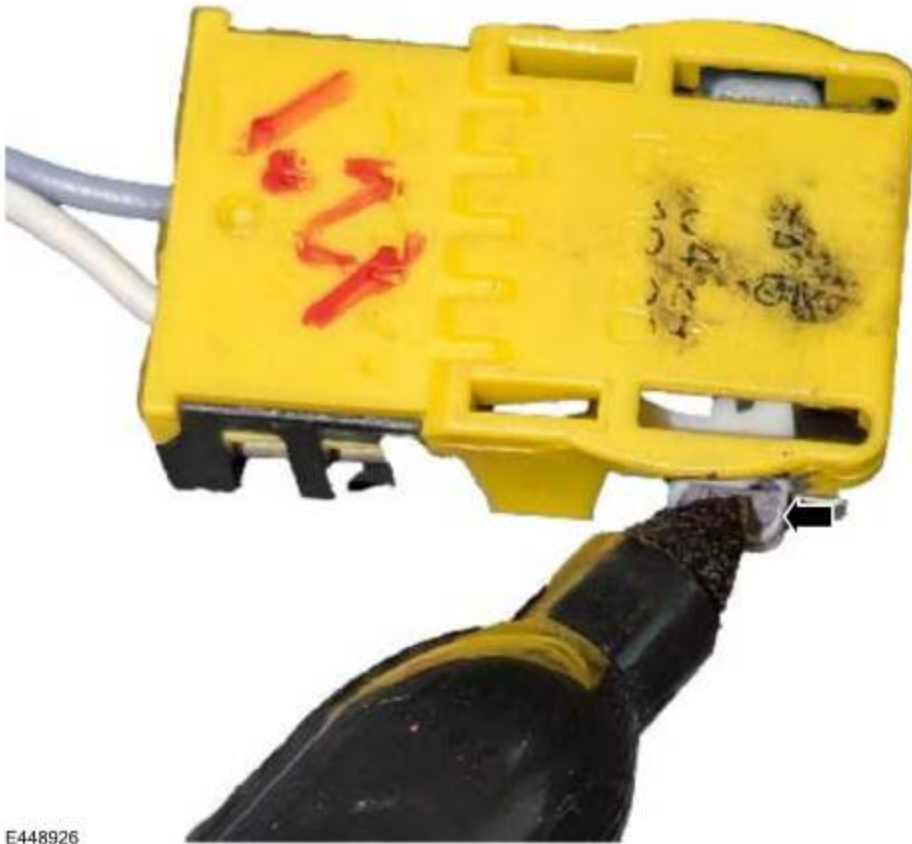
1. Gain access to and disconnect all four of the following airbag connectors: passenger side air curtain connector C9032, driver side air curtain connector C9031, passenger knee airbag connector C2433, driver knee airbag connector C2432. Refer to WSM, Section 501-20B Supplemental Restraint System.
2. On each of the 4 airbag connectors, identify the moulding number on the locking tab. This will be located on the right side ear of the locking tab as shown in Figure 1.

**3.** Do any of the four locking tabs have the numbers 02, 03, 09, 11 or 14 stamped on them or are any of the connectors damaged?

- (1). Yes - replace the affected connector(s) with a service replacement pigtail. Refer to WSM Section 501-20B.
- (2). No - this article does not apply. Refer to WSM for normal diagnostics.

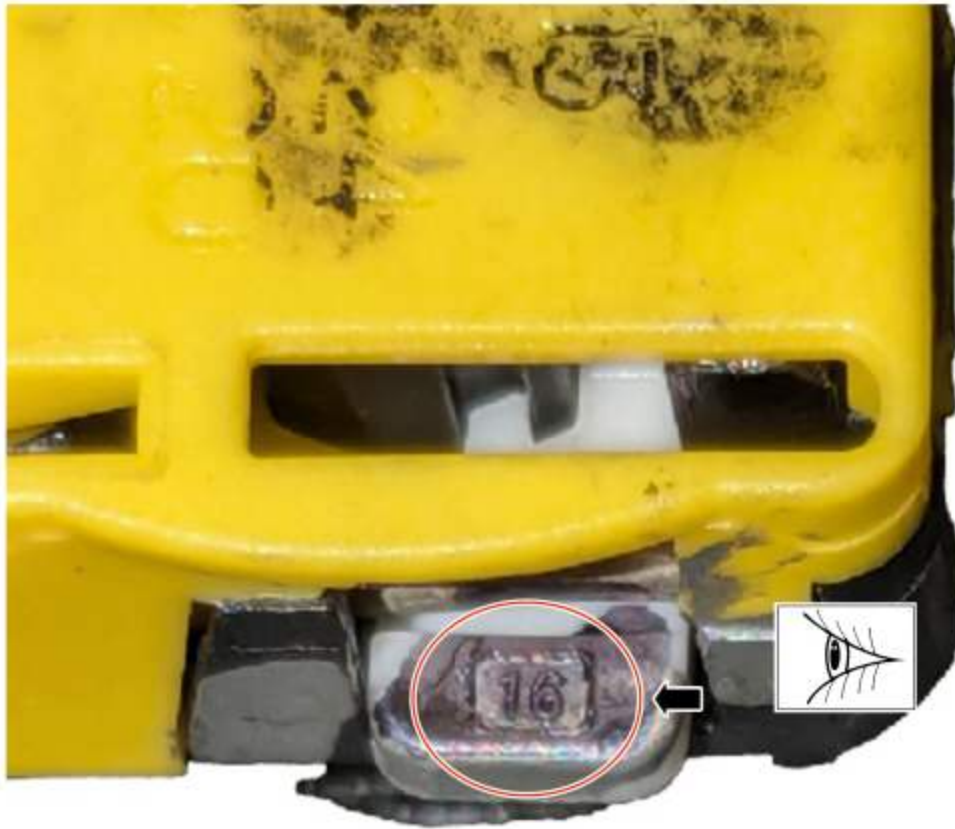
E448927

- (1). Using a black permanent marker, color the locking tab similar to Figure 2. The use of a magnifying glass or quality camera can make it easier to see the number.
